UNDERPINNING THE CONCORD ROAD BRIDGE UNDER TRAFFIC – WESTCONNEX M4 EAST PROJECT

Puvaneswary Rajarathnam¹, Toni Donegan², Sam Mirlatifi³ and Henk Buys⁴

*¹Geotechnical Engineer, ²Senior Geotechnical Engineer, ³Principal Engineer, ⁴Technical Director
Ground Engineering and Tunnelling Team, AECOM Australia Pty Ltd (^{1,3,4}Sydney, ²Melbourne), Australia*

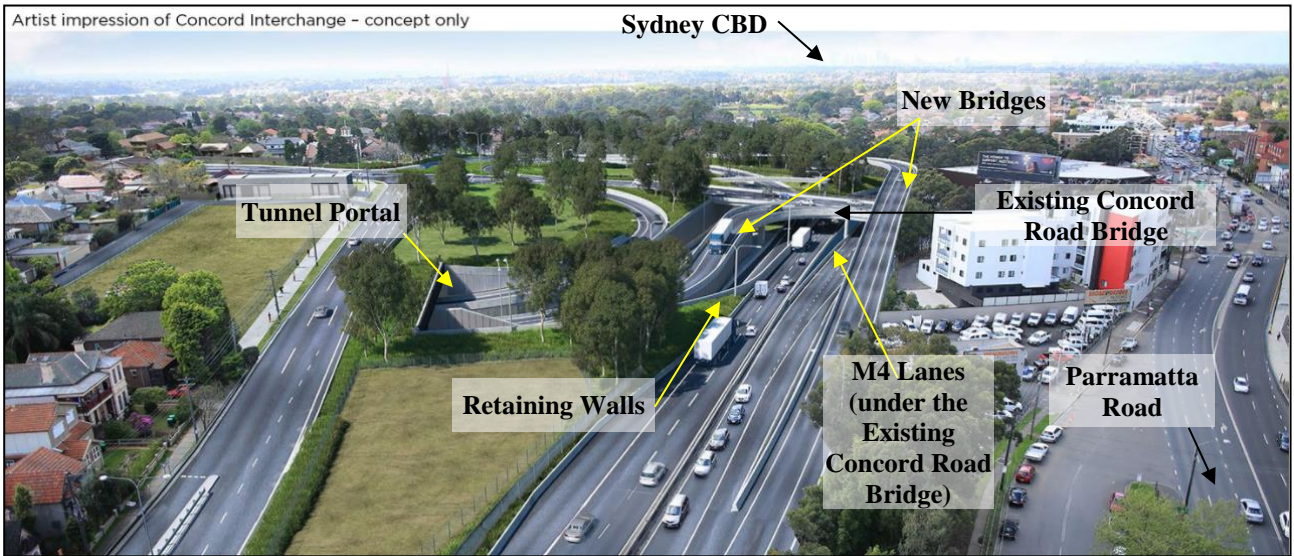
Figure 2: Artist Impression of the Proposed Concord Road Interchange – Concept

The proposed Concord Road Interchange is located approximately 10 km west of the Sydney Central Business District (CBD) (Figure 1). It is a complex junction of new bridges, a cut-and-cover tunnel portal, retaining walls and modifying the existing M4 Motorway lanes. An artist’s impression of the proposed Concord Road Interchange is shown in Figure 2. The locations of the new structures are marked up in the figure for ease of reference.

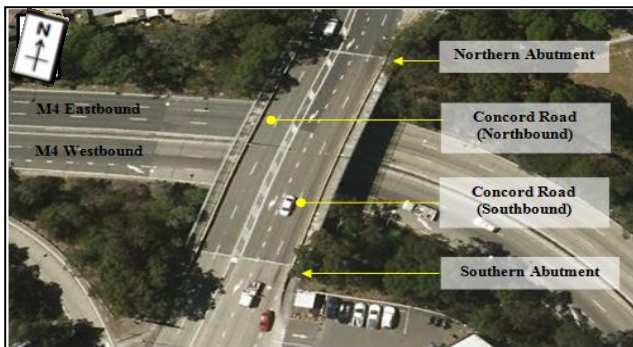
Figure 4: Plan view of the existing Concord Road Bridge circa April 2016 (Google Earth, 2017)

The existing Concord Road Bridge was designed and constructed circa 1984. It has a pre-tensioned continuous concrete bridge deck with three spans approximately 5 m above the M4 Motorway. The middle and end spans are 30 m and 10 m long, respectively. The bridge comprises four through lanes, with two lanes each way, as well as a turning lane in the southbound direction. There are 2 m-wide footpaths located along both sides of the bridge. These features are shown in plan view in Figure 4. An elevation of the bridge is shown in Figure 5. The bridge is articulated with the continuous deck rigidly connected to two piers and expansion joints at the abutment ends. The shorter end spans of the

superstructure span over the approximately 1(V):2.5(H) cut batters. The two piers comprise twin columns supported on independent spread footings. The abutments are supported on 900 mm-diameter cast-in-place bored piles at 4 m centres. The existing M4 Motorway crosses under this bridge, between the northern and southern piers. Upgrade of the M4 Motorway requires modification works to the existing Concord Road Bridge.

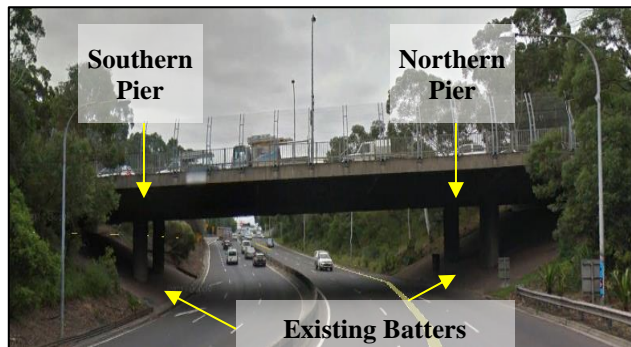
Figure 5: Elevation view of the existing Concord Road Bridge circa April 2016 (Google Earth, 2017)

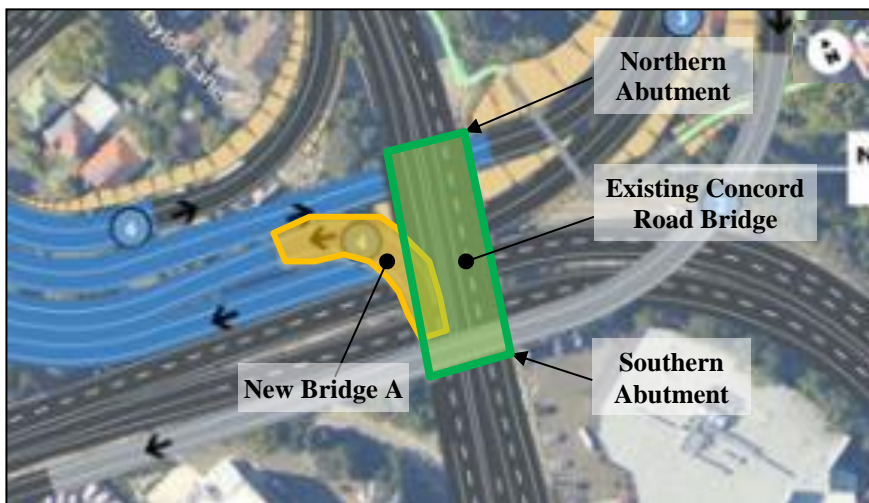
Figure 6: Proposed new bridge adjacent to the existing Concord Road Bridge – Indicative

The scope of modification works for the Concord Road Bridge include altering the alignment of the M4 Motorway below, as well as the construction of a new bridge adjacent to it ('New Bridge A') as shown in Figure 6. The existing batter at the southern abutment of the existing bridge will be cut back to accommodate the new westbound M4 carriageway under the bridge. The existing batter at the northern abutment of the bridge will be cut back to accommodate the new southbound carriageway under the bridge. Construction of these works would impact on the stability of the abutment piles, and hence it would be necessary to underpin and provide lateral restraint and underpin the existing bridge. These works presented several geotechnical design and construction challenges for the project team.

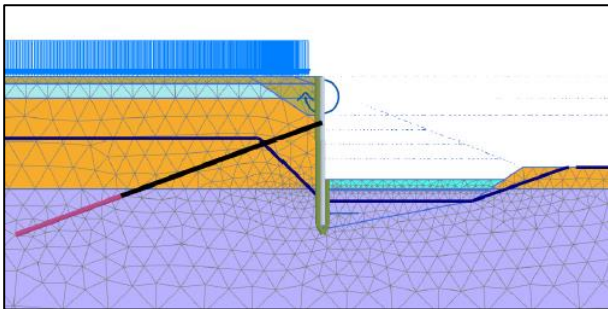
Figure 8: Example PLAXIS 2D model at southern abutment

Geotechnical analysis of the soil-structure interaction was carried out using finite element (FE) analysis in both PLAXIS 2D and PLAXIS 3D (version 2015). The PLAXIS 2D analysis was carried out initially to assess the feasibility of the design solution. A plane strain condition was assumed in the analysis. The 15-node elements, using the Mohr Coulomb constitutive soil models were used to simulate the soil and rock behaviour. The piled abutments were modelled using plate elements. Interface elements with reduction factor of 0.67 were used to simulate the contact between the piles and the soil / rock. Analysis was undertaken considering the short term and long term bending stiffness of the piles to account for additional deflections due to creep under sustained loading. Seismic analysis was

also undertaken using the pseudo-static approach by Mononobe-Okabe, described in AS4678. An example PLAXIS 2D model and output is shown in Figure 8 to Figure 11.

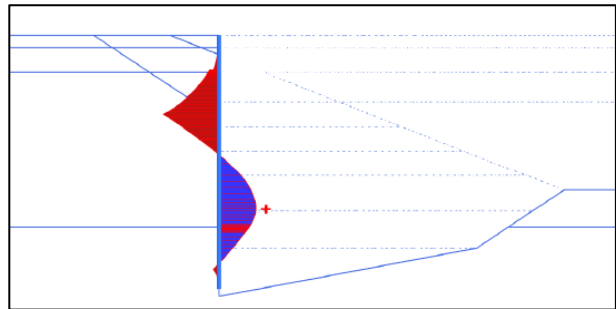
Figure 9: Example bending moment profile from PLAXIS 2D

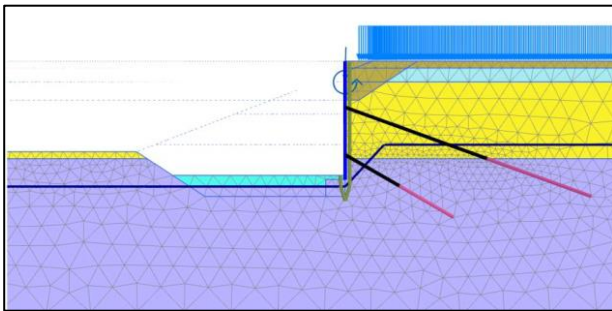
Figure 10: Example PLAXIS 2D model at northern abutment

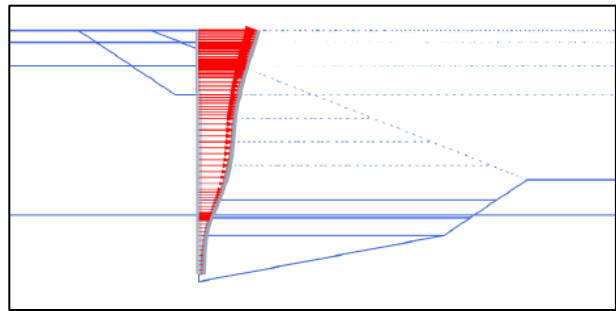
Figure 11: Example deflection profile from PLAXIS 2D

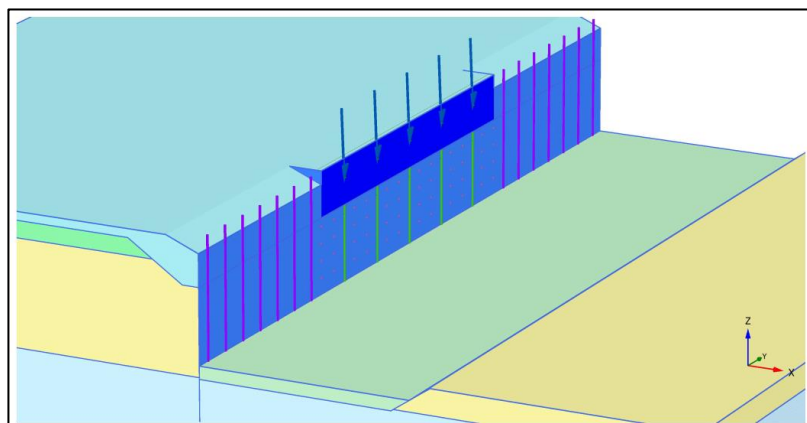
Figure 12: Example PLAXIS 3D model

The PLAXIS 3D analysis was carried out to provide a better estimation of earth pressures and 3D effects acting on the piles and taken up by the intermediate rock bolts. An example PLAXIS 3D analysis is shown in Figure 12. The anchor spacing and prestress forces were adjusted in this analysis to optimise the design, primarily to assess if pile bending moment, shear force and deflection were within the capacity assessed by the structural design engineer.

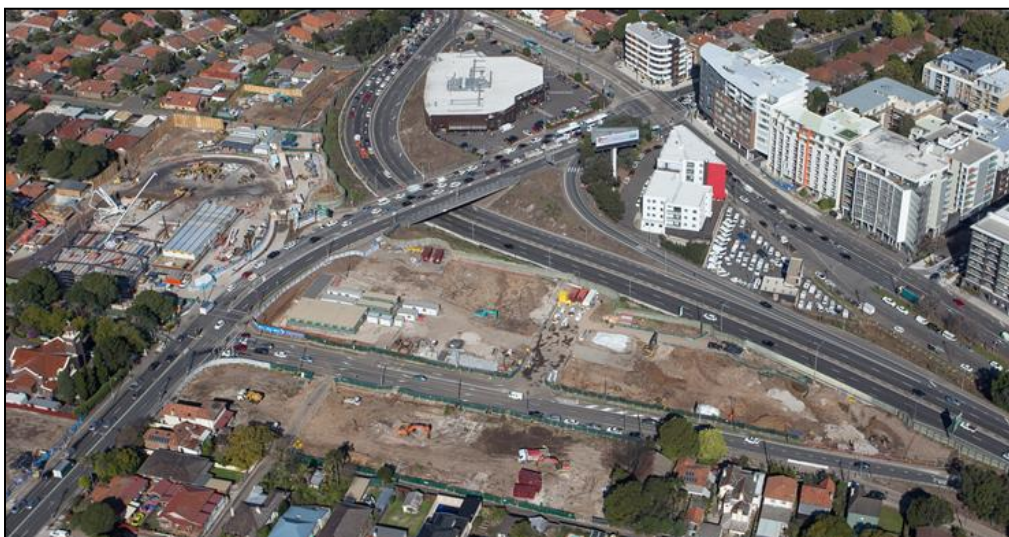
Figure 13: Construction works at the proposed Concord Road Interchange in December 2016 (site photo).

Construction works for the proposed Concord Road Interchange commenced in 2016. Figure 14 shows the extent of construction works as at December 2016. Preparatory work for surface works was being carried out at that time. Figure 15 shows that the works have since progressed substantially by April 2017. By this time, the M4 lane realignment works had already begun, as shown in Figure 15. Parts of the cantilevered bored pile retaining walls adjacent to the existing Concord Road Bridge had also already been constructed by that time, as shown in Figure 16.

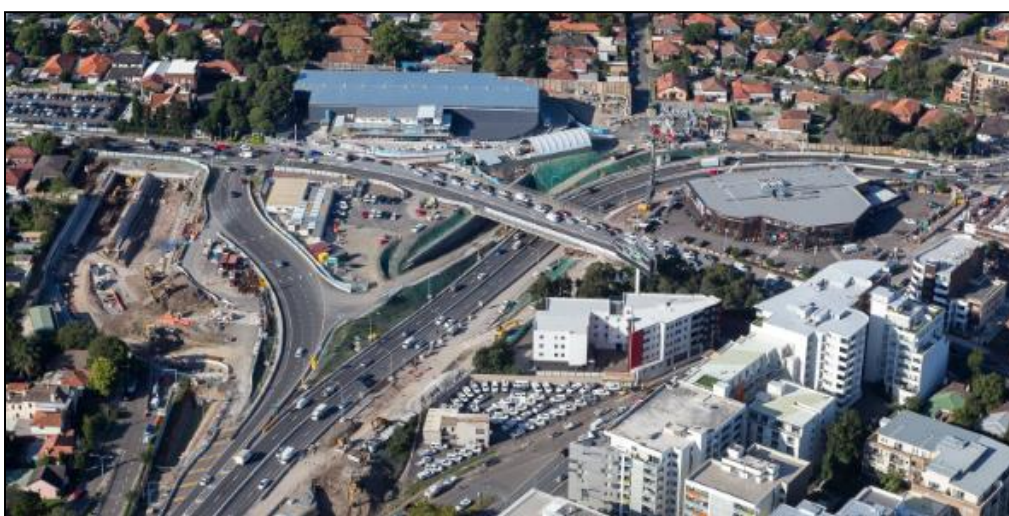
Figure 14: Extensive construction works at the proposed Concord Road Interchange in April 2017 (site photo).

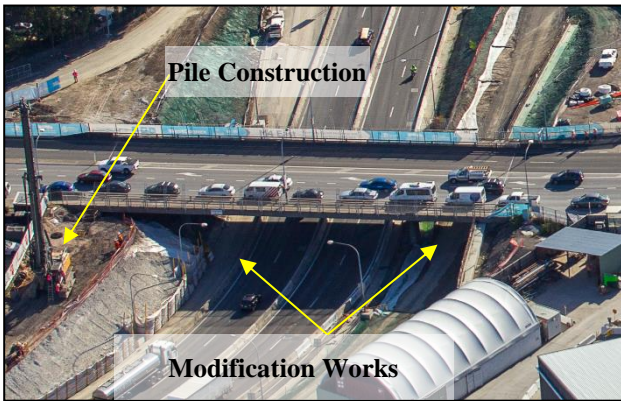
Figure 15: Pile construction and M4 lane works at the existing Concord Road Bridge in April 2017 (site photo).

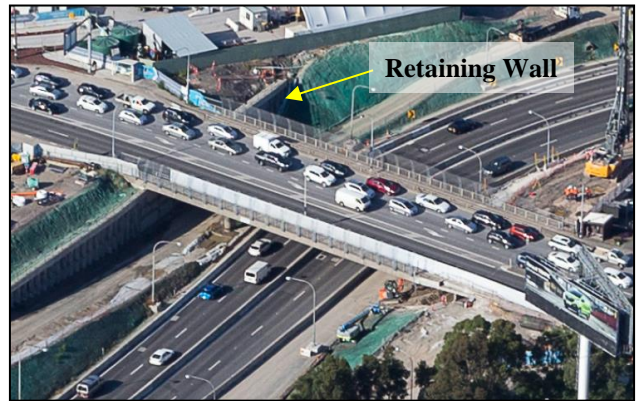
Figure 16: Cantilevered bored pile retaining wall along the northern side of the existing Concord Road Bridge in April 2017 (site photo).

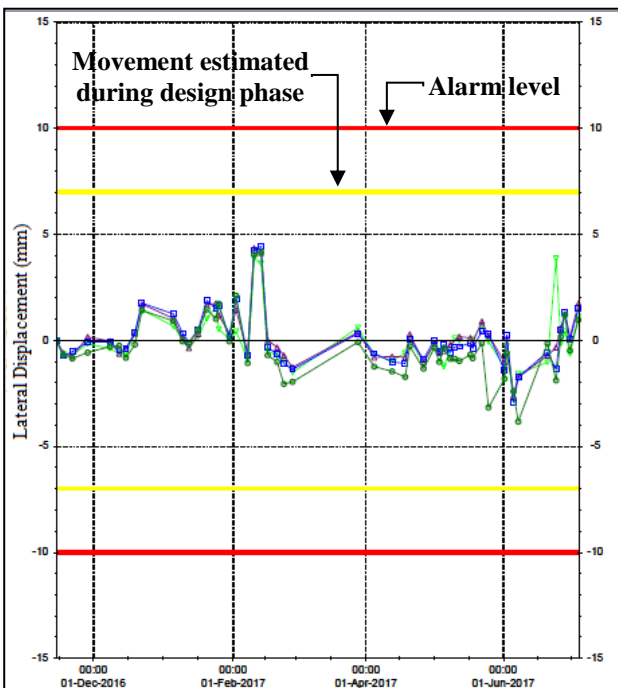
Figure 17: Measurements of optical survey targets on the northern abutment of the existing Concord Road Bridge.

Measurements from optical survey targets on the northern and southern abutments of the existing Concord Road Bridge are shown in Figure 17 and Figure 18, respectively. It can be seen from these figures, that the measured movements of the bridge abutments are smaller than the movements estimated during the design phase. This difference between the measured and estimated abutment movement could potentially be due to the presence of stiffer material behind the bridge abutments than what was assumed for the base case during the design phase.

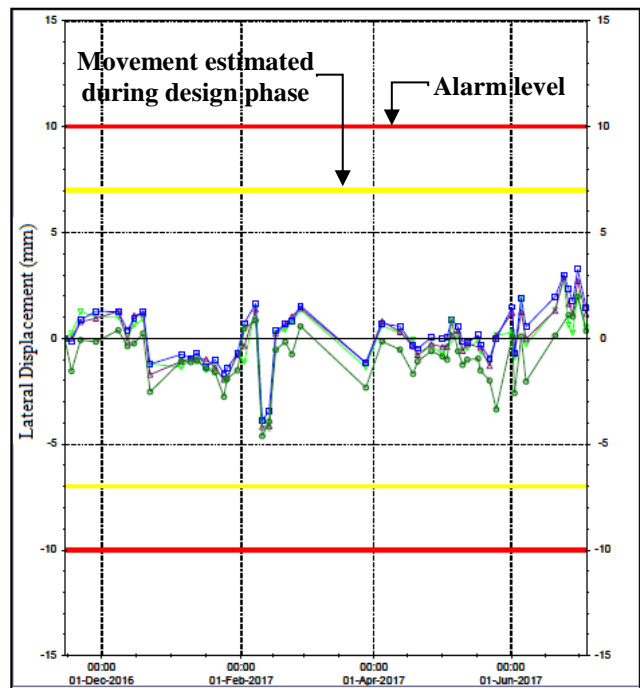
Figure 18: Measurements of optical survey targets on the southern abutment of the existing Concord Road Bridge.
