SLOPE RISK ANALYSIS SUPPORTING POST-DISASTER RECOVERY: THE 2016 KAIKŌURA EARTHQUAKE

ABSTRACT

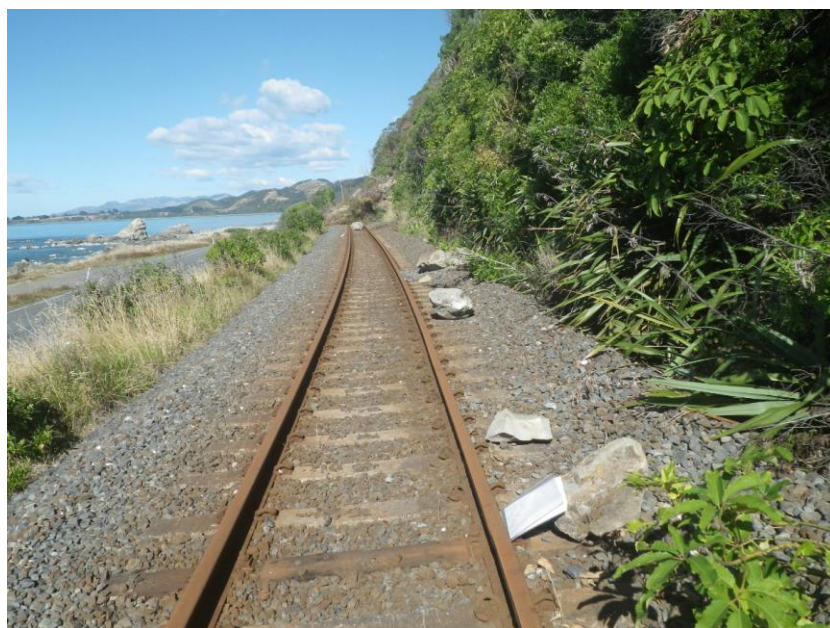
Figure 3: Railroad acting as a catch bench for rockfall

Existing debris observed from the site mapping provided a baseline of run-out, including boulder size and distance from source. Site mapping showed where debris had stopped and how it had been stopped (e.g. by trees or naturally come to rest). An important observation was the spatial relationship between the railroad and SH1, as the railroad in many places creates a rockfall catch bench that reduces P_t (Figure 3).

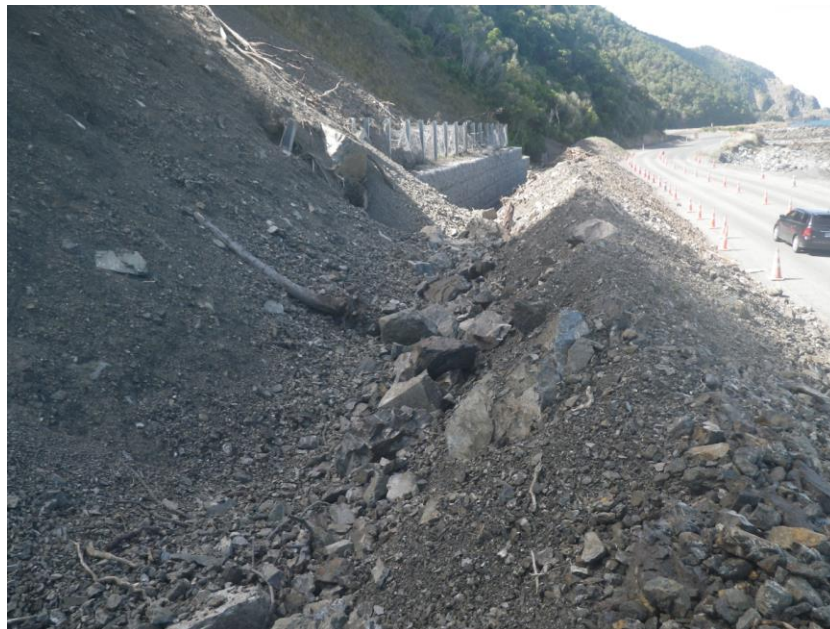
Figure 4: Temporary Rock Bunds. Note recent boulder fall.

Temporary mitigation included shipping containers and un-engineered debris berms at the toe of high risk slopes (Figure 4). The presence of temporary barriers demonstrated a significant reduction in P_t .

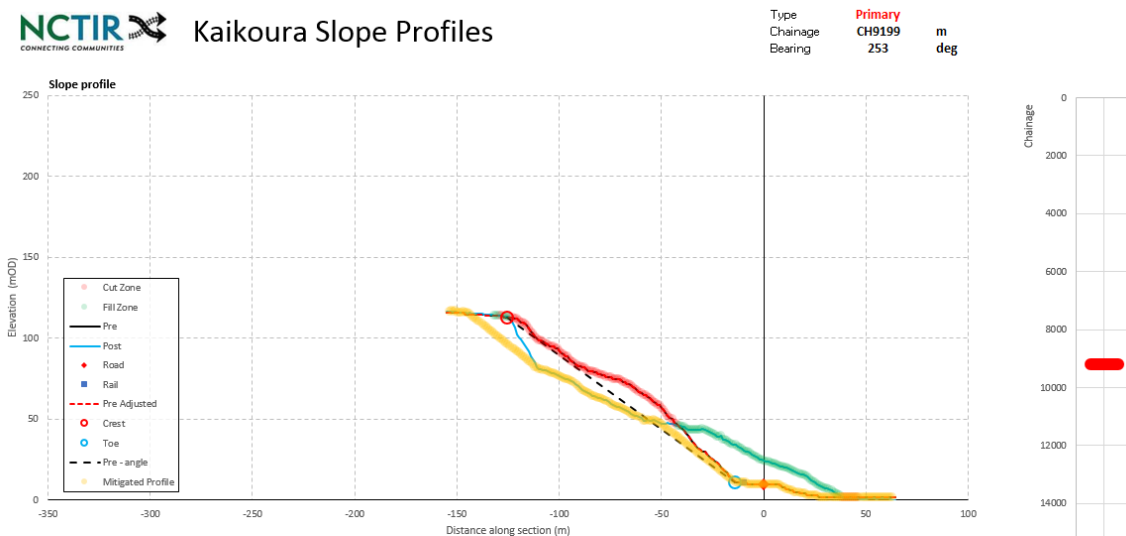
Figure 5: Automaed grading cross-sections showing pre- and post- slope profiles and initial regrading profiles.

To support the process, GIS was used to automate generic slope cross-sections. Figure 5 shows an example pre- and post-earthquake slope profile with a pre-earthquake linear profile from the toe back to crest (dashed) and a mitigated profile (yellow). This allows the volume of material in the source area and the debris has been quantified. The proposed mitigated slope profile is then able to be directly imported into a rockfall analysis packages to allow iteration of design options.
