GEOTECHNICAL LESSONS FROM AN EXTREME GEO-DISASTER: VISIT TO THE MAY 2008 WENCHUAN EARTHQUAKE ZONE, CHINA

M.J. Eggers
Pells Sullivan Meynink

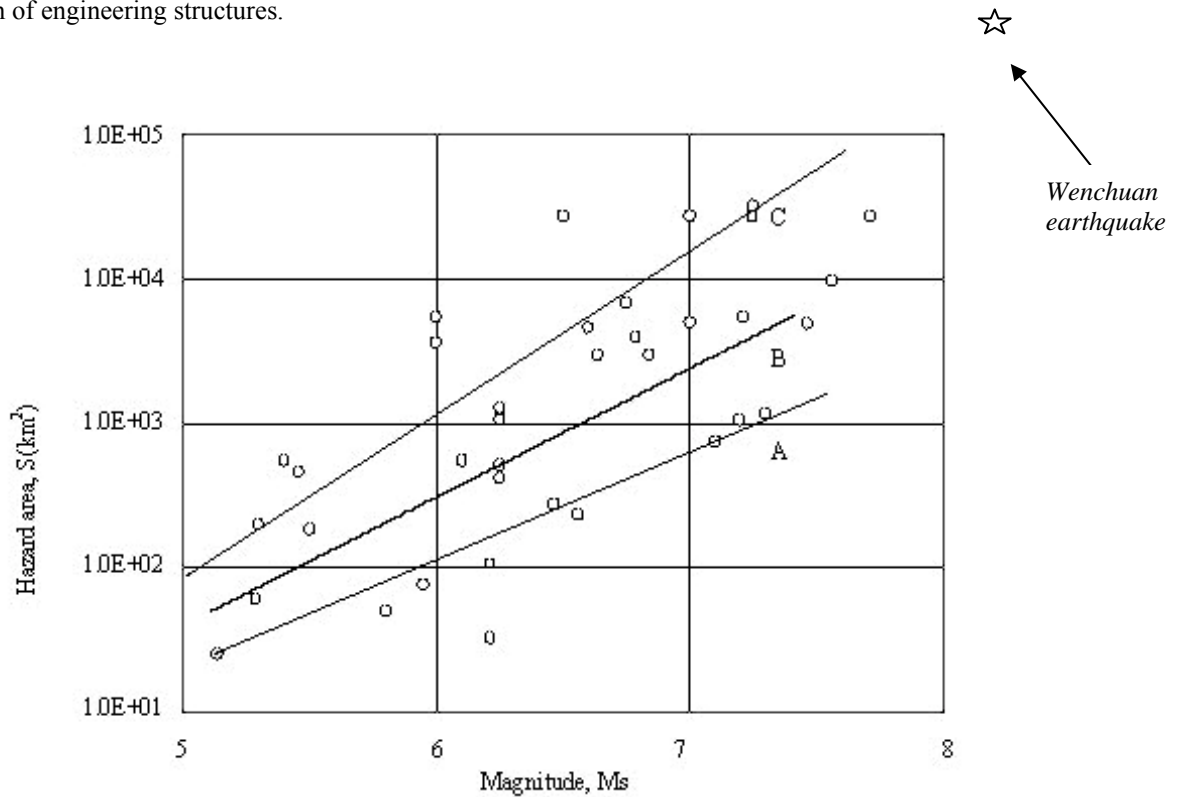
Figure 1: Seismic hazard area versus earthquake magnitude (Keefer 1984 as presented in Wang *et al* 2009).
A – lower band, B-mean band, C-upper band.

Extreme disasters are characterised by the large area that is impacted and evaluating the limits of the affected area is a key component of the risk assessment. For earthquakes the impact area is related to magnitude as studied by Keefer (1984) in relation to landslides (Figure 1). In the case of the Wenchuan earthquake the disaster area covered 440,000 km^2 which is larger than the maximum area of historical events. Factors other than magnitude must also contribute such as susceptibility of geological structures, topography, population density and location of engineering structures.

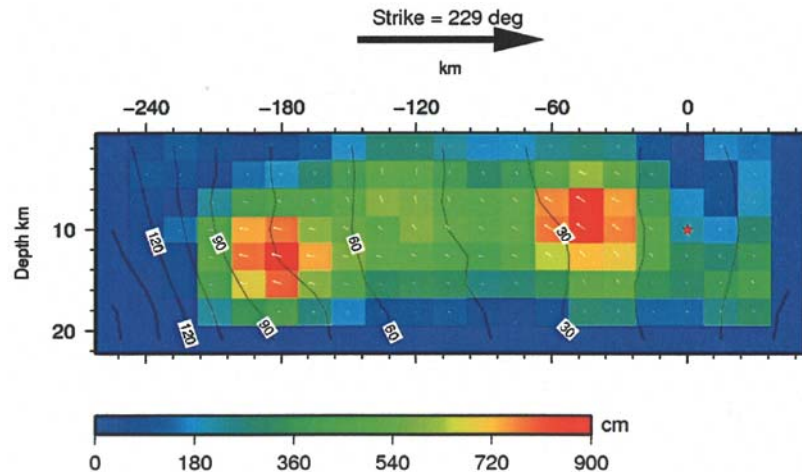
Figure 5: Cross section of slip distribution; hypocentre location is indicated by red star, slip amplitude is shown in colour, motion direction of the hanging wall relative to the footwall is shown by the white arrows and the contours show the rupture initiation time in seconds (http://earthquake.usgs.gov/earthquakes/eqinthenews/2008/us2008ryan/finite_fault.php).

The primary geological structure of the earthquake was the Yingxiu-Beichuan fault which ruptured for a length of some 220 to 300 km over a duration of 120 seconds. The rupture plane was assessed as striking 229° (USGS website, July 2010) with rupture propagation in a single direction towards the northeast (Figure 5). Vertical offsets ranged from 1.6 m to 10.3 m, averaging 3.4 m while horizontal offsets varied from 0.2 m to 6.8 m, averaging 2.9 m (Li *et al.*, 2009). Hence the ratio between thrust and dextral strike-slip movement was approximately 1:1 with the relatively strong vertical component of movement controlled by the imbricated thrust tectonics. Some key findings on the primary rupture by Li *et al.*, 2009 include:

- The largest offset did not occur at the epicentre,
- Surface rupture was smaller than the largest underground displacement by around 60-70%,
- However, the largest surface rupture was approximately coincident with maxima displacement underground and
- Rupture during this earthquake occurred in areas with historical displacements suggesting they are likely to be the location of rupture during future events.

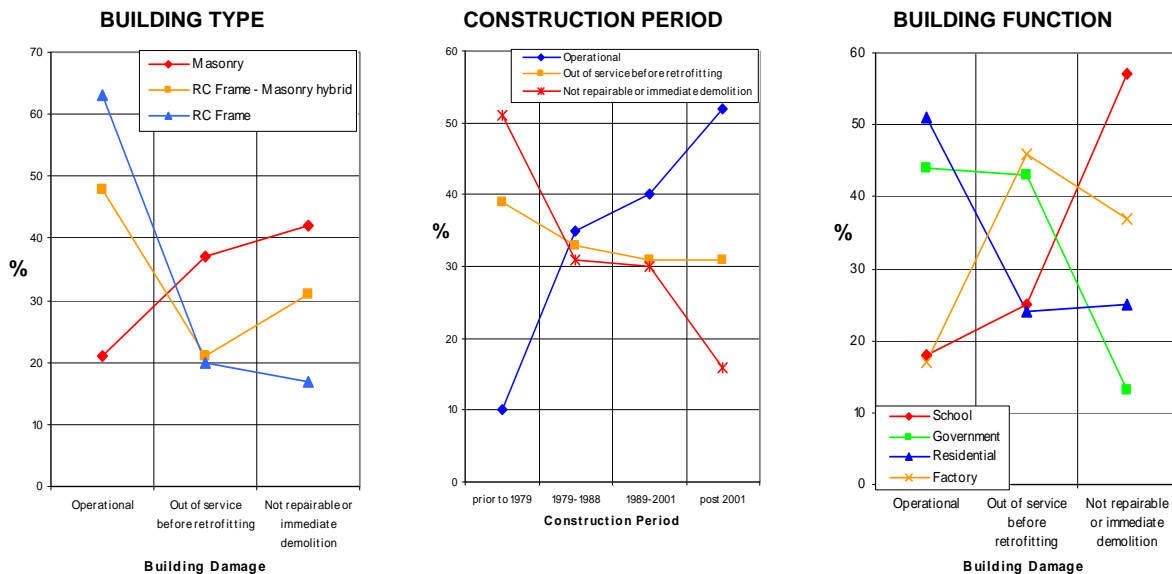
Figure 6: Results of building seismic damage survey (Ye et al 2008).

The level of damage was assessed by building type as presented in Figure 6 with the following conclusions (Ye *et al* 2008).

Assessing damage by building function reveals an interesting trend (Figure 6). The worst performing buildings were schools where 57% collapsed or were deemed unrepairable. This contrasts with government buildings where only 13% were in the worst category. A large number of school buildings comprised masonry structures with large window openings in the load bearing walls and Ye *et al.* (2008) state some of these buildings were constructed without any seismic design and construction measures. Government buildings, on the other hand, are typically RC frame structures which performed relatively better. About half residential buildings remained operational, a quarter required retrofitting and quarter were unrepairable or collapsed.

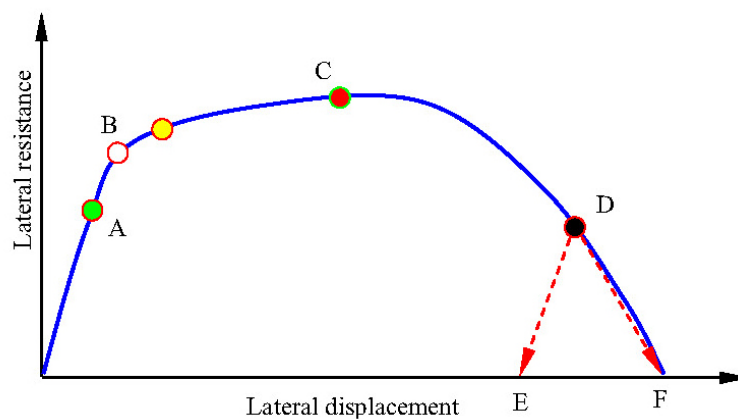
Figure 7: Lateral load resistant behaviour of structures (Ye *et al.*, 2008).

Ye *et al.* (2008) describe the Phase 1 design as the “fundamental strength safety margin” and the Phase 2 check as the “integrated safety margin”. On a lateral resistance to displacement curve (Figure 7), Phase 1 is represented by the curve between points A and B while Phase 2 corresponds to the curve between points B and C. They go on and suggest there should be a third phase which considers the portion between points C and D, the latter being the collapse point. They called this phase the “unexpected safety margin” and would take account of the low probability, high magnitude and high consequence event and is probably equivalent to Tsang’s “intrinsic conservatism”. In other words, the safety margin between points C and D would help prevent building collapse; certainly during the Wenchuan earthquake many buildings were severely damaged with deformations greater than point C but did not collapse which saved lives.

In summary, the Phase 1 fundamental safety margin helps secure the building under predicted, relatively minor earthquakes; however, the Phase 2 integrated and Phase 3 unexpected safety margins are required to resist severe earthquakes.

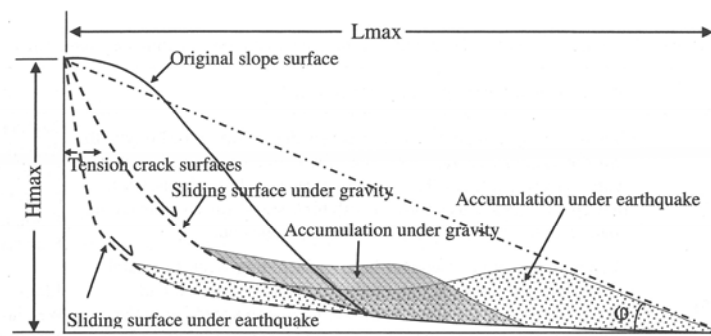
Figure 8: Schematic section showing characteristics of “shattering-sliding” landslide (Huang *et al.*, 2009).

The shattering-sliding mechanism (Figure 8) was the most common slope failure type. Discontinuities seem to play a major role in influencing the propagation behaviour of the seismic waves and can form a stepped sliding surface at the base of the shattered and disintegrated rock mass. Several sub-types are defined based on the role of structure: tension crack, bedding or shearing shattering-sliding and a mixture sub-type. It is probable that non-daylighting but unfavourably oriented bedding and foliation plane shears were a major control on instability with toe breakout through the “shattered” rock mass.

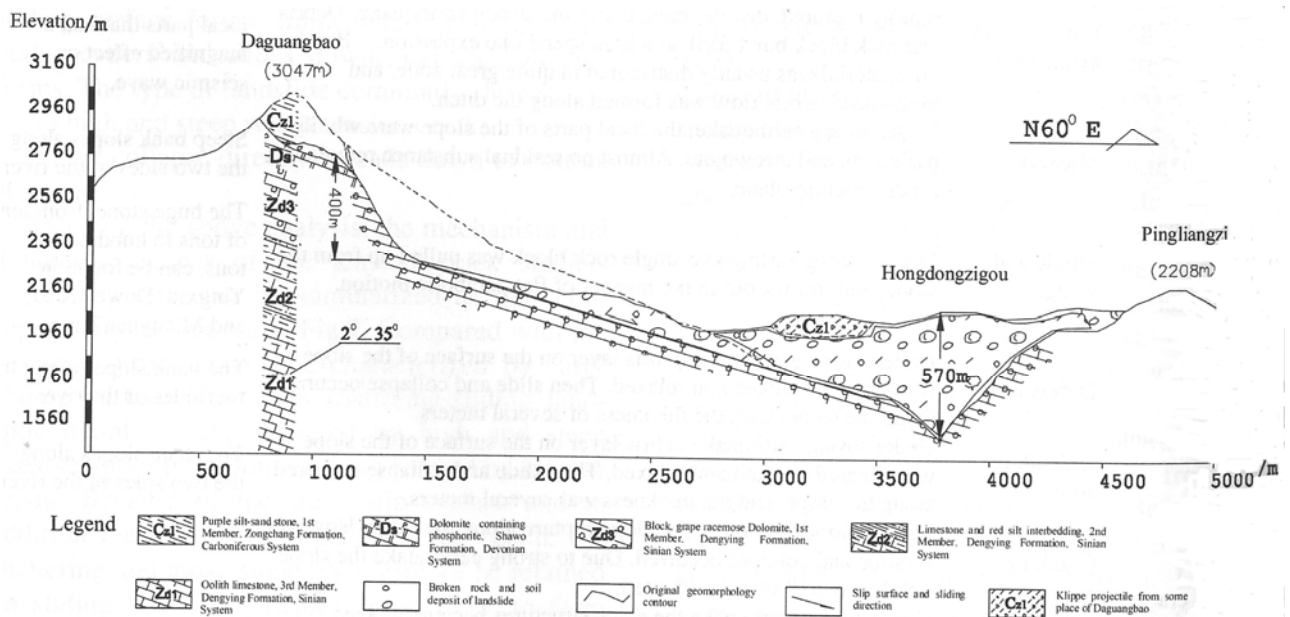
Figure 9: Longitudinal section through the Daguangbao landslide (Huang *et al.*, 2009).

Shattering-sliding failures occur at high speed and result in long travel distances with runout zones ranging between 600 m and 1300 m. In some cases the shape of the debris lobe was said to resemble an “airplane wing” resulting in an aerodynamic effect which was considered to contribute 180-350 m to the runout distance (Yin *et al.*, 2009). The largest example of the shattering-sliding mechanism is the Daguangbao landslide (Figure 9) situated 7 km from the Yingxiu-Beichuan fault. The slide geometry comprises (Huang *et al.*, 2009):

- 4.2 km long in the main slide direction,
- Up to 2.2 km wide,
- An area covering 7.8 km²,
- With an estimated volume of 742 million m³.

This failure formed a landslide dam up to 690 m high, probably the highest landslide barrier dam known in the world.

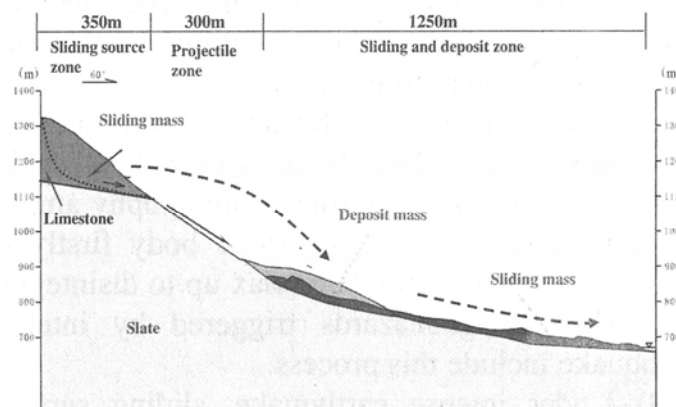
Figure 10: Displacement process of the Donghekou landslide showing the “ejection” mechanism (Huang *et al.*, 2009).

The ejection mechanism can involve movement of a single or small group of blocks or ejection of a large portion of slope. Block ejection occurred with rocks up to hundreds of tonnes in size. A 300 ton block at Yingxiu was estimated to have been ejected by a ground acceleration of 1.38 g (Huang *et al.*, 2009). The Donghekou landslide, situated 3 km from the primary Yingxiu-Beichuan fault, is an example of a large-scale slope ejection with an estimated projectile distance of 300 m (Figure 10).

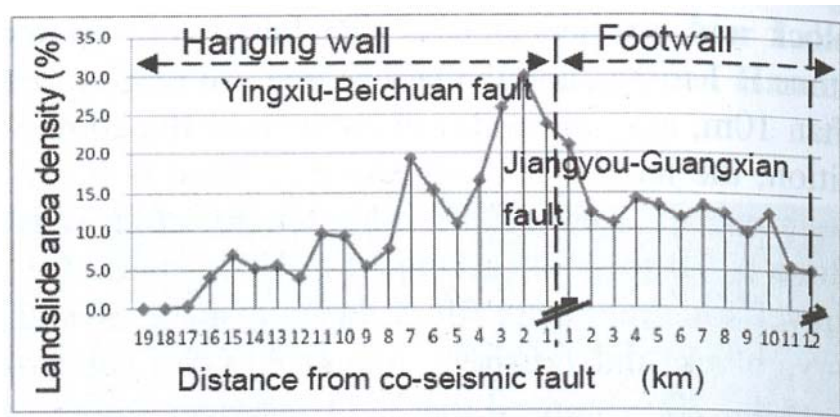
Figure 11: Landslide distribution between hanging wall and footwall of fault (Li *et al.*, 2009b).

Significantly, density of landsliding on the two sides of a major ridgeline was quite different. Slopes opposing the central fault contained a higher density of failures compared with slopes facing the fault with the same pattern for both hanging wall and footwall terrain. Further, slopes orthogonal to the fault direction are more susceptible than slope aspects parallel to the fault. These topographic relationships of landslide distribution are likely to be controlled by the response of different slope configurations to the dominant seismic wave direction and the corresponding amplification effect.

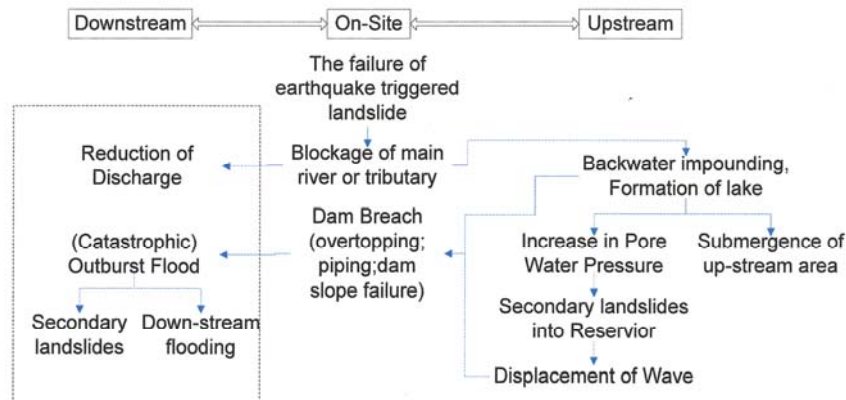
Figure 12: Hazards related to landslide dams (modified by Xu *et al* 2009 from Korup 2005).

Barrier or earthquake lakes formed by landslide dams are considered to represent the most dangerous earthquake hazard (Costa and Schuster 1991). The obvious hazard is created by flooding upstream of the dam and dam-break resulting in catastrophic flooding downstream, however, the geohazard model is actually more complex as originally assessed by Korup (2005) and summarised in Figure 12.

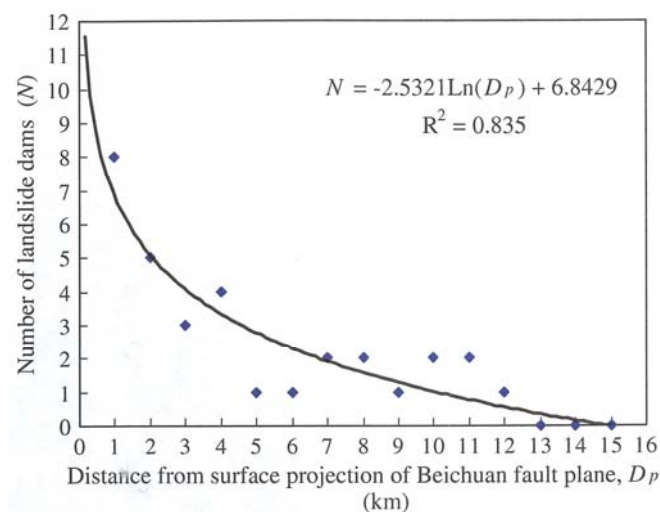
Figure 13: Landslide dam concentration versus distance from the primary fault zone (Xu *et al.*,2009).

In the Wenchuan earthquake area 256 barrier lakes were identified with data available for 32 lakes that posed a threat to people (Xu *et al.*, 2009). The relationship between landslide dam concentration and distance from the Yingxiu-Beichuan fault is presented in Figure 13, which shows a logarithmic decrease in dam numbers away from the primary structure.

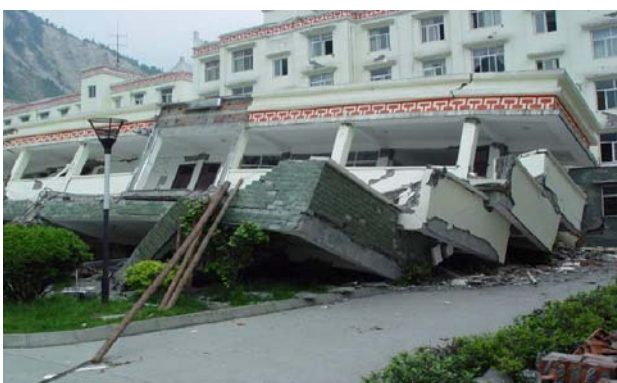
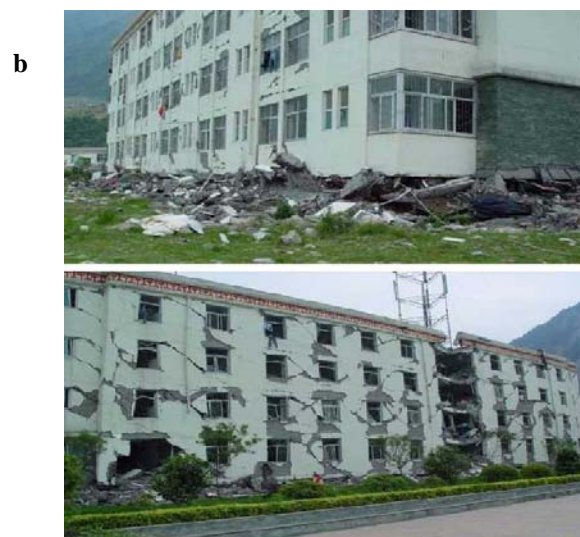
a

b

Figure 14: Examples of earthquake damage and destruction from Yingxiu Middle School; a - classroom building, b – collapsed first storey of dormitory building

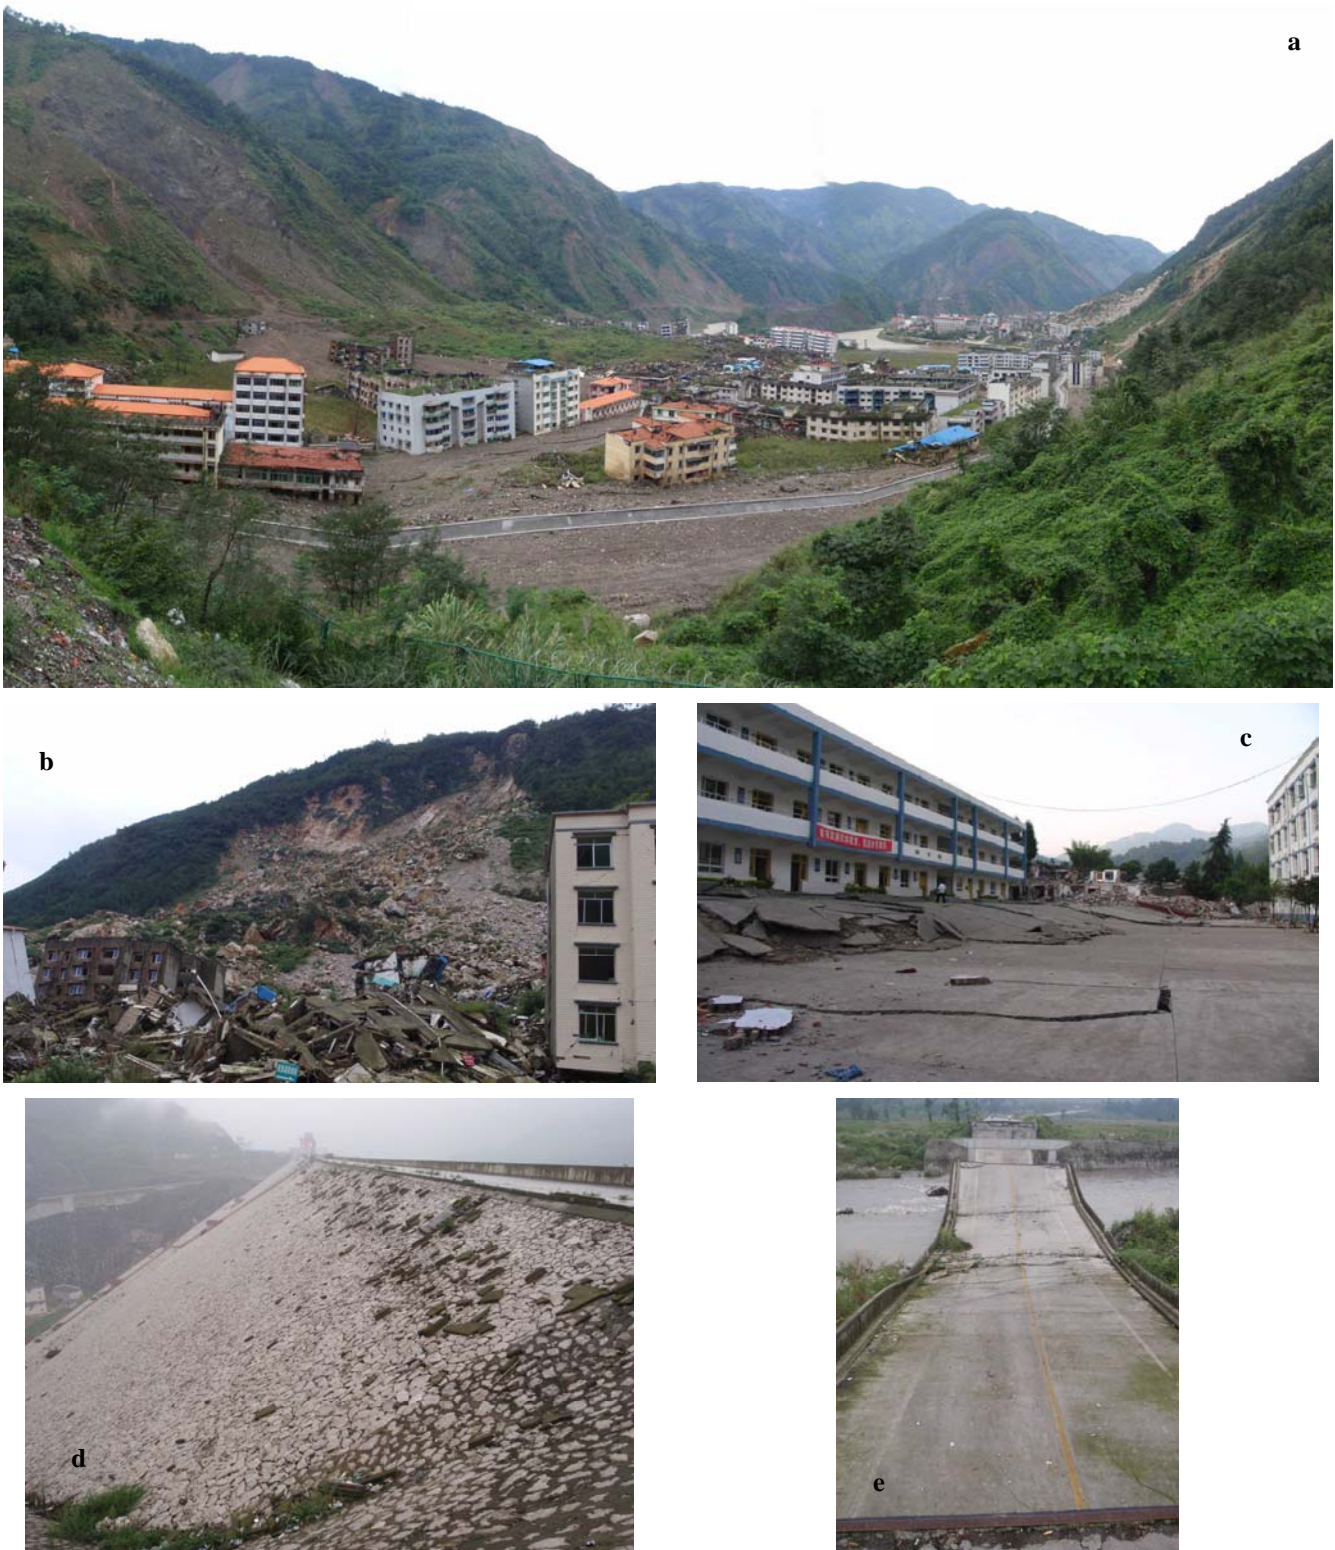
Figure 15: Examples of earthquake damage and destruction; a – overview of destruction at Beichuan Town, b – Beichuan Middle School landslide, c – fault rupture in school playground at Bailu Town, d – downstream face of Zipingpu dam, e – collapsed middle span of Xiaoyudong Bridge

- Subsidence of the crown in the central part of up to 0.81 m with 0.3 m horizontal movement,
 - Deformation of the lower downstream face over an area of about 1000 m²,

- Deformation of structural elements through out the face of the dam including widening of construction joints up to 15 cm in the upper face,
 - Landslides throughout the reservoir slopes.

The total reservoir volume of the dam is approximately 1.2 billion m³ of water. After the initial survey of damage, the reservoir was discharged through the emergency spillway to lower the water level. However, only a low increase in overall seepage flows (<15 l/s) was recorded and inspection of the grouting gallery indicated no serious damage to the grouting curtain or interior of the dam (Wang, 2009b). Repair works were completed within 3 months and power generation was resumed. One hundred fishermen were reported to have been killed
