# DESIGN AND CONSTRUCTION OF AN IMPERMEABLE SILT CURTAIN IN A TIDAL ZONE

<sup>1</sup>Bob Batchelder, <sup>2</sup>Jillian Smith, <sup>3</sup>Danielle Starring, <sup>4</sup>Kate Cole

<sup>1</sup>Principal Geotechnical Engineer, GHD, Sydney, <sup>2</sup>Senior Maritime Engineer, GHD, Sydney, Australia, <sup>3</sup>Technical Advisor, Thiess Services, Sydney, <sup>4</sup>Senior Project Engineer, Thiess Services, Sydney, Australia

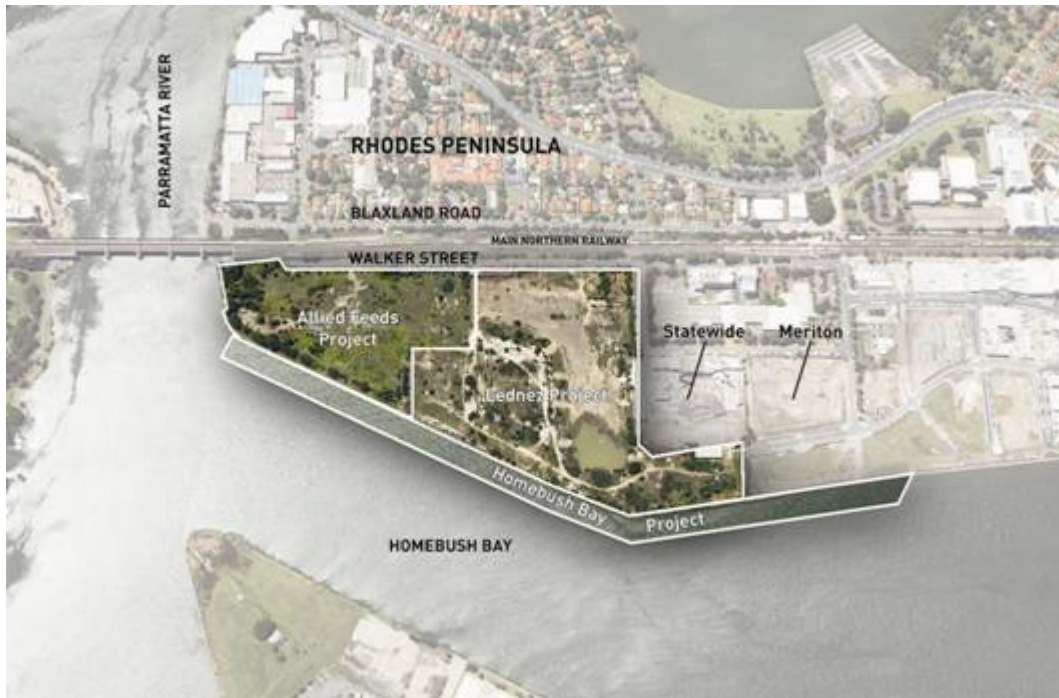
Figure 1.1: Aerial View of Rhodes Peninsula

The original approved area for sediment excavation occupied approximately 5.2 ha, and extended on average 45 m from the existing seawall over a length of 1160 m. Figure 1.1 shows an aerial view of the bay remediation footprint and Figure 1.2 shows interpreted surface concentration of dioxin in the eastern part of Homebush Bay. Within this area, under the site rehabilitation requirements, sediment was to be removed to a depth of 0.5 m below the seabed, and the excavation reinstated with clean materials from the Lednez site, placed over a geotextile layer.

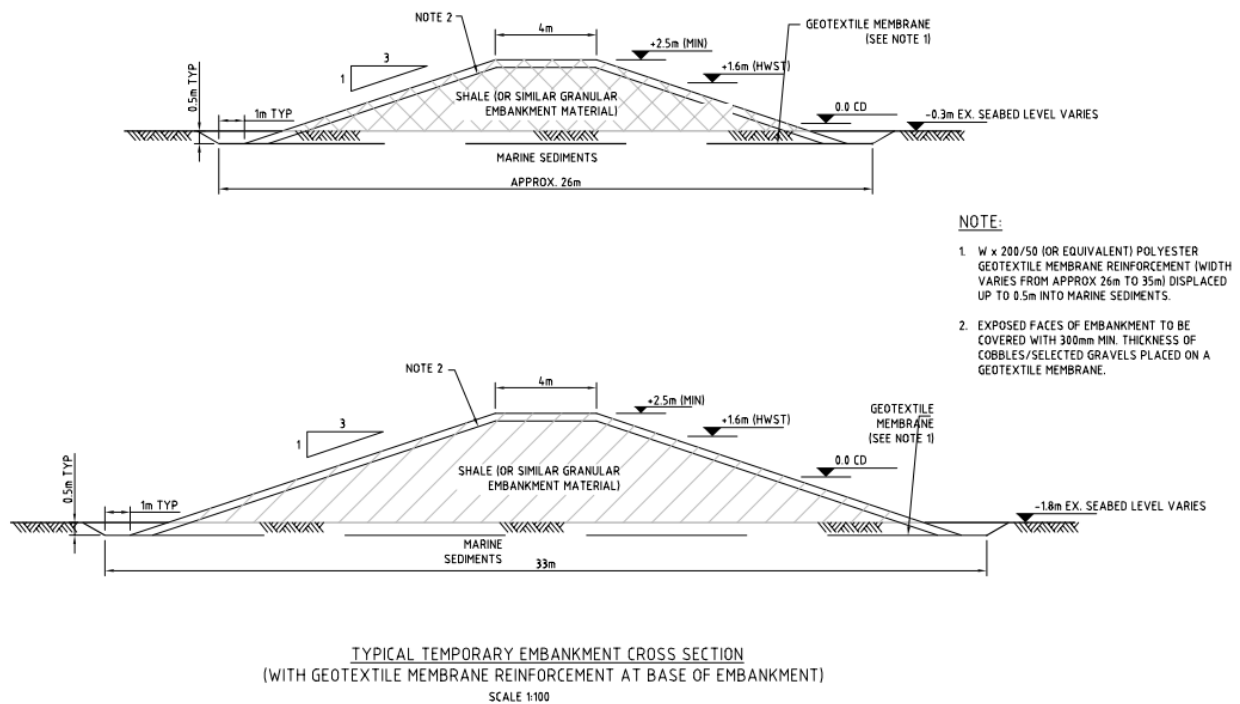
Figure 2.1: Typical cross section of reinforced embankment in line with original approval.  
 (GHD Dwg. 21-1460700-S008, 2007)

The original bay sediments remediation design comprised a series of earthfill cofferdams constructed out into the bay, to cover the full 1100m length of foreshore. These structures would have required ‘end dumping’ earthfill into deep, soft mud to form the embankments, which would settle and likely mix (even with geotextile underlay) with the underlying very soft mud. The embankments thus produced would have been up to some 7m in depth of construction and of approximate base width between 26 m to 35 m as shown in Figure 2.1.

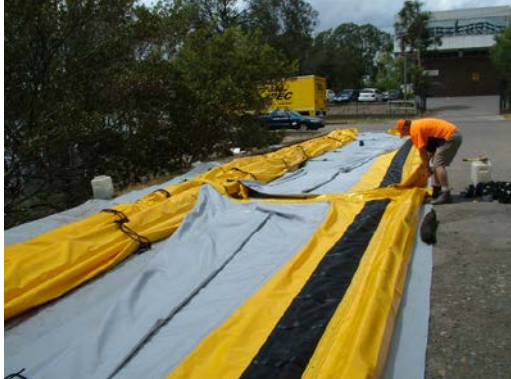
<p><b>Plate 2</b>                  Installing floats inside the pre-manufactured WEB prior to installation in the Bay</p>

allowed water to move through the upper section of the WEB to enable the tide to equalise on either side. (Ref Plate 2).
