# GEOTEXTILES IN SPECIALIST MARINE APPLICATIONS: AN AUSTRALIA PERSPECTIVE OVER 32 YEARS

W.P. Hornsey

*Geofabrics Australasia Pty Ltd, Gold Coast, Australia*

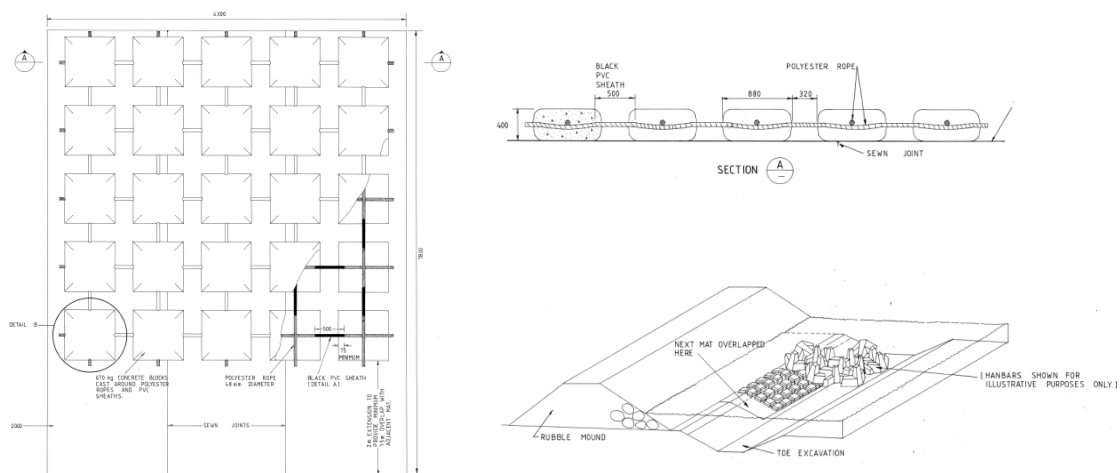
Figure 3: Arrangement of geotextile concrete block mats (*Andrew Dunne*)

The robustness of the block mats was demonstrated on several occasions during construction, when two were dropped while hanging from the crane and three were dragged out of the trench and onto the construction platform by the dragline bucket with little or no damage occurring. All five were subsequently re-used in the construction.

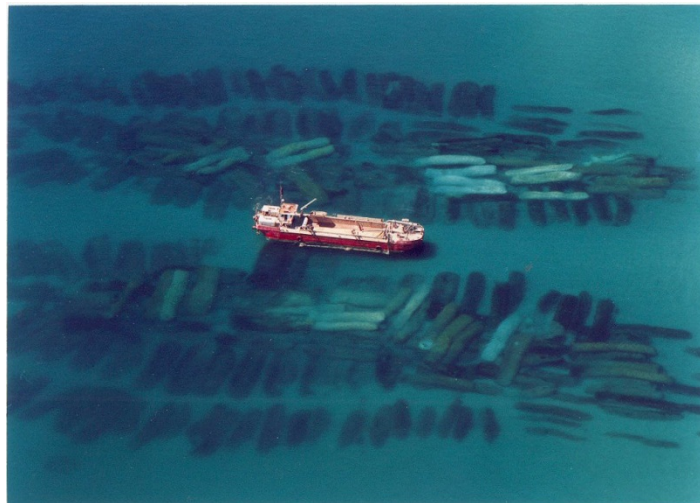
Figure 4: Placement of containers using a split hulled barge

Nearly 400, 20 m long mega sand containers varying from 3.0 m to 4.6 m in diameter, were placed using the split hulled, trailing suction hopper dredge, *Faucon*, fitted with computer interfaced DGPS. This purpose fitted out vessel, was again unique, in that a single vessel was used to carry out all the functions required to construct the reef from filling the container to accurate location and placement. The containers were accurately filled utilising a calibrated flow density meter, ensuring repeatability and consistency of the construction. The marine contractor was required to work in very difficult conditions. These became progressively worse as the height of the structure was raised, resulting in shallower water and increased wave heights above the structure due to shoaling. Notwithstanding these difficult conditions, the contractor was still able to manoeuvre his ship in such a way that containers were generally placed to a horizontal accuracy of  $\pm 0.5$  m (Figure 4).

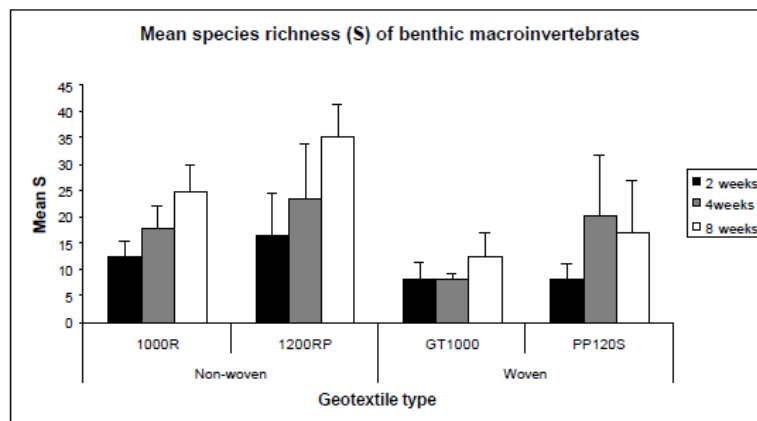
Figure 5: Ability of Geotextile to support and encourage marine life

The reef provided a full scale model to measure and observe the performance of exposed geosynthetics in the marine environment and valuable data has been collected on the suitability of geotextiles as marine structures. In 2004 the National Marine Science Centre, carried out a detailed analysis of two facets of the structure: a) the ability of the geotextile to support marine life (four different geotextiles were trialled) and b) to compare the fish and benthic communities found on geotextile reef with natural rock reefs in the area Edwards *et al.* (2005). The results of which showed that geotextile choice will have an influence on the marine growth (Figure 5) and that while fish abundance was comparable with the other reefs, the structure lacked complexity (e.g. sufficient voids) to make it an ideal habitat.

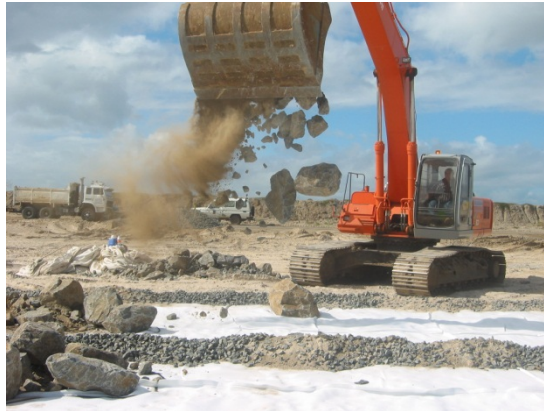
Figure 7: Trial panel set up with 3 m drop in progress.

The individual rolls of geotextile were stitched together to form a panel of approximately 12 m x 12 m. Two types of seams (J – Seam and a Butterfly Seam) were used to make an additional check on the effects on seams. To hold the geotextile in place, smaller rock was placed as a weight along the edges and down the centre of the test panel.

The panel was divided into 4 equal cells so that the seams were running along the centreline of the cells. The trials were conducted using maximum 300 mm rock core with varying the number of drops and/or drop height of 1.5 m and 3.0 m (Figure 7). On completion, rock core was carefully removed from the geotextile to assess, measure and photograph the damage prior to quantifying the damage.

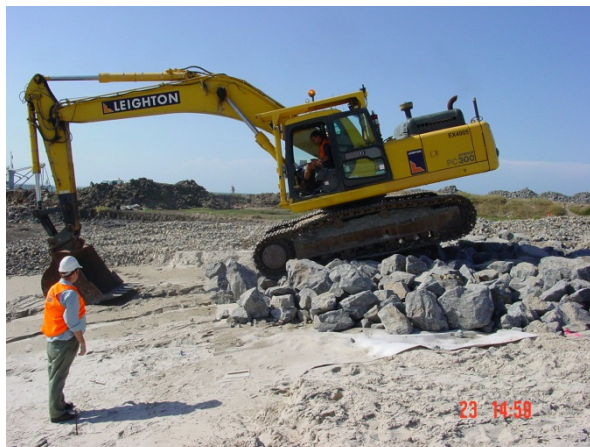
Figure 8: Trafficking with excavator.

To assess the effect of construction vehicle movement, the removed rock core was placed over the geotextile to form an access track wide enough for a large excavator to travel. The length of the access track was about 5 m and the height was 1.0 m (Figure 8). This track was then subjected to 16 passes of the excavator moving parallel to the weft direction. The number of passes used was excessive compared to actual conditions during construction.

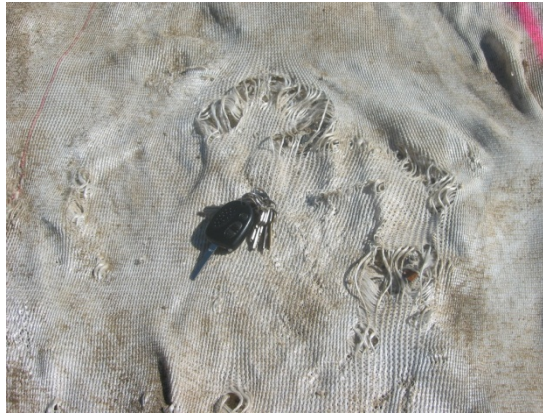
Figure 9: Typical high strength geotextile damage.

- Except for an outlier, the damage factor varied between 1.2 and 1.8 (Figure 9).
- WX800 showed better resistance than WX200.
- Tracking damage is more significant than damage created by rock core drops.
- WX200 was significantly damaged by the tracking trial.

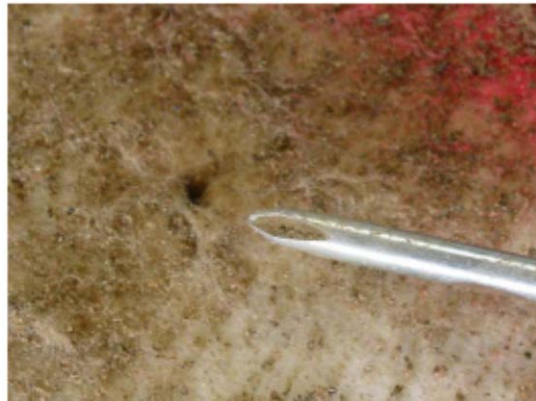
Figure 10: 3 m drop height damage to nonwoven geotextile.

No.	Drop Height (mm)	No. of fabric punctures
1200/1	1500	Nil
1200/2	1500	Nil
1200/3	3000	1 x 1mm diameter puncture
1200/4	3000	Nil

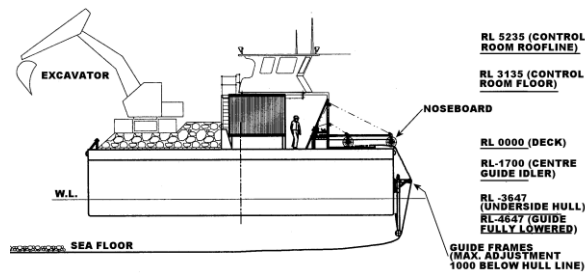
Figure 11: Deployment barge

A 'multipurpose' barge was used for laying both geotextiles and for placing the sand through a spreader system. A flat-top barge, 53 m x 17 m, with an unloaded draft of 0.6 m was modified for the Project (Figure 11).

In general the barge consisted of three zones:

- The high strength geotextile deployment zone on the port side of the barge.
- The ballast storage and loading zone on the starboard side of the barge later used for the deployment of the filtration geotextiles.
- The barge controls, facilities, power and hydraulic systems running along the centre of the barge.

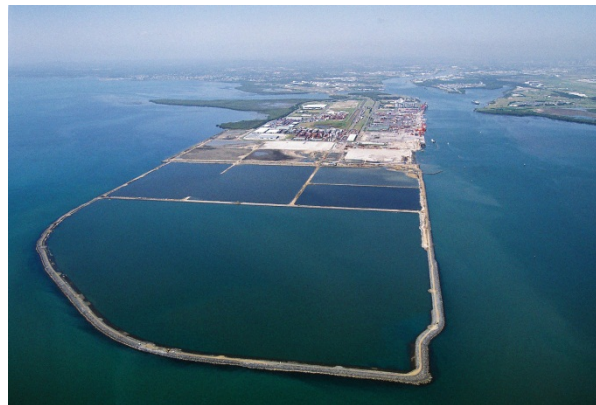
Figure 12: Completed Seawall

The Port of Brisbane is located at the mouth of the Brisbane River at Fishermans Island in Brisbane. The objective of the project was to allow the Port to reclaim and develop an additional 230 ha of port land including extending the current quay line by a further 1800 m. The first stage of this process was the construction of a 4.6 km long and up to 8 m high seawall to encompass the area so that reclamation could be carried out in an environmentally friendly and controlled manner (Ameratunga *et al.*, 2006). What makes this project unique is the damage trials carried out in order to assess the suitability of the various geotextiles offered and the method of installation (Figure 12).

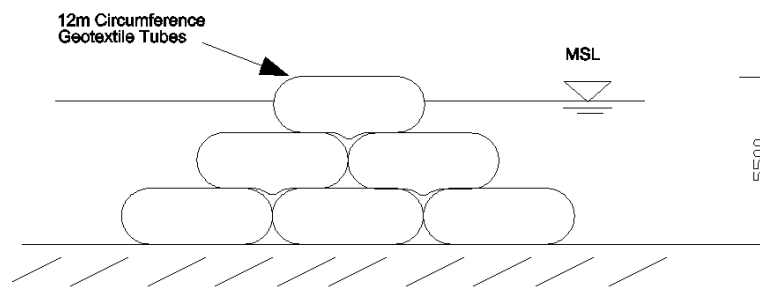
Figure 13: Section through breakwater

In order to achieve the desired crest height, a 3-2-1 stack of geotextile tubes was constructed as shown in Figure 14. The base layer consisted of three 14 m circumference containers with a theoretical height of 2.3 m, and 40 m each in length. The middle and top layers made use of 12 m circumference containers with a theoretical height of 2.1 m and a length of 35 m and 30 m respectively. The overall dimensions of the island breakwater are 80 m long and 16 m wide at the base, with a crest length of 60 m and width of 5 m.

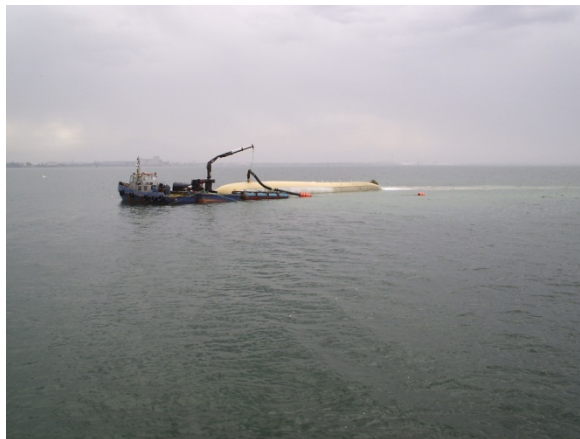
Figure 14: Geotextile tube filling

Accurate placement of the containers was of the utmost importance to ensure the final height achieved the specified design height. In order to achieve this, anchor blocks were placed at the end of the structure and along the length to hold the containers in position while they were being filled. Deployment of the mega containers was carried out off a 3 m x 3 m floating pontoon which also acted as the support platform for the dredge pipe (Figure 14). The containers were filled using a 10 inch (250 mm) suction cutter dredge. Due to the very fine nature of the dredge material the containers took 5-8 hours to fill, compared with the normal 2-3 hours which can be achieved when using good quality sand.

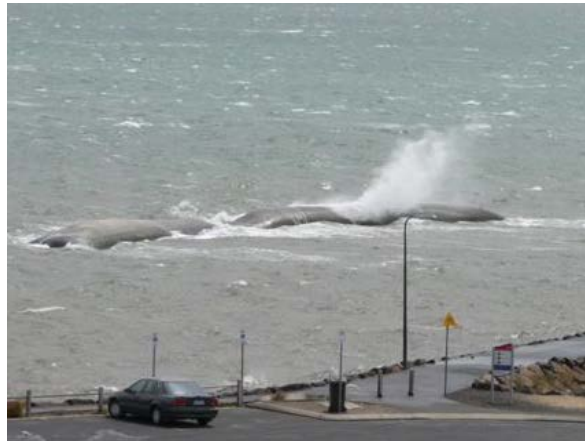
Figure 15: Limeburner's Breakwater under wave attack

To date the project has provided the required protection to the harbour, with modelling showing reducing the maximum wave heights at the pontoons from Hs of 0.35 m to Hs of 0.12 m (Cardno, Lawson and Treloar, 2008). The structure poses limited threat to the small craft using the harbour and in the unlikely event that they should
