PROCEEDINGS  
2018 AUSTRALIAN GEOMECHANICS SOCIETY  
VICTORIAN SYMPOSIUM  
**Geotechnics and  
transport infrastructure**

# Geotechnical design and construction performance of abutment modification

M. P. Chan and M.Y. Broise

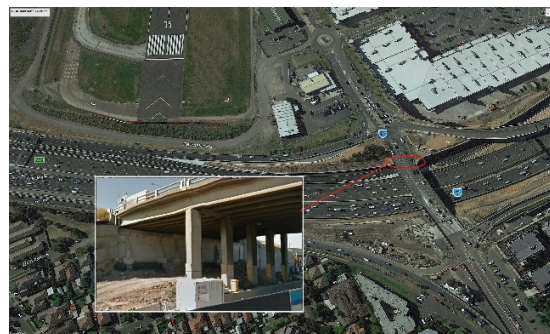
Figure 1. Bulla Road bridge north abutment location

The bridge site (see Figure 1) is located on Quaternary age Newer Volcanics Basalt terrain which forms an undulating plateau. The Tullamarine Freeway at this location is in a 7 m deep cutting.

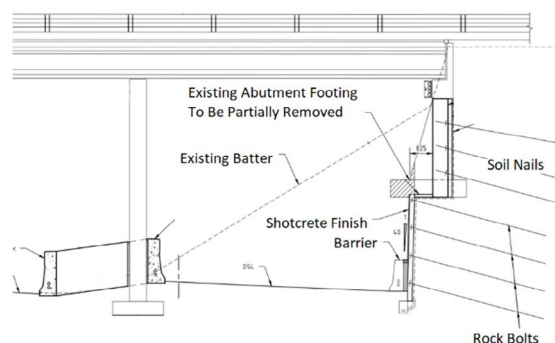
*Figure 3. General arrangement of abutment retention*

To provide lateral retention against earth and surcharge pressures, ground retention was achieved using a combination of soil nails above the abutment footing and tensioned rock bolts beneath the base of the abutment footing. The general arrangement of the abutment modification is shown in Figure 3.

A new blade wall and a continuous strip footing connecting the existing spread footings were formed to transfer and resist the axial loads from the abutment. The width of the new wall is similar to the thickness of the existing footing column.

The abutment wall consisted of seven rows of permanent anchorages. The three upper rows were 8 m long soil nails and 25 mm diameter galvanised threaded bars encapsulated in a corrugated HDPE sheath. These were expected to be installed through soil and rock or a combination thereof. Rows 4, 5, 6, and 7 consisted of double corrosion protection (DCP) expanded shell rock bolts, initially tensioned via the expansion head prior to final grouting. The advantage of using this bolt type is the ability to apply nominal end fixity to counteract potential loosening or opening of joints within the stressed block. However, an expanded shell relies on being securely wedged against the rock interface to provide resistance. Bolt layout was on a staggered pattern with a horizontal and vertical spacing of 1.2 m and 1.0 m respectively. Physical properties for the bolts are given in Table 2.

The alternative design at Bulla Road Bridge involved removing the existing spill-through abutment and literally slicing through the buttress retaining wall spread foundations at mid-slope height to form a vertical face down to the final carriageway level to create the necessary formation width for two traffic lanes between the abutment and adjacent pier.

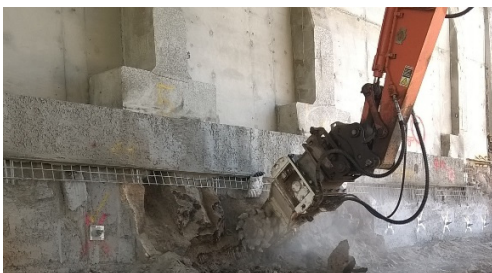
Photo 1. Rock face cutting below new continuous footing and saw cut buttresses.

Excavation and face trimming continued below the spread footing into the weathered basalt rock mass. The hit and miss sequence was continued using an excavator mounted twin head rock grinder, a low vibration method of rock extraction. See photo 1.

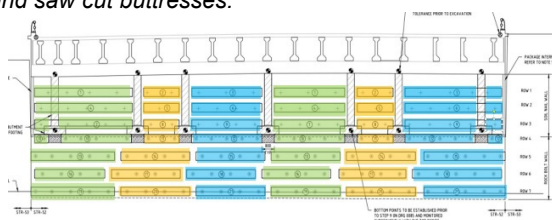
Figure 4. Implemented sequential construction method

Firstly, the batter was trimmed to allow for machinery access. Each bench was then excavated in divided bays using a “hit and miss two” sequence to enable the installation, grouting and nominal stressing across each single row of retention and shotcreting. The sequential method is shown in Figure 4 which is a full height elevation of the north abutment, illustrating the I-girders,

the counterfort buttresses and level of the modified abutment footing.

The principal objective of the sequential pattern was to utilise the arching effects between the left in place intervening buttresses to support sections of the excavated faces until such time that the nailed retention took effect.

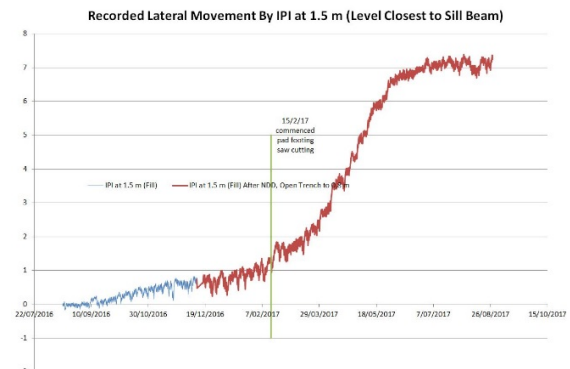
Figure 5: Lateral soil movement in IPI at 1.5 m depth

The recorded lateral movement at 1.5 m depth in the IPI behind the north abutment is shown in Figure 5. Very small displacements (< 1 mm) in the direction away from

the abutment were experienced as a result of the excavation down to footing level. However the displacement velocity increased following commencement of saw cutting through the buttress footings but movement stabilised at a maximum of 7 mm.

The accuracy of the measurements was judged to be of the order +/-1 to 3 mm taking into account various effects including vibrations, thermal movements etc.

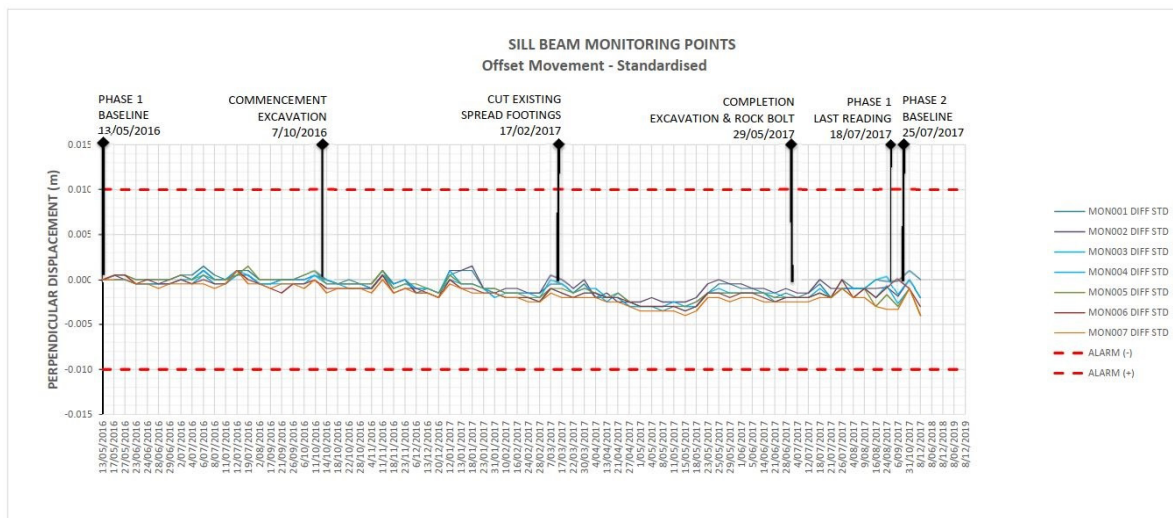
Figure 6: Abutment sill beam monitoring results (standardised)

The survey results from the monitoring points installed on the north abutment sill beam of the bridge are shown Figure 6. The monitoring data has been standardised (i.e. normalised) to eliminate differential cyclical thermal effects along the structure.

The results had shown that there was a slight trend of outward movement starting from commencement of excavation. The overall trend slightly increased after cutting through the existing spreading footings resting on weathered basalt but plateaued towards the end of the excavation and on completion of rock bolting.

It is apparent from the graph that the maximum overall deflection arising from the abutment modification works was approximately 4 mm. The magnitude of movement was well within the permissible threshold established for the bridge.
