AGS VICTORIA 2017 SYMPOSIUM
Reactive clays and light structures

Influence of trees on expansive soils in Melbourne

In Australia, distortions of residential buildings caused by tree drying settlement have been widely reported, particularly in areas of expansive or reactive soils. The paper presents the results of two major projects dealing with trees and expansive clay soils in the Melbourne Metropolitan area. The first project is the long-term field study of the effects of trees on the performance of a building, soil moisture patterns and ground movement in basaltic clay. The second project is a case study of a residential house damaged by expansive soil movement due to tree root drying. In this field study the sap flow rate of a tree was seen to be closely correlated with solar radiation. It was also observed that the soil moisture content profile near the tree was significantly lower than that away from the tree. The findings of the second study clearly indicated that trees, growing in close proximity to a house could cause more severe damage to the buildings than the expected moisture changes due to seasonal effects and re-distribution of soil moisture arising from constructio

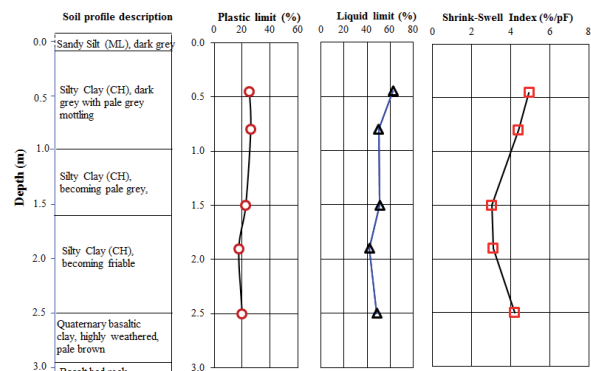
Four boreholes were drilled at the Glenroy experimental site. The soil profile across the site was relatively uniform. The average soil profile can be described as 12 cm of sandy silt topsoil underlain by high plasticity silty clay to a depth of approximately 2.5 m, then highly to extremely weathered basalt with high strength basalt encountered below 2.9 m (Figure

4). Figure 4 shows the profiles of shrink-swell indices, plastic limits and liquid limits. The site classification according to Australian Standard for Residential Slabs and Footings (AS2870, 2011) is H1 (ie. highly reactive with $40 \text{ mm} < y_s \leq 60 \text{ mm}$).

Figure 4. Typical soil profile at the Glenroy site

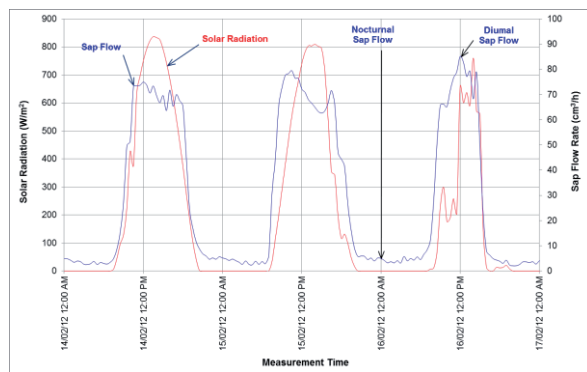
The Glenroy field site has been monitored since May of 2011. The measured solar radiation and sap flow rates of eucalyptus ficifolia during representative clear days in February 2012 are presented in Figure 6. It is interesting to observe that the sap flow rate began to rise from nearly zero after sunrise, reached a maximum around 12:00 noon, then decreased gradually to nearly zero until midnight. The diurnal

courses of sap flow exhibited a bell shape curve that closely correlated with changes in solar radiation.

Figure 6. Diurnal variation of sap flow rate and solar radiation from 14 to 17 February 2012

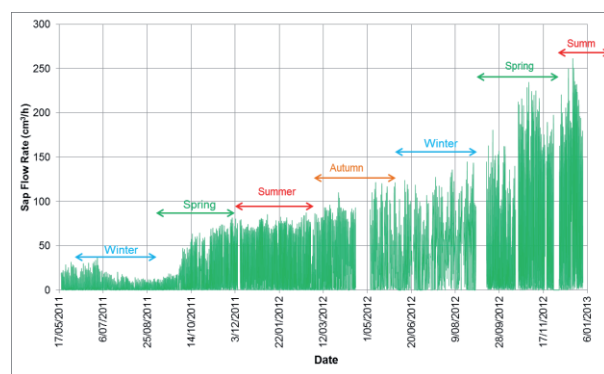
The measured sap flow rate from May 2011 to January 2013 is plotted in Figure 7. During the first winter (between June and early September 2011), the sap flow rate of the tree varied from 0.1 to 37 cm³/h. Once the warm weather occurred, the sap flow rate increased to 50 – 75 cm³/h (between October and early December). From Figure 7, it can be seen that the sap flow rate of the eucalyptus tree increased significantly in the second year.

Figure 7. The measured sap flow rate (cm³/h) from May 2011 to January 2013

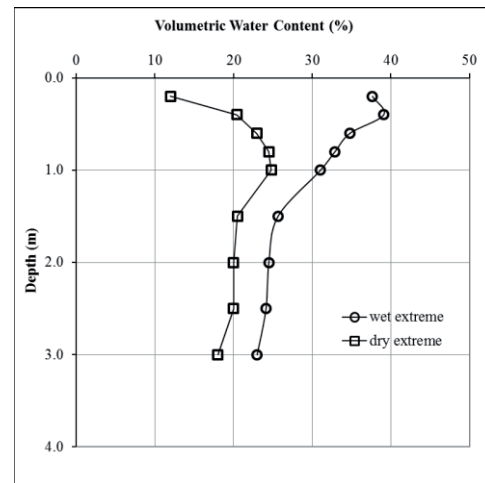
The volumetric moisture content change profiles shown in Figure 8 represent the upper and lower envelopes of all readings taken at each depth from the beginning in May 2011 to December 2016. Intermediate values were omitted for clarity.

From Figure 8(b), it can be seen that the maximum moisture content change at NP5, 3 m away from the tree, is mainly confined to the top 2 m. Essentially there is no change below 3 m. The drying influence of the tree is apparent. As shown in Figure 8(a), the soil moisture content at NP3 (1 m away from the tree) was

much lower than at NP5 (3 m away from the tree). This was due to the stand of tree extracting water all year round and depleting the soil moisture. As well, the depth of soil moisture variation at NP3 was extended below 3 m (Figure 8(a)).

(a) 1 m away from the tree

(b) 3 m away from the tree

Figure 8. Volumetric moisture content change profiles between May 2011 and December 2016

The *in situ* soil moisture content has been regularly measured by using a CPN 503 Hydroprobe (neutron probe) at the different locations as shown in Figure 3. The complete presentation of the neutron probe soil moisture profiles for all locations is beyond the scope of this paper. Figure 8 shows the extremes of moisture content measured with the neutron probe at two different locations (NP3 and NP5).

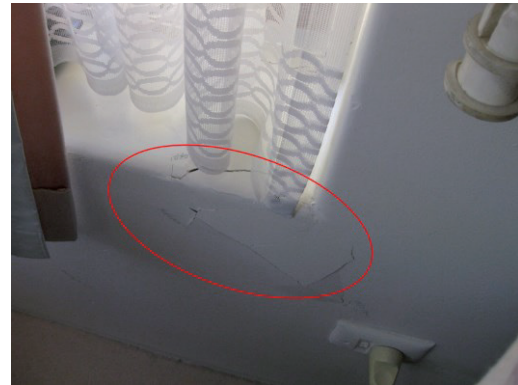
- Extensive settlement and cracking of the concrete kerb along the west boundary of the property (Figure 10);
- Severe wall cracking in bedroom 2 (Figure 11), bedroom 1, living room, bathroom, and kitchen;
- Ceiling cornice cracking in most rooms;
- Doors to front entry, bedroom 1, bathroom and kitchen were inoperable;
- Re-opening of previously repaired cracking in the garage eastern wall. The width of the new cracking was approximately 5 mm.

Figure 11. Cracking on the wall of bedroom

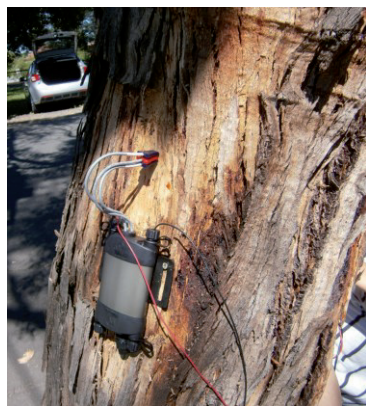
Two SFM sap flow meters were installed to obtain the transpiration rate of the tree by measuring tree trunk sap flow (Figure 15). The measured data indicated that this large Eucalypt tree was transpiring 73-87 litres per day during summer.

Figure 15. Sap flow meter installed on the street tree

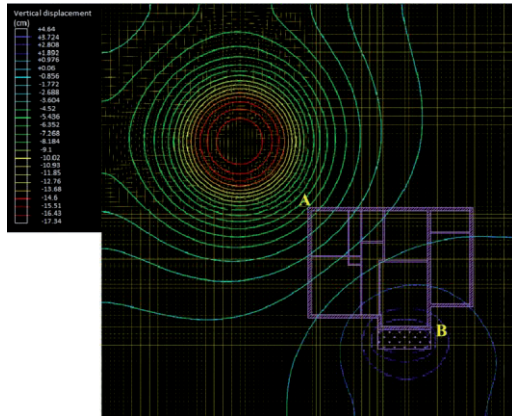
The distribution of soil suction predicted by the numerical model is shown in Figure 17. The effect of tree root drying and garden over-watering is clearly evident in Figure 17. The contour plot of the calculated ground surface movement after 90 days (Figure 18) shows that a severe shrinkage settlement occurred at the north-west corner of the house (near to large Eucalypt tree) while heaving of foundation soil occurred near to the front garden (in the front of the living room). The maximum predicted ground settlement was about 4.2 cm, while heave was almost 4 cm. The maximum differential movement was 8 cm. The deformation pattern compared reasonably well with the observed distortion pattern of the slab. The calculated level differences between Point A (the north-west corner of bedroom 1) and Point B (the south-east corner of living room) are plotted in Figure 19.

Figure 18. Contour plot of calculated ground movement after 90 days

The differential movement induced by tree root drying was exacerbated by a well-watered small garden, which caused the swelling of foundation soil and resulted in slab heave at the south-east corner of the living room. The numerical analysis indicated that the maximum vertical differential movement of the ground was 80 mm. The original footing slab system was relatively shallow and inadequate (by current standards) to cope with such a large differential movement. A much stronger footing would have been required in this case.

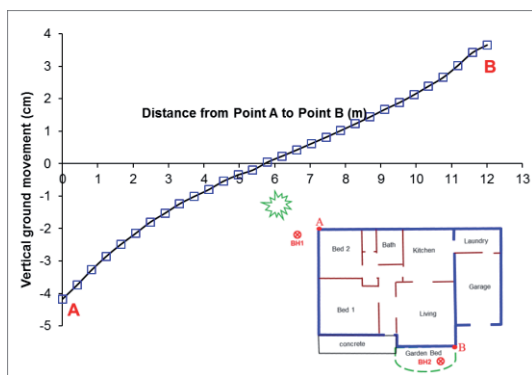
Figure 19. Calculated ground surface movement between Point A and Point B
