PROCEEDINGS  
2019 AUSTRALIAN GEOMECHANICS SOCIETY  
VICTORIAN SYMPOSIUM

**Geotechnical characterisation –  
managing design and construction risk**

# Site characterisation along the Shipwreck Coast – two case studies using multiple geotechnical investigation techniques

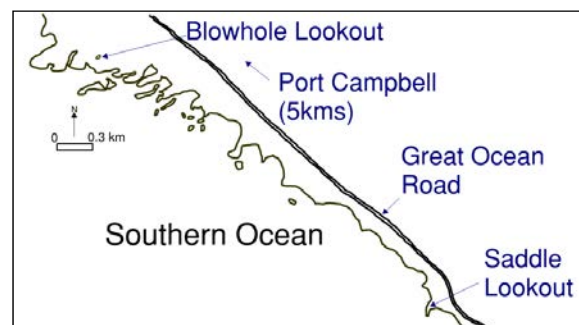
Figure 1: Lookout Locality Plan

The structure locations are shown in Figure 1.

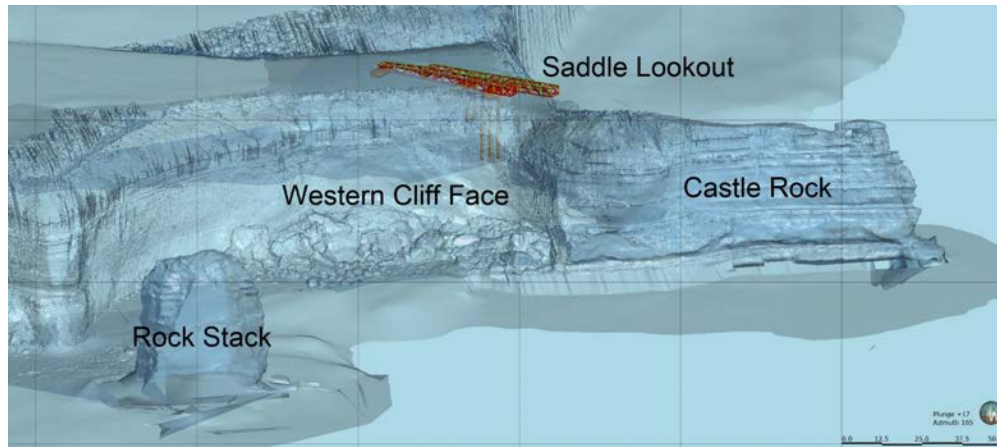
Figure 2. Saddle Lookout (Perspective View)

The site of the Saddle Lookout comprises a significant north-south trending promontory (Castle Rock) leading from mainland (Figure 2).

Progressive erosion of the cliffs is ongoing and over a timescale of decades to hundreds of years it is expected the Castle Rock headland will completely detach from the mainland and form a new sea-stack; or collapse completely into the ocean. Some undercutting has already occurred at the wave zone on both the western and southern cliffs.

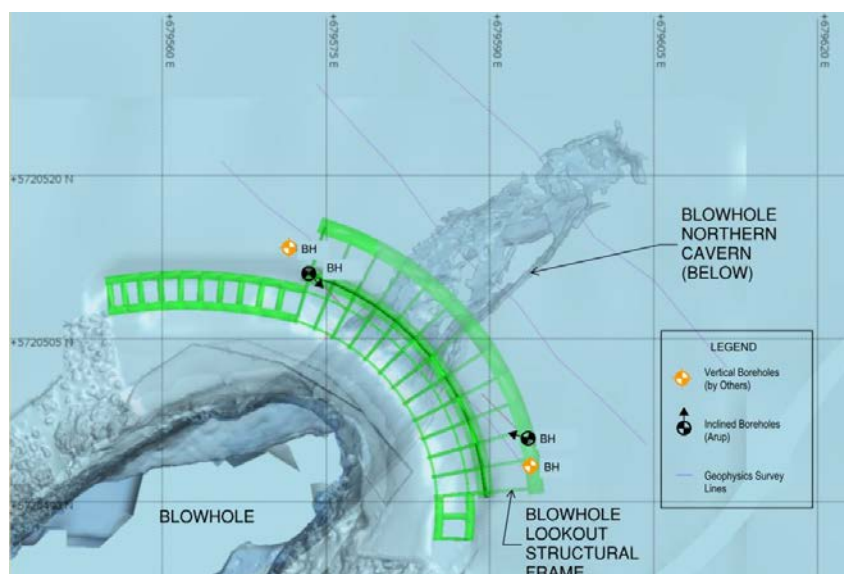
Figure 3. Loch Ard Gorge Blowhole (Plan View)

The site of the Blowhole Lookout is a north-east to south-west trending karst feature comprising a longitudinal tunnel (doline) leading from the ocean to an oval shape opening to the ground surface (the Blowhole) (Figure 3). The cavern continues north-east from the Blowhole where it likely terminates some distance inland.

The cavern was formed due to progressive erosion of the limestone, due to chemical dissolution and wave action. The blowhole itself was likely formed due to weakening of the cavern roof leading to a large scale collapse.

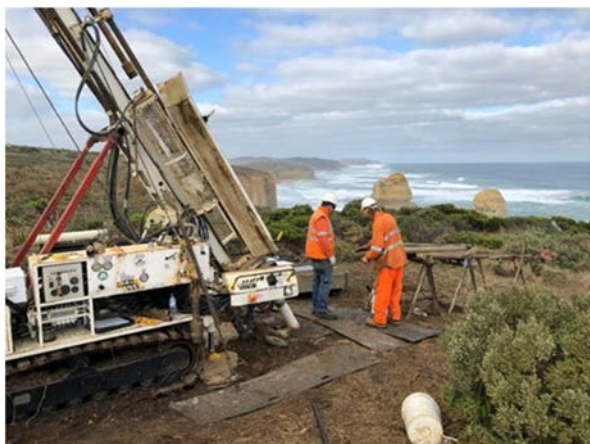
Figure 4. Inclined borehole drilling at the Saddle Lookout site

Seven boreholes were completed (four at the Blowhole site and three at the Saddle site) utilising HQ3 wireline drilling techniques. The boreholes were drilled to a maximum depth of 60 m. (Figure 4)

The boreholes were oriented 30 degrees from vertical and were angled perpendicular to the cliff faces and cavern crown. The objective of the angled holes was as following:

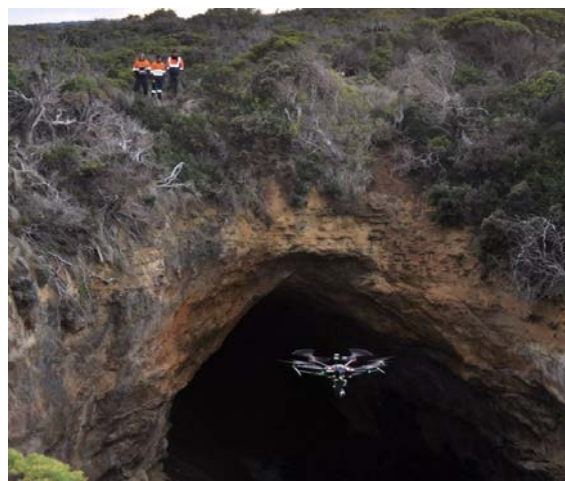
Figure 5. RPAS survey of Blowhole cavern

To acquire data within the blowhole cavern, the operator was able to manoeuvre the Remotely Piloted Aircraft (RPA) at the blowhole cavern entrance and acquire LiDAR data approximately 12 m past the lip of the blowhole cavern (Figure 5). Photogrammetric survey was not possible within the Blowhole cavern due to low light conditions, but was undertaken on all the light-exposed cliff faces of the Blowhole Lookout and Saddle Lookout sites.

The LiDAR survey was performed with a multirotor 'Inspire 2' RPA equipped with a LiDAR system. A Post Processed Kinematic workflow corrected the RPA's trajectory and referenced the data to the adopted ground control.

LiDAR was captured and processed to create a point cloud. The point cloud was later classified and further processed to create a Digital Terrain Model and elevation contours. The LiDAR data was also used to create a digital three dimensional surface mesh inside the Blowhole cavern.

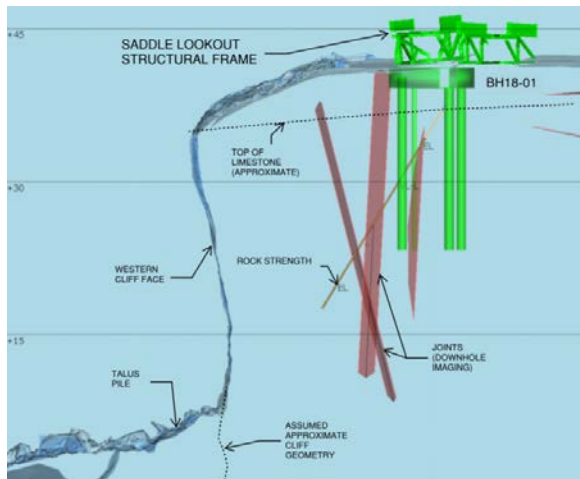
Figure 6. Saddle Lookout Cross Section

These joints were plotted in a three dimensional model and are represented as discs at the encountered depth in the three dimensional geological model. The joints are plotted relative to the boreholes, foundation pile group for the lookout structure and western cliff in Figure 6.

The downhole imaging completed in the three boreholes identified five individual joints. Jointing was tight with no

observed aperture. Joint sets of a consistent spacing were not encountered in the Geotechnical Investigation.

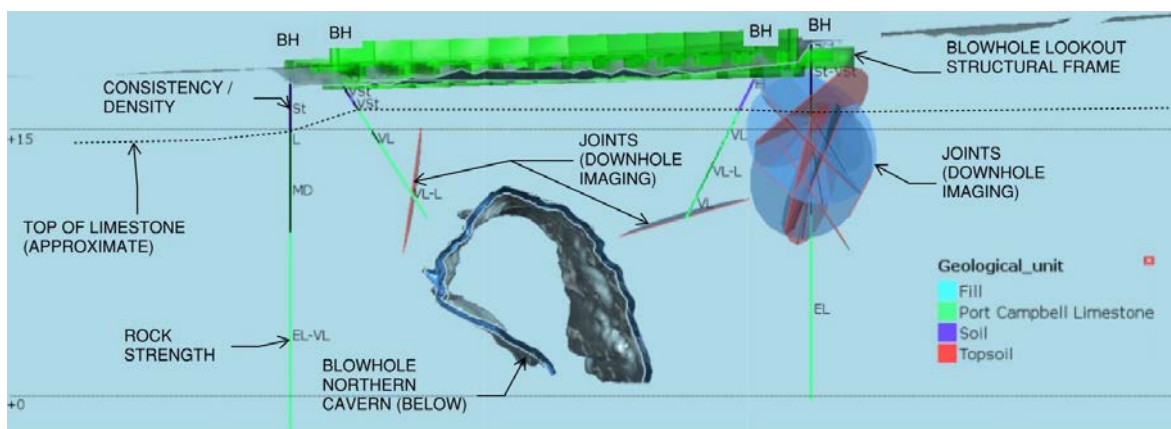
Figure 7. Blowhole Lookout – Cross Section

Erosion of the tunnel roof will likely occur via a slab failure mechanism where blocks of limestone fail along intersecting joint surfaces. The persistent joint surfaces appear to be a sub-horizontal bedding surface and two orthogonal joint sets dipping at approximately 45 degrees, and striking approximately along the alignment of the tunnel system.

The intersection of the joints defines a lineament parallel to the axis of the tunnel. A sketch indicating the persistent joint sets at the brow adjacent to the proposed lookout structure is shown in Figure 7.

The minimum thickness of the rock bridge directly above the tunnel at the proposed location of the Blowhole Lookout structure is estimated to be approximately 7 m.
