PROCEEDINGS
2018 AUSTRALIAN GEOMECHANICS SOCIETY
VICTORIAN SYMPOSIUM
**Geotechnics and
transport infrastructure**

Soil nails and rock bolts: construction challenges

T. A. McCartney

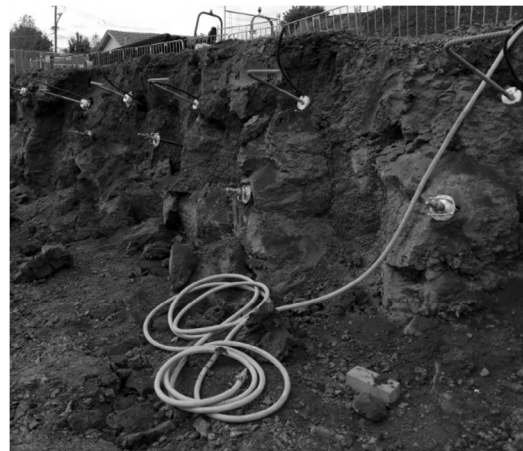
Figure 2. Example of overbreak in basalt rock

Despite the efforts of line drilling, significant overbreak of rock occurred during bulk excavation under tight timeframes at Alphington and resulted in caving up to 1000 mm beyond the design face of the shotcrete wall. The largest voids were generally confined to the upper portion of the excavation where the rock mass was blocky. It was quickly apparent that it was not feasible to build out overbreak of that extent due to the weight of the additional shotcrete.

In areas where overbreak was limited to approximately 500 mm, the voids were built out in multiple layers of shotcrete and mesh before applying the main shotcrete face. The potential for the shotcrete to slump was reduced by allowing the layers of shotcrete to cure before continuing. Where overbreak was more significant, the protruding rock was scaled back to contour the rock face and provide more gentle transitions. An example of the overbreak encountered, and modified bolt plate is presented in Figures 2 and 3.

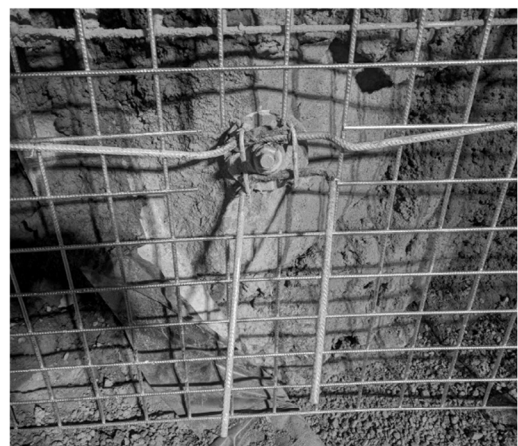
Figure 3. Example of modified lacer bar and mesh

To maintain the design bonded length of the bolts, each bolt was installed and anchored onto the rock face as per standard practises. However, this led to difficulty for the installation of SL81 shotcrete mesh as the rigid mesh could not be contoured to suit areas of overbreak. Modified lacer bars were used to tie the bolt handle plate to the SL81 shotcrete mesh, providing a rigid connection

between the anchor plate and the shotcrete mesh. The use of lacer bars to maintain rigidity ensured that the design bond length could be utilised to retain the basalt rock.
