AGS VICTORIA 2016 SYMPOSIUM
Excavations and slope stability
in Melbourne geology:
experiences and recent developments

DESIGN “RIGHT” AT THE EDGE OF THE EARTH

Timothy Holt, Director A S James Geotechnical Engineers, MIEAust EC1022

Since the publication “Innovative Slope Engineering” published in the Geomechanics Journal, March 2010, by the above author and colleague Shyamalee Herath, more people seem to want to build in more crazy places and this is a selected few examples in Melbourne and environs.

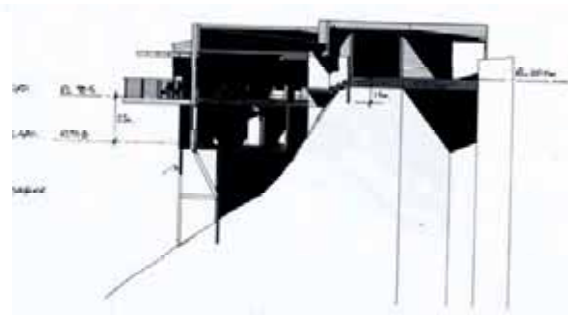
Figure 1. Typical Elevation indicating slope and structure layout

The difficulties that exist for construction at the site can be seen by the following architectural diagrams (Figures 1 & 2). The slope ranges from 45°-60°, is largely inaccessible and had relatively dense vegetation. It did have a more stable zone that was able to be utilised as an “anchor point” for piles that were eventually adopted.

- The site has an inherently unstable surface profile (approx. 1.0-1.6m) slumping and progressively slipping.
- An architecturally "interesting" shape not suited to conventional strip or grid footing layouts.

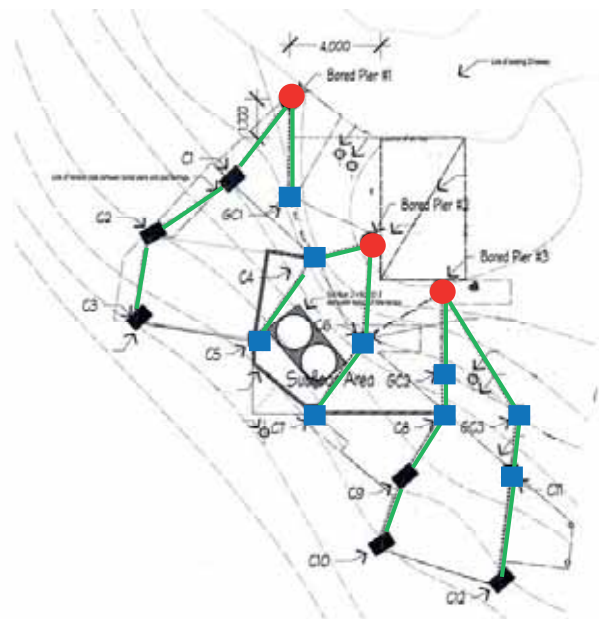
Figure 3. Footing Layout (Key elements labelled)

1. (Red) The piles are anchor piles (laterally loaded vertical piles). These were proportioned using the following parameters for a distinctly weathered siltstone.
Short term – $C_u = 200$ kPa below 1.5m
Serviceability – $E = 200$ MPa

2. (Green) The green lines are tension rods running down the slope and connecting pad footings. The design of the lateral forces transferred into the tie rods and then back to the anchor piles was advised to be taken as the sum of the "At Rest" lateral force of 1.5m height of soil (active zone) acting against each individual pad footing on the grid.

3. The solid lines are "bracing" infill walls where compression forces resulted.
4. (Blue) Pads are conventional pads hand excavated to the siltstone and to resist smaller lateral (sideway) forces. Grout bars were used into the siltstone as a precaution.

The foundation arrangement chosen was a "spider web" arrangement where bored piles were utilised to anchor the residence on the accessible area. These were designed as laterally loaded bored piers with the lateral load being the forces at ground level induced by the tie rods. Pad and strip footings down the slope were effectively suspended on tie rods running down the escarpment and picking up each individual footing and joining it to the web and then to the piles. This is indicated on Figure 3.

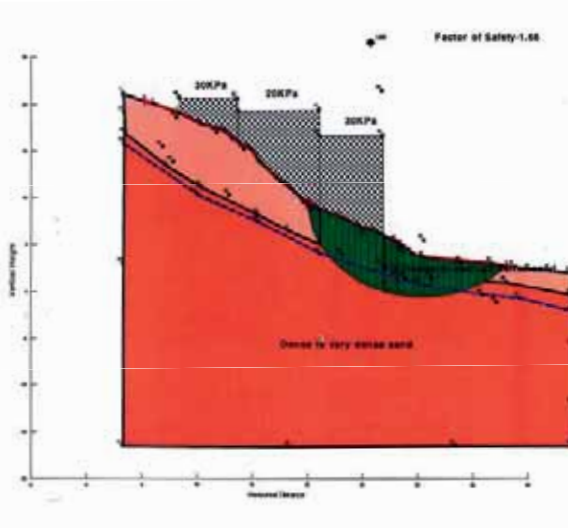
Figure 4. Sample Slope Stability Output (Deep Seated Failures, Factor of Safety 1.66)

The global stability issue at this site is best highlighted by reference to Figure 4.

- Surface Fill and Sand (Hillwash Deposits) - $C' = 0$ kPa, $\phi' = 28^\circ$, $\gamma = 17$ kN/m³
- Firm-Stiff Silty Sandy Clay (Tertiary) – $C' = 10$ kPa, $\phi' = 22^\circ$, $\gamma_w = 18$ kN/m³
- Medium Dense Silty Clayey Sand - $C' = 3$ kPa, $\phi' = 34^\circ$, $\gamma_w = 18$ kN/m³
- Medium Dense to Dense Silty Clayey Sand (Extremely Weathered Granite) - $C' = 5$ kPa, $\phi' = 36^\circ$, $\gamma_w = 18.5$ kN/m³

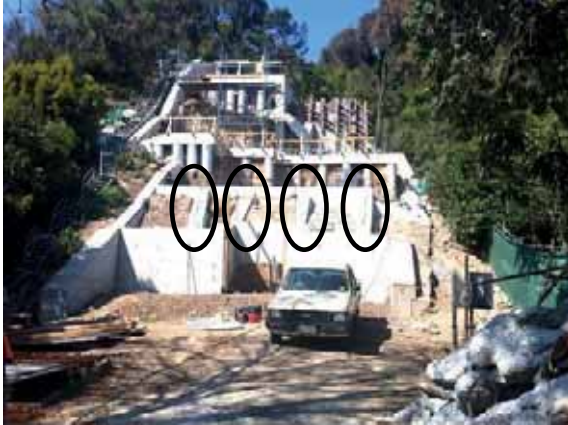
Figure 5. Foundation Arrangement (Piles & Lateral Transfer)

This can be seen in the following photograph (Figure 5) taken during construction where the lateral loads are being transferred to the base by blade columns.

The retention/support piles, spacing 2.5m or less.

A "bound" foundation arrangement links piles with substantial ground beams. "Bound" in this context means tied together.

"Buttress" (Blade Columns) type lower structure that transferred lateral load to raking piles at the base (not seen, but below ground level).

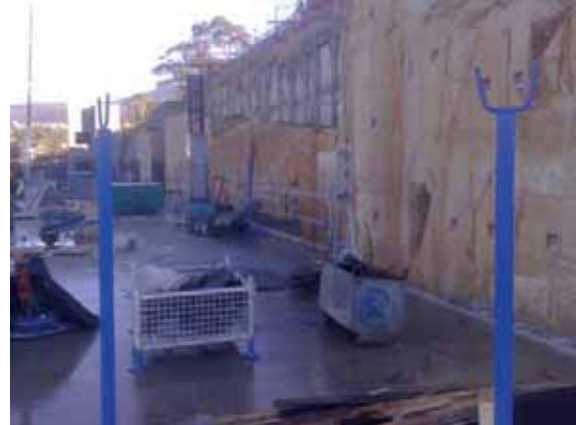
Figure 6. Example of Face Cut with Diamond Saw Fitted to Excavator, Rock Bolts in Place

Design Issues: The following three photographs are taken around the third of approximately five inspections to this site. It was early in the construction of this exposed rock feature wall constructed in Sandstone, it became apparent as can be seen in numerous road cuttings coming from the airport that once exposed the sandstone weathers quickly accelerated by what appears to be an immediate increase in moisture content, causing perhaps slight volume increase and joint weakness.

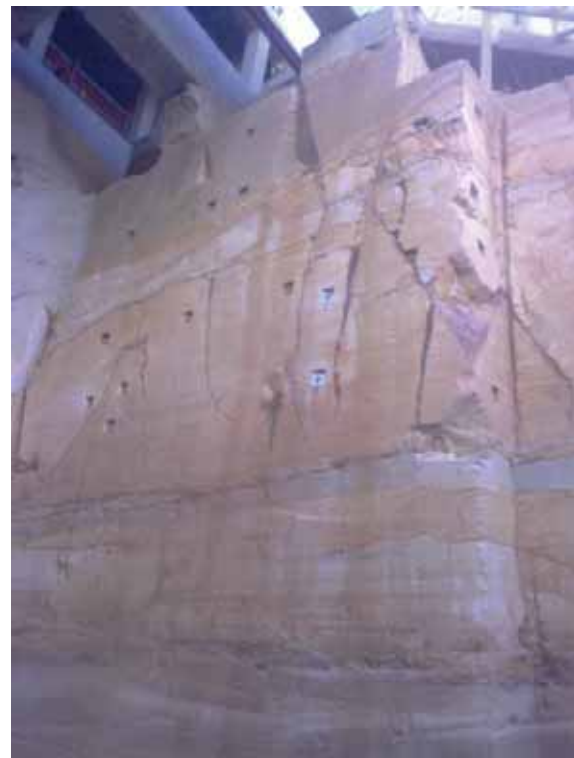
Figure 7. Example of Potential Rockfalls

Rock Bolting had been carried out of the medium and large block wedge potential rock falls. A study of discontinuities joints and bedding had previously been carried out by others and despite this bolting falls were being experienced. Failures were defined by the following Table 1.

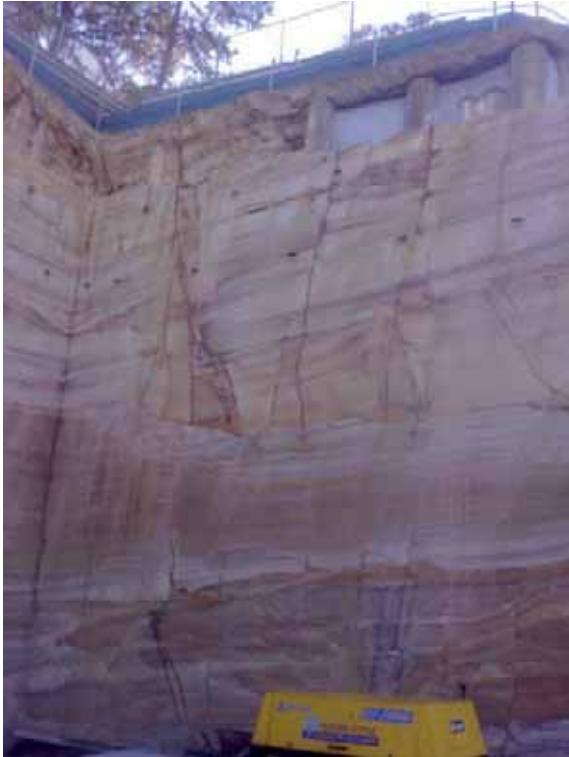
Figure 8. Example of Potential Rock Falls

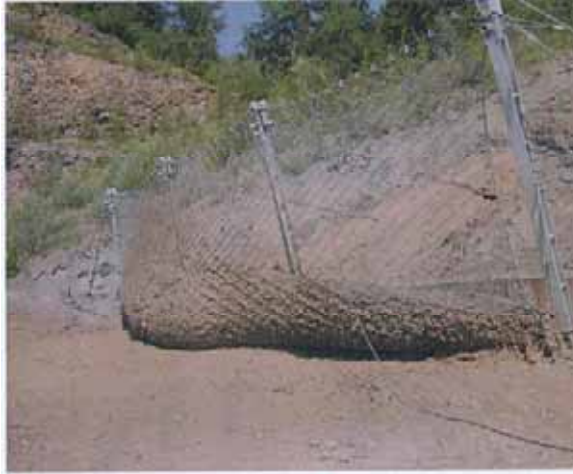
Figure 10. Debris Flow Barrier (Geobrugg)

The issues at this site were twofold to firstly provide a foundation arrangement for the residence, but most importantly to construct a debris flow barrier as indicated on Figures 9 and 10 in the uphill zone was subject to localised shallow instabilities and debris flow.
