Utilising laser scanner and unmanned aerial vehicle (UAV) geotechnical data capture to manage visitor safety in the Buchan Caves

C. Coulson¹ and J. Richards²

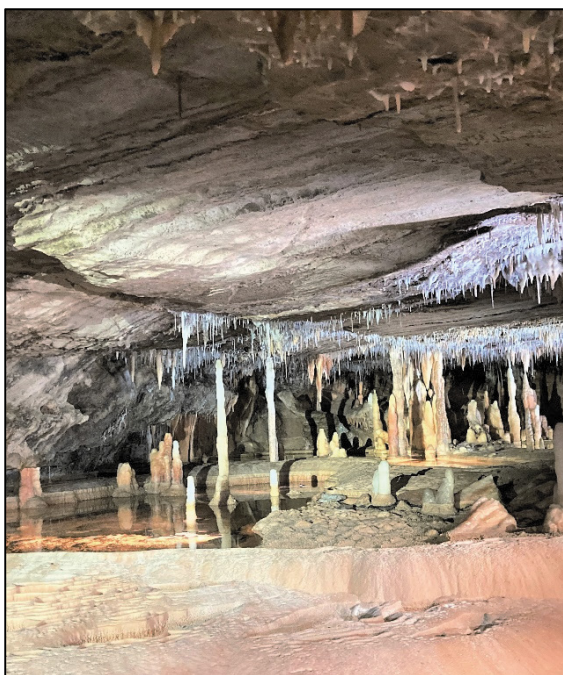
Figure 4. Cavern with a flat roof in Royal Cave

formation occurred more than 750,000 years ago (Webb et al., 2003). The caverns generally formed with a flat roof, cut across bedding, following enlargement by historical karst forming processes beneath the groundwater table (Webb et al., 1992). A flat roof is still visible in many caverns (Figure 4). Regional groundwater is now below the level of the visitor caves, with stream flows continuing in deeper caverns.

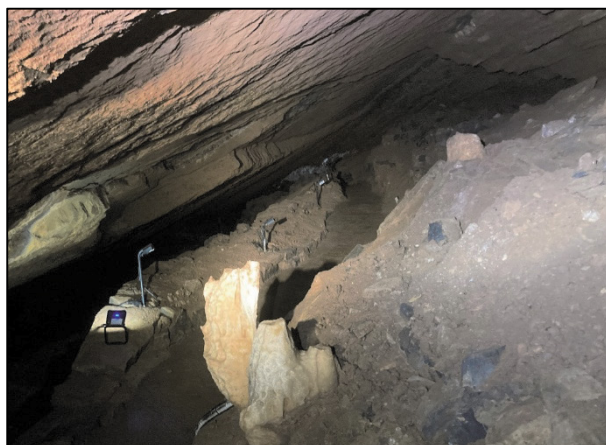
Figure 6. Bedding units in Federal Cave roof and corresponding breakdown pile on floor

Figure 6 shows thick inclined bedding units forming the roof of the Federal Cave. Rock and soil debris, from the breakdown of the original cavern roof, has accumulated as piles lining the cavern floor. Breakdown of cavern roofs, sidewalls, and of debris piles within the caves could pose potential hazards to the management of underground infrastructure and safety of cave visitors and Parks Victoria staff.

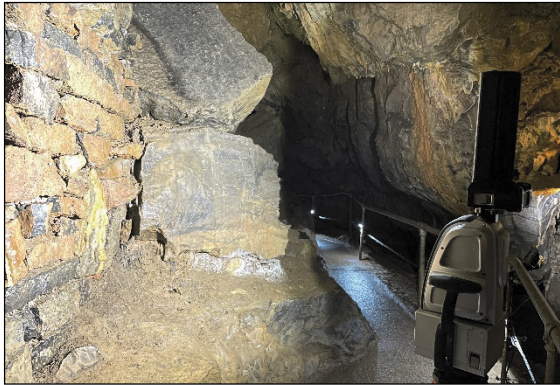
Figure 7. Maptek SR3 scanner with light

undertaken. This process to generate a 3D point cloud involved utilising 2 tripod-mounted Maptek SR3 laser scanners to scan the cave system. It was crucial that adequate overlap of pointcloud data was achieved between scanning locations to produce a continuous model. This allowed detailed data analysis, identification, and safe recording of key geological and geotechnical features, especially in areas that cannot be safely accessed. Maptek SR3 laser scanners were nominated on this project due to their high resolution and accuracy, supplemented with photo realistic imagery capture with lighting affixed to the scanners (Figure 7).
