RESILIENT FOUNDATIONS: BUILDING IN REPAIR CAPABILITY

Y. Duraisamy¹ and D. Airey²

¹PhD Candidate, ²Professor, School of Civil Engineering, The University of Sydney, Sydney, Australia

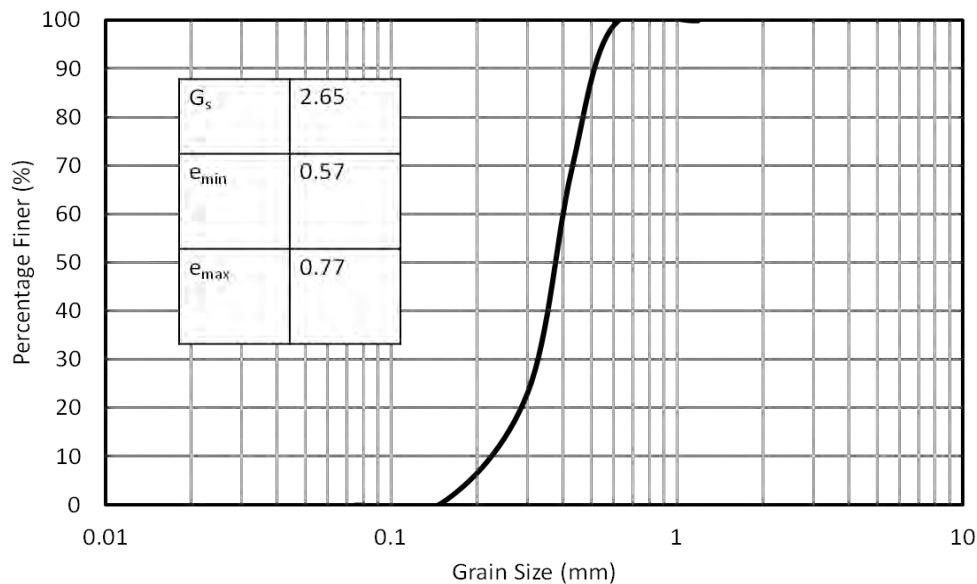
The soil used in the triaxial and model tests is Sydney sand, a quartz sand with sub-angular particles. Some of the basic soil properties obtained using Australian standard tests and the particle size distribution are shown in Figure 1.

Figure 1: Properties and the particle size distribution of Sydney sand.

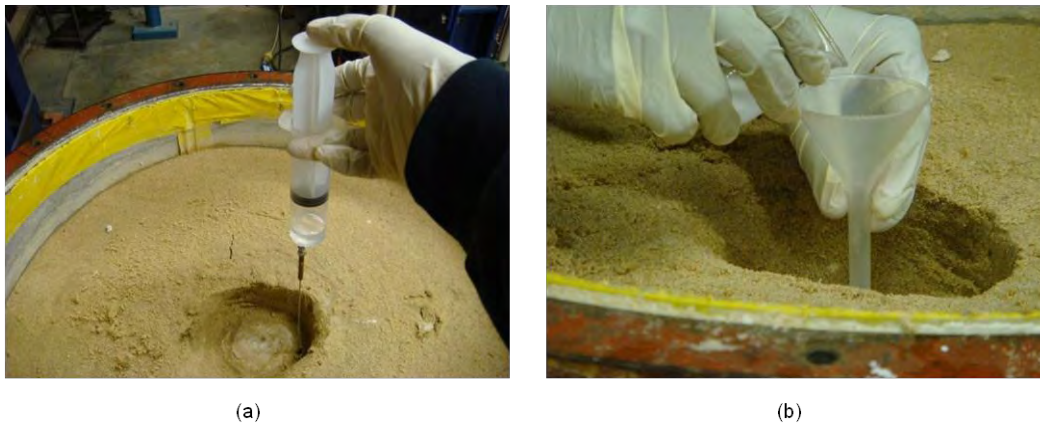
this point load was removed and the column repaired. The first repair technique involved injection of the bacterial solution (bacteria and nutrients) around the cemented column in the vicinity of the break as shown in Figure 3a. Five points, equi-spaced around the column were injected with 2 mL of the bio-solution, with each point at a distance of about 40 mm from the centre of the column. The second repair technique involved simply pouring 10 mL of the bio-cement forming solution into the hole in the centre of the column using a funnel as shown in Fig 3(b). The third repair technique also involved pouring 10 mL of nutrients (urea + CaCl_2) into the central hole, but in this case no bacteria were added. The third approach was used on columns that had already been repaired using the second method and had been reloaded to failure. The third technique was designed to assess whether residual bacteria from the previous repair could be reactivated by providing additional nutrients. Tests have been performed with the sand surrounding the cemented columns in both dry and saturated states.

Figure 3: Foundation repair using (a) injection into surrounding sand and (b) pouring solution into the hole in the centre of the column.

The physical model tests outlined above were extended to study the potential of bio-cement for repairing damaged pile foundations. As discussed further below, loading of the footing led to all the cemented columns breaking into two, approximately one footing diameter below the surface. Three different strategies were investigated for repairing the damaged columns. In all cases the cemented columns were made by mixing 15% gypsum with the sand. To allow for later repair a glass rod of 8 mm diameter was placed in the centre of the columns after mixing in the gypsum, and this was removed after 2 hours when the gypsum had set leaving behind a hole down the centre of the column for the full length of the cemented column. The column was then left to cure for at least 24 hours before loading the footing. The footings were loaded until a sudden drop in load indicated the breaking of the column. At

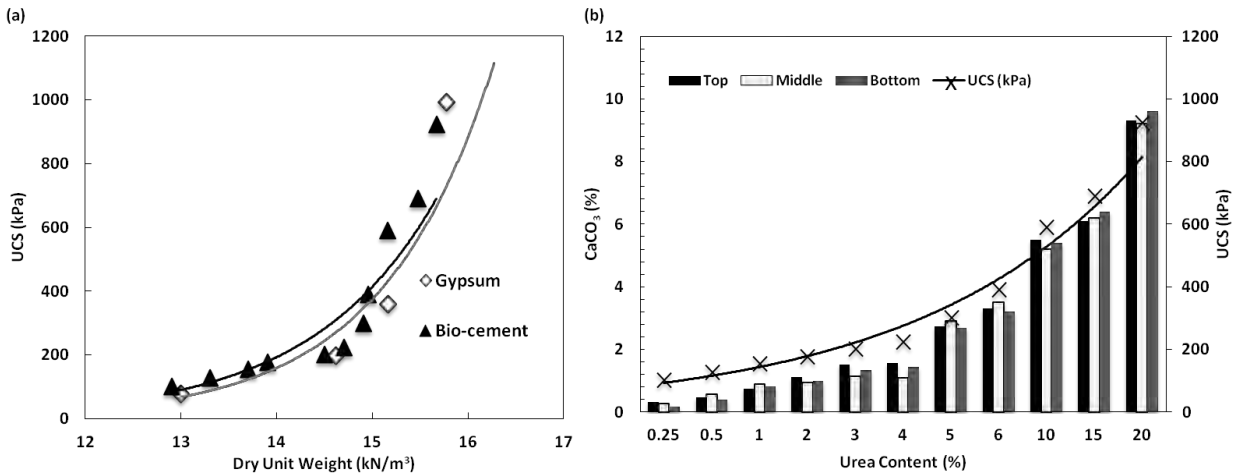
The variations of the unconfined compressive strength of gypsum and bio-cemented specimens with unit weight are shown in Figure 4(a). This figure shows that the strength increases with dry unit weight, and that a similar trend is observed for both the bio-cemented and gypsum cemented specimens. Interpretation of Figure 4(a) is not straightforward as the increases of unit weight are also associated with increases in the amount of calcite in the bio-cemented specimens, and increases in the gypsum content in the gypsum cemented specimens, and it is well established that the strength of artificially cemented soils increases with both cement content and unit weight. The similarity of the behaviour of soils cemented with gypsum and calcite has been noted in other studies (Ismail et al., 2002), and this is why comparative tests using gypsum are included here. Furthermore, the similar strengths of calcite and gypsum cemented specimens suggest that the method of calcite precipitation is not that important.

Figure 4(b) shows the relations between the amount of urea, which is the same as the amount of calcium chloride, in the bio-cement mixtures and the amounts of calcite precipitated and the UCS. Figure 4 also shows that the amounts of calcite precipitated in each specimen at three locations (top, middle, and bottom) are similar without any consistent pattern. There was less than 5% variance in the calcite distribution which compares favorably to other

Figure 4: Variations of UCS strength with (a) dry unit weight (b) urea content of bio-cemented sample.

The amount of calcite precipitated is generally reported as the amount of bio-cement and this can be correlated with the UCS strength. This provides a strong linear correlation ($R^2 = 0.97$) which can be described by Equation 3, where C is percentage of calcite precipitated. The trend of linearly increasing strength with increasing calcite content is similar to that previously reported (Al Qabany et al., 2011). Alternatively, the amount of urea required to precipitate the calcite, can be used as a means to estimate and monitor the degree of cementation in this study.

Analysis of the data shows that the calcite cement is twice as effective as the gypsum, that is the UCS strength with 10% gypsum is similar to the UCS strength with 5% calcite. For example, Figure 4b shows that approximately 5% calcite is produced by adding 10% urea and 10% calcium chloride to the bacterial solution.

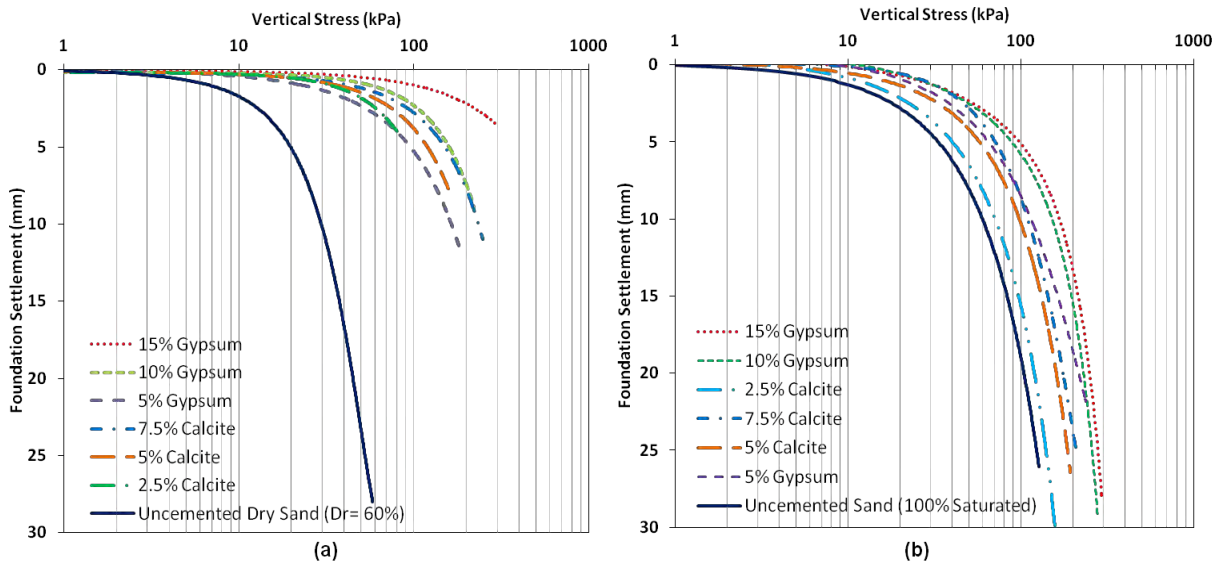
Figure 5 shows the evolution of the average vertical pressure (load divided by area of the footing) with vertical displacement for the model footing tests. Results are shown for surface footings, footings on gypsum cemented columns, and footings on bio-cemented columns. The soil surrounding the columns was Sydney sand with a relative density of about 60% in both dry and wet conditions. As expected, the cemented columns significantly increased the stiffness of the foundation response compared to the tests with no columns, and increasing amounts of both gypsum and bio-cement increased the stiffness and load carrying capacity of the footings. All footings on the dry sand failed in a general shear mode, with a shear plane forming and breaking the column about one diameter below the footing. Failure was associated with a sudden loss in load and tests were terminated when this occurred. In the saturated sand the columns also failed in a similar manner, however this was not evident in the load, deformation responses (Figure 5b) which generally showed a monotonic increase in resistance. The tests in saturated sand also appeared to show a smaller difference than for dry sand between the footings with and without the cemented columns.

Figure 5: Stress, displacement responses from model foundation tests in (a) dry sand (b) saturated sand.

In UCS tests it was found that the strength and stiffness of specimens cemented with either gypsum or calcite were similar when the percentage of calcite was half that of gypsum. However, in the footing tests the gypsum cemented columns were superior to the bio-cemented columns with equivalent UCS strengths, providing higher strengths and stiffnesses. This difference was more pronounced in columns mixed in saturated soil where gypsum cemented columns gave almost double the resistance of the bio-cemented columns. These differences are believed to be

related to insufficient curing of the bio-cemented columns. By monitoring the shear wave velocity it has been found that about 24 hours is needed for completion of the bio-cementation reaction in UCS specimens (Duraisamay, 2015), but the extra 6 days curing time of the UCS specimens may have resulted in some additional slight strength increase. Under saturated conditions the curing process of the bio-cemented specimens could be affected by the surrounding water. This is possible because dilution by the water may limit changes in pH which are necessary for calcite precipitation. During microbial activity in soil the pore fluid pH increases and calcite typically precipitates when the pH is 8.5 to 9.0 (Stocks-Fisher et al. 1999).

In practice cemented columns are used to control settlements and in these model tests settlement reductions of 50% in dry sand and 32% in saturated sand were observed using bio-cemented columns (7.5% calcite). Similar trends were also observed in other footing tests when the sand surrounding the columns had relative densities of 40% and 50%. Similar settlement reductions have been reported in other model tests using bio-cementation (Martinez and Dejong, 2009). These tests have shown the potential of bio-cementation to create cemented columns of sand, however uncertainty remains regarding the influence of the ambient temperature, which can affect the calcite precipitation; the speed of the mixing auger which can affect the bacterial activity and influence the amount and distribution of calcite; and the curing time required on site.

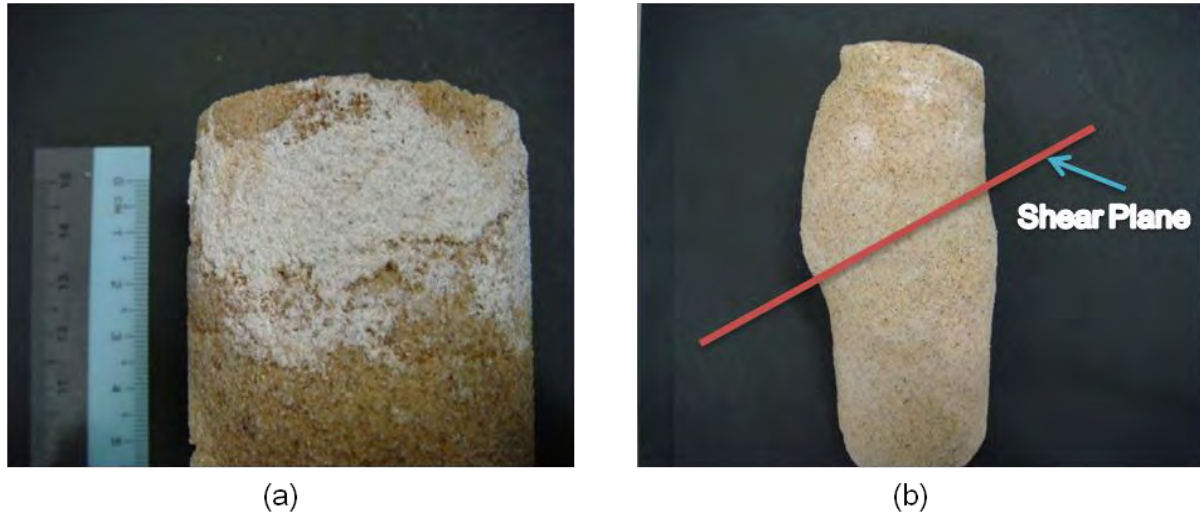
The effects of the repair techniques could also be investigated by extracting the columns from the sand after the loading tests. Two repair mechanisms could be identified. First, in the tests where the bacterial solution was injected around the pile evidence of calcite precipitation on the surface of the column was evident as can be seen in Figure 7a. This precipitation appeared to be primarily filling in cracks in the column surface created during the first loading. There was no evidence of cemented sand surrounding the column, but this may have been because this cementation was broken down during the loading of the repaired column. These observations suggest that injection of bacterial solution in the vicinity of cracks may be effective in sealing them and be able to prevent damage from water entry. Second, when the bacterial solution was poured through the central hole it was able to weld the two parts of the damaged column together as shown in Figure 7b. This observation suggests that there is potential for pile repair providing provision is made for tubes that can enable the bacterial solution to be directed to regions needing repair.

Figure 7: Samples retrieved from model test showing (a) sealing (b) welding effects.
