GEOTECHNICAL CHALLENGES FOR CONSTRUCTION OF DIAPHRAGM WALLS AND FOUNDATION OF SYDNEY'S TALLEST BUILDING, CROWN SYDNEY HOTEL RESORT

Crown Sydney Hotel Resort is the Stage 1C component of Barangaroo South and is being developed as a single high rise mixed use tower of 72 stories (271m high), rising over a multi-level podium and a 3 level basement car park (total 75 levels). The Crown Sydney Hotel Resort basement retaining wall comprised 33 diaphragm wall (D-wall) panels and 36 barrettes for the foundation of the main tower and more than 130 bored piles (including bored compression piles, bored tension piles, bored sleeved piles and permanent plunge column piles). AECOM were engaged as designers of the foundation works by Piling Contractors Bauer Australia Joint Venture (PCBAJV) who constructed the foundation works as the D&C foundation contractor. The depth of foundation elements varied from 25 m to 50 m below ground level.

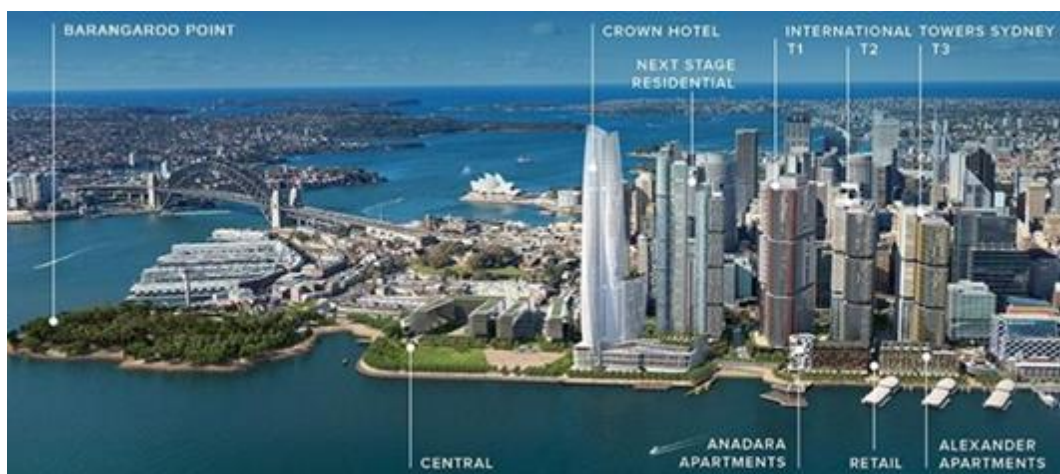
Figure 1: Crown Sydney Hotel Resort location (Courtesy of Wilkinson Eyre Architect)

The Barangaroo South Precinct is a 22 ha land parcel located on the north-western edge of the Sydney CBD. Crown Sydney Hotel Resort is located on Stage 1C of Barangaroo South. Crown Sydney Hotel Resort will be Sydney's tallest building with 75 floors (including basements) and a height of 271m. Furthermore, Crown Sydney Hotel Resort will be the first 6-star luxury hotel. The project is currently under construction and is expected to be completed in 2021. Crown Sydney Hotel Resort (the Crown development site) is surrounded on 3 sides by other areas of the Barangaroo development precinct and, on the western side, is adjacent to Darling Harbour (see Figure 1).

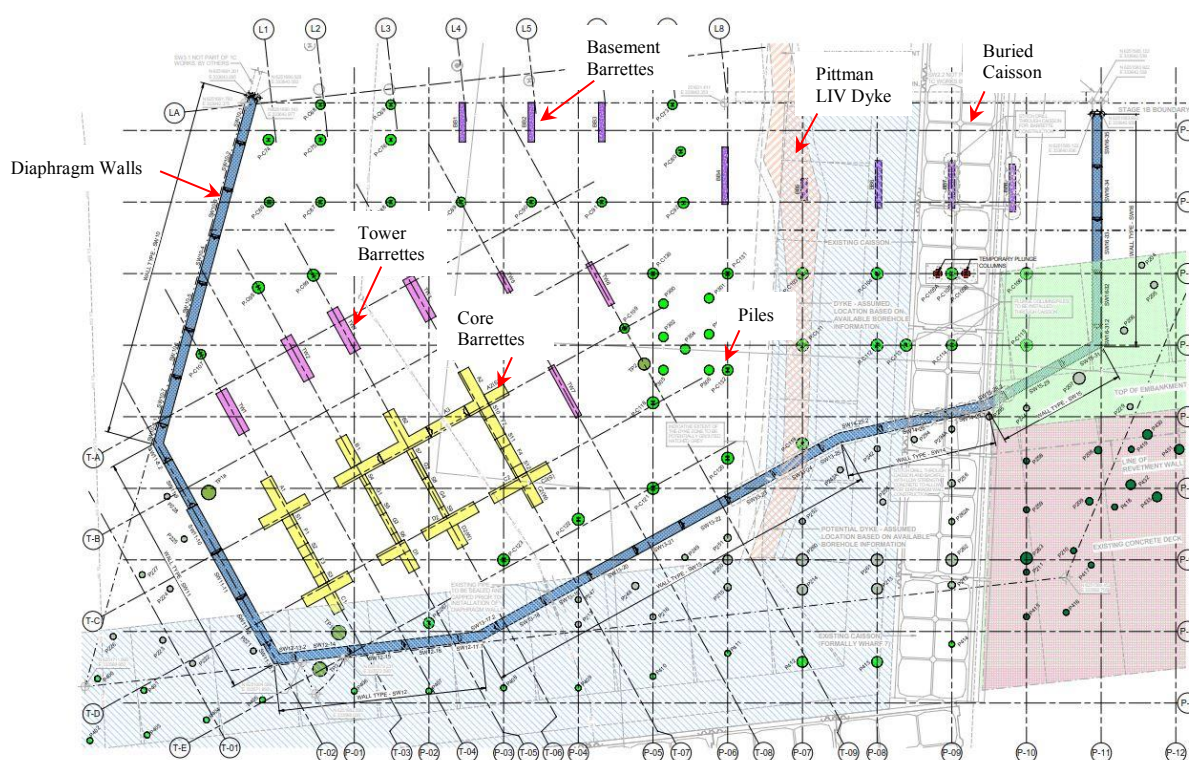
Figure 2: Crown Sydney Hotel Resort basement foundation plan

A full top down methodology for concurrent tower and basement construction was adopted in order to meet overall project deadlines for Stage 1C with all foundation elements constructed in-situ from ground level (see Figure 2). The perimeter retention walls and the tower and podium foundations were installed from ground level, after which the ground floor slab was fully constructed, with the subsequent, concurrent construction of the tower and podium occurring simultaneously with the excavation and construction of the basement works. In order to facilitate the top down methodology, plunge columns were selected to support the ground floor slab and the construction of the podium levels above, while basement excavations were taking place below. The plunge columns consist of a rolled steel I-Section inserted into a concrete bored pile. The plunge columns are embedded into and are supported by the concrete bored piles with cut-off levels below the lowest basement slab level (B3 Slab). The plunge columns have prefabricated collar plates that are connected to the basement level slabs as the basement is constructed.

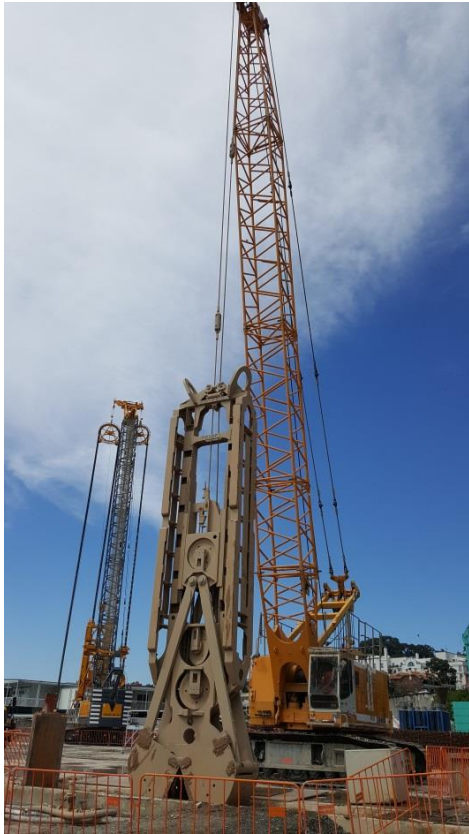
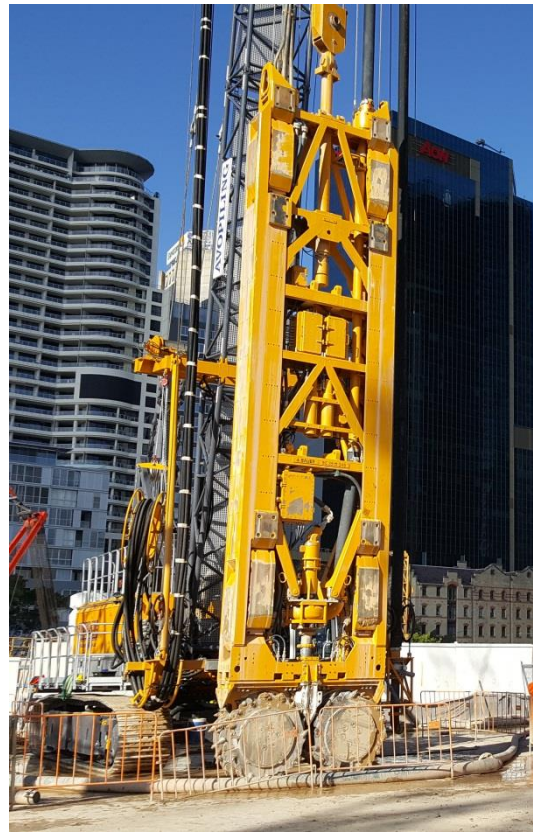
Figure 5: (a) Clamshell grab; (b) hydraulic trench cutter

The diaphragm wall panels and barrettes were constructed by excavating the panels under bentonite to the required depth using clamshell grabs and hydraulic trench cutters (Figure 5). The diaphragm wall was constructed in a series of panels. Panels were constructed in a planned sequence, with every second panel constructed initially as primary panels. This is followed by construction of the secondary and closing panels between the previously constructed primary panels.

Due to the ground conditions, the excavation of diaphragm wall panels and barrettes was carried out in two stages. A clamshell grab is used to excavate fill, alluvium and weak or highly weathered rock in each panel. Upon reaching refusal of the clamshell grab, the grab is exchanged with the hydraulic trench cutter and the excavation process is continued into the rock using a hydraulic trench cutter to the designed level.

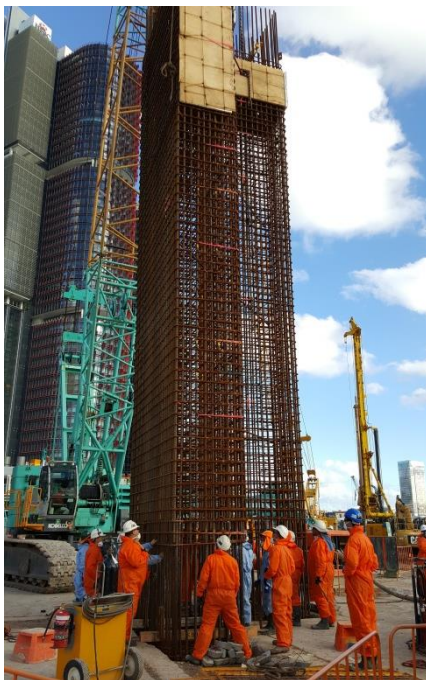
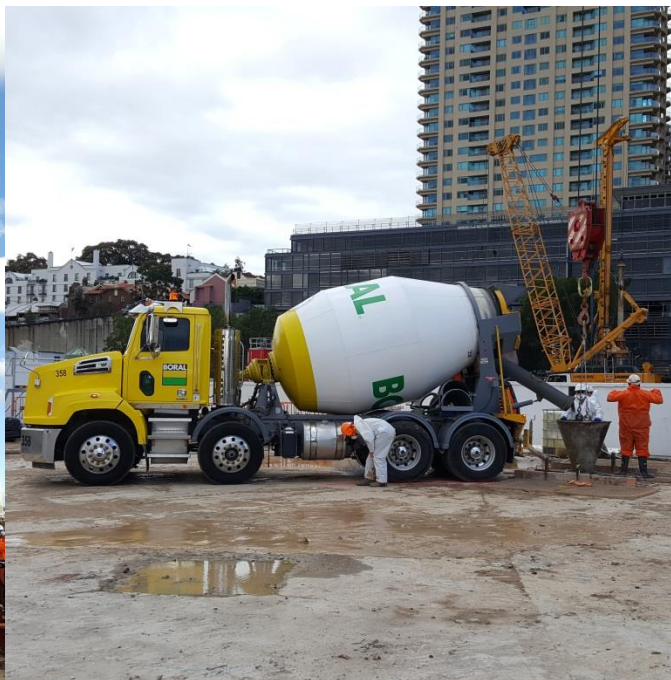
Figure 6: (a) Lowering steel cage; (b) pouring concrete

During excavation, the sides of the excavated trench are supported by bentonite slurry. Upon completion of the excavation, the working bentonite slurry is replaced by fresh bentonite slurry prior to installing the reinforcing cage and concreting. The panel is dipped with a weighted tape to verify that it has been excavated to the required depth. The steel reinforcement cage is lowered into the cleaned slurry and concrete is then tremied into the trench (Figure 6). As the concrete level rises, displaced bentonite is drawn off and pumped back to the bentonite plant for treatment and re-use.

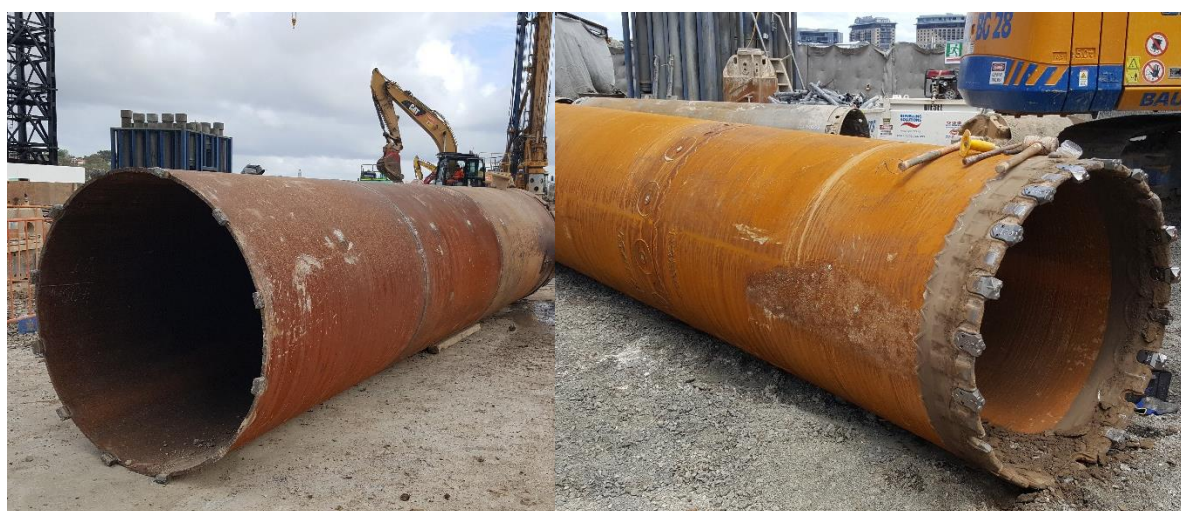
Figure 7: (left) Single wall casings with permanent teeth, and (right) double wall casing with interchangeable teeth

Pile construction commenced by stabilizing the top section of pile hole using appropriately sized temporary or permanent casing. The starter casing was then advanced into the ground applying a combination of rotary torque and crowd force directly from the drilling rig. The starter casings were fitted with either interchangeable or permanent teeth (depending on the casing type) in order to advance the casing through hard soils (Figure 7).

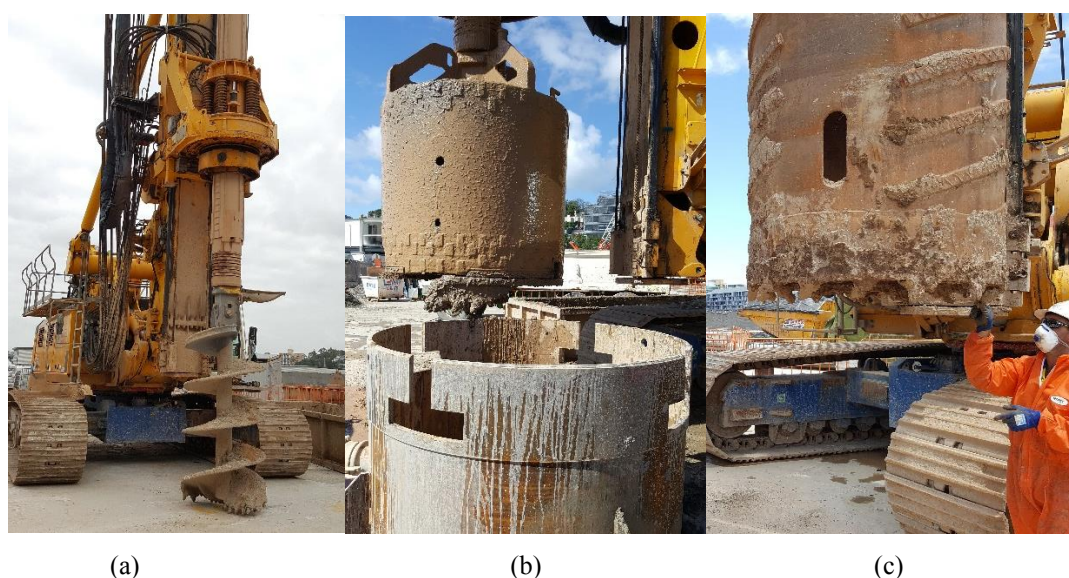
Figure 8: (a) Auger, (b) drilling bucket and (c) core barrel

To excavate to the design depth a combination of drilling tools (e.g. Auger, Drilling Bucket and Core Barrel) were used (Figure 8). Initially, the auger was used to establish the location of the pile and excavate through the fill above the groundwater level. The Drilling Bucket was used for most of the pile excavation in the fill below groundwater level and when the bentonite slurry was introduced into the pile shaft. The sandy to clayey fill had inclusions of slag, concrete and steel over significant lengths of the pile shafts (Figure 9). In addition, the piles had to be constructed through existing buried caissons. A combination of Core Barrel and Drilling Bucket was used to core through these zones and also into the high strength rock that formed the pile socket. The Core Barrel initially cuts the core and the Drilling Bucket is then used to collect and bring out the rock fragments.

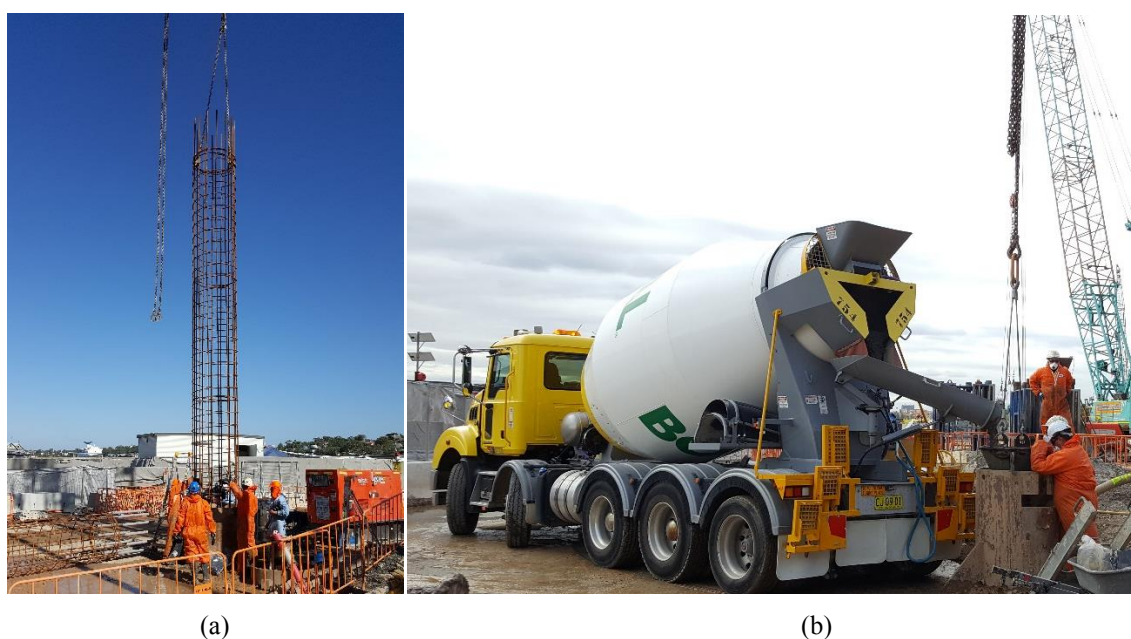
Figure 10: (a) Lowering steel cage into bentonite slurry, (b) pouring concrete

Rock commencement and final founding levels were confirmed by the geotechnical representative on site to confirm the rock socket requirements. During excavation, bentonite slurry was used to stabilize the hole. After completion of excavation, the base of the shaft was cleaned with a cleaning bucket and then the working bentonite slurry was completely replaced by fresh bentonite slurry. To assure that pile base was clean, bentonite slurry was tested to meet sand content requirement of less than 2%. The piles were dipped with weighted tape. The steel reinforcement cage was then lowered into the bentonite slurry and concrete was tremied into the hole (Figure 10).

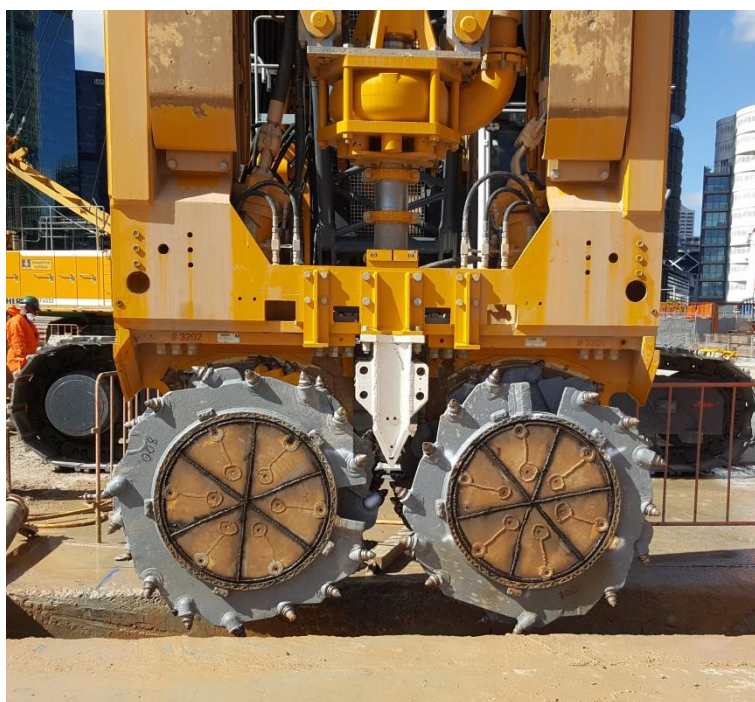
Figure 12: Hydraulic cutter with protruding teeth

Prior to commencement of construction, PCBAJV demonstrated that their construction methodology, based on using hydraulic cutters with protruding teeth was able to achieve the required socket roughness (Figure 12).

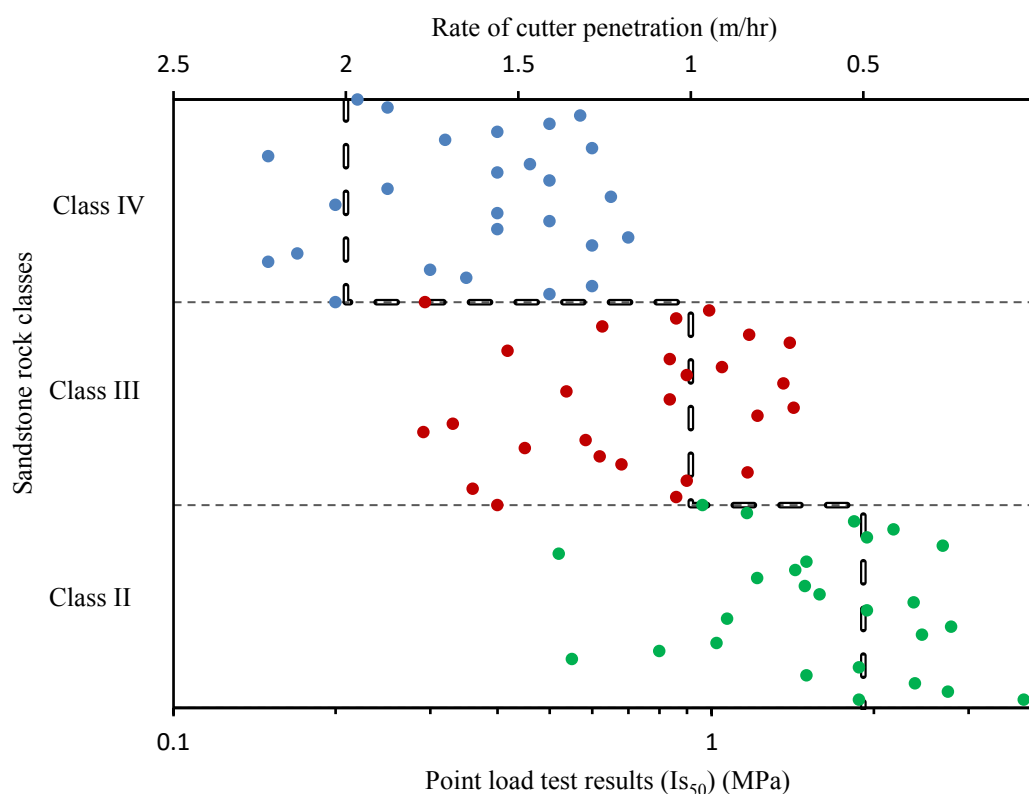
Figure 13: Hydraulic trench cutter observed penetration rate into Sydney sandstone rock classes

Comparing borehole logs with recorded site observations indicated that the hydraulic trench cutter penetration rate reduced with increase in rock strength. The penetration rate halved from approximately 2m per hour for sandstone class IV to 1m per hour for sandstone class III. The indicative average rate of penetration in the sandstone rock classes versus point load test results is depicted in the Figure 13. Due to variations in rock characteristics (e.g. bedding planes, weak zones, and possible localized higher strength bands) the average penetration rates are indicative and can vary from site to site.

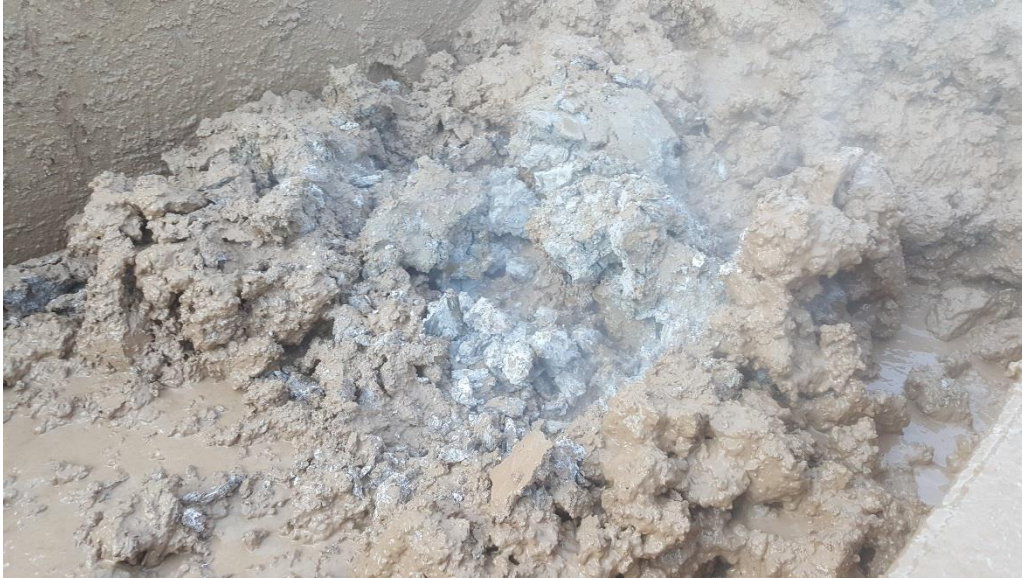
Figure 15: Excavated rock with high temperature and water vapour

Rock quality was assessed initially by visual inspection and examining hand specimens of the excavated rock from the pile shaft and comparing with borehole logs at the piles. The lower the strength of the sandstone, the easier to mould the excavated material by hand. The excavated material tended to become friable when the strength was closer to sandstone rock class IV. Higher strength sandstone (sandstone rock class II) was excavated as sharp fragments, friable and not remouldable. Rock temperature was qualitatively recorded and compared with ambient temperature and weather as an indicator of rock strength. Higher strength rock required more torque, pressure and time for the drilling rig to excavate and consequently tended to generate much higher temperature and water vapour (steam) intermittently (Figure 15). These initial assessments and comparison with borehole logs allowed the on-site geotechnical engineer to assess founding conditions for subsequent pile sockets.

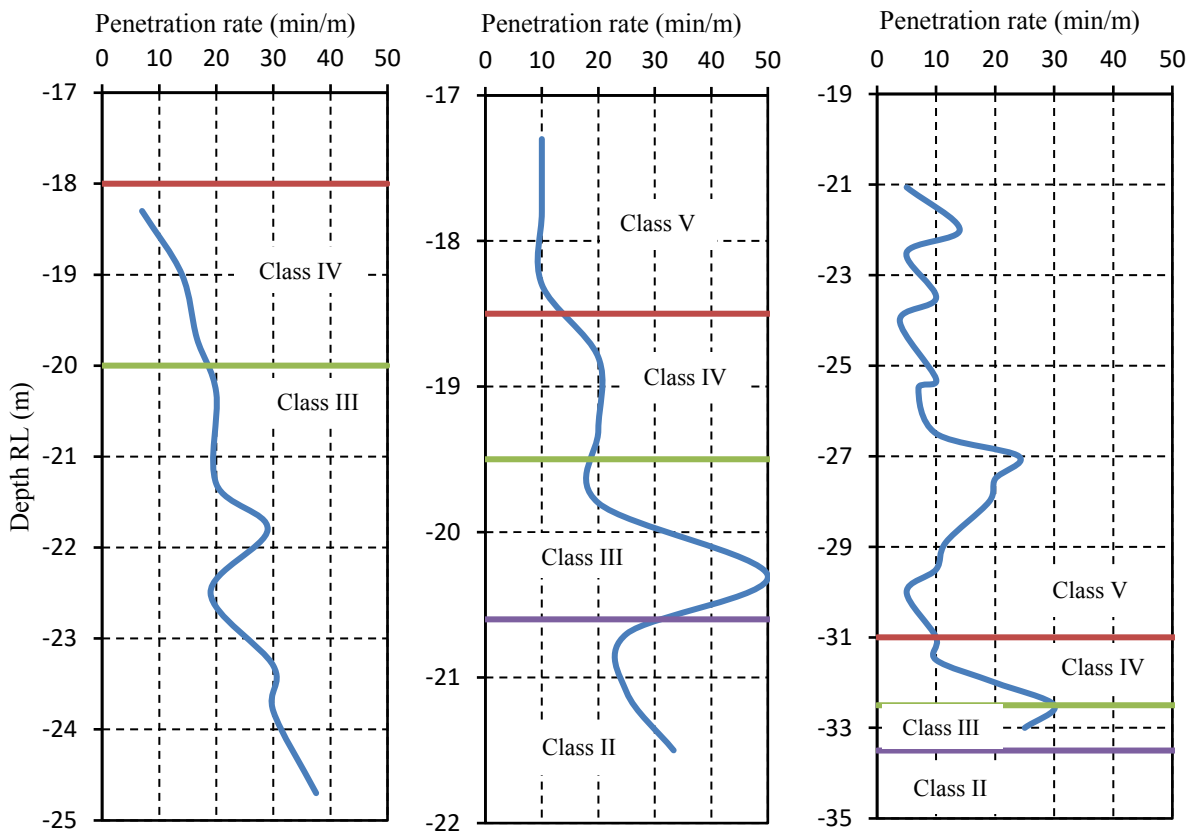
Figure 16: Example of excavation penetration rate in comparison with classified Sydney sandstone classes in nearby boreholes (piling rig) (after Azari et al. 2019)

The penetration rate for piles at borehole locations was monitored and measured to establish a baseline to assist the on-site geotechnical engineer to classify the rock on site. Figure 16 depicts three examples of excavation penetration rate compared with rock classification from nearby boreholes. Type of plant, operator experience, thin layers of high strength rock, clay lenses and tools efficiency play an important role in determining the penetration rate as can be seen in the spikes recorded in Figure 16. It is however evident that a meaningful relationship can be established between penetration

rate and rock classes in Sydney sandstone for the particular conditions at this site with the higher strength sandstone requiring more time to excavate and resulting in a lower penetration rate.
