LAKE TEWA - MODULAR LINER SYSTEM USING GCLS

Dr Jan Kupec¹ and Rob Kerr²

¹Aurecon, Christchurch, New Zealand, ²Kerr + Partners, Christchurch, New Zealand

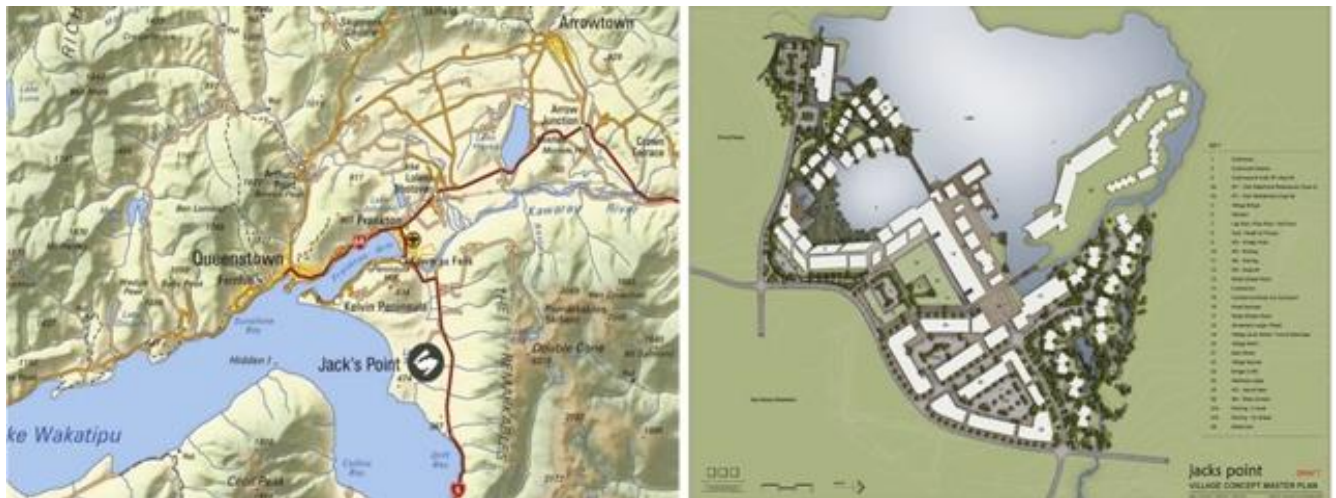
Figure 1: Site location and development master plan.

Jack's Point is some 10 km south east from Queenstown on the shores of Lake Wakatipu, and 5 km south of Kawarau Falls and the Queenstown Airport, see Figure 1. Photo 1 shows the aerial view of the greater Jack's Point area with the location of Lake Tewa indicated. The climatic and meteorological data relevant to the project were taken from Queenstown Airport Station using the NIWA Climate Website. The data comprised daily solar radiation, both short and long-wave, air temperature, air pressure, wind speed and daily rainfall. Based on the data, the environmental conditions for the exposed and submerged lining system were determined. The temperature varies seasonally from -10 degrees Celsius to more than 30 degrees Celsius.

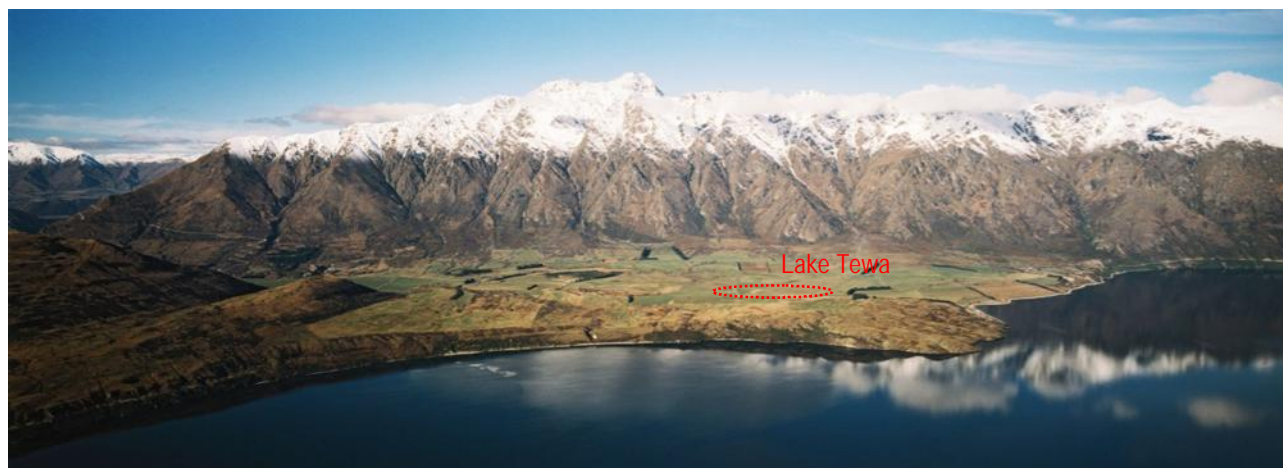
Photo 1: View of the greater site with the Remarkable Mountain Range in the background and Lake Wakatipu in the foreground.

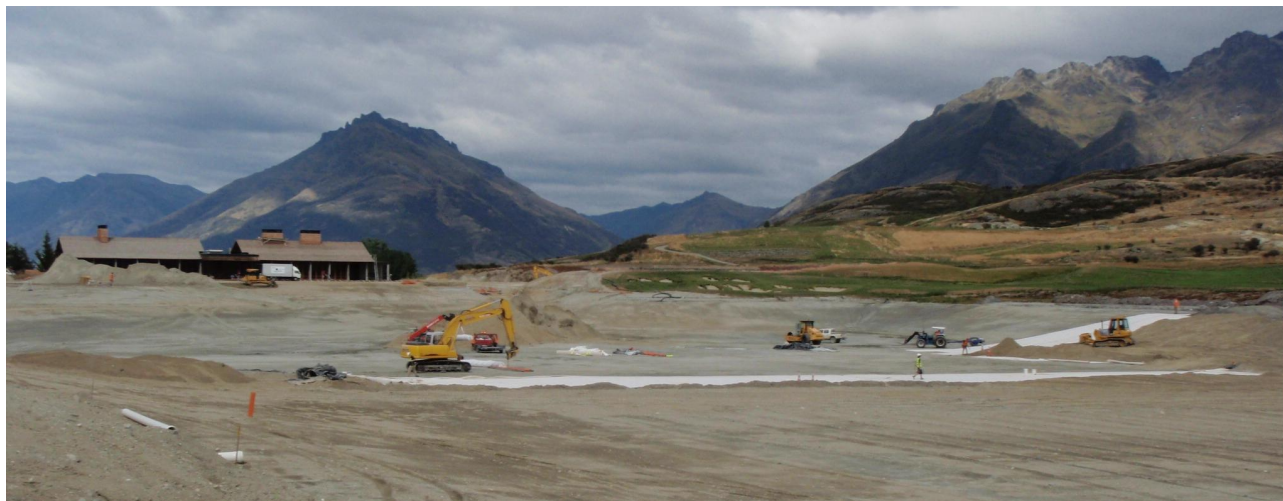
Photo 2: Construction period.

The subgrade was very variable across the 5 ha of lake base. In the northern section fine silts required conditioning and proof rolling, whilst in the southern section the glacial till was undercut and replaced by *in situ* fines from the northern section. The site silts were excavated from the northern section to grade and proof rolled using a smooth steel roller with no vibrations. Where silts were used as a fill the silt moisture content was reduced to less than 35% by handling, spreading and air drying. For installation only light compaction was specified, i.e. 92% of Maximum Dry Density at +/- 2% of Optimum Moisture Content. Additionally a uniformly smooth subgrade was required. In the southern area the glacial till layers were undercut by 200 mm to 300 mm and replaced by lightly compacted conditioned silts. The GCL was then placed directly on the lightly compacted silts. The glacial till excavated from the southern section, essentially comprised of a sandy cobbly gravel was used as confining cover material. Approximately 300 mm of confining cover soil was placed with a light bulldozer (D3) immediately after installation of the GCL, with no compaction required. Where site trafficking was expected the cover layer thickness was increased from 300 mm to 600 mm to spread the wheel loads. To prevent installation damage no heavy tracked or wheeled plant was allowed across the completed liner sections. To allow complete water drawn down, if required at a later stage, the lake base was very gently inclined into a centrally located sump. Photo 2 shows the site half way through the construction period.

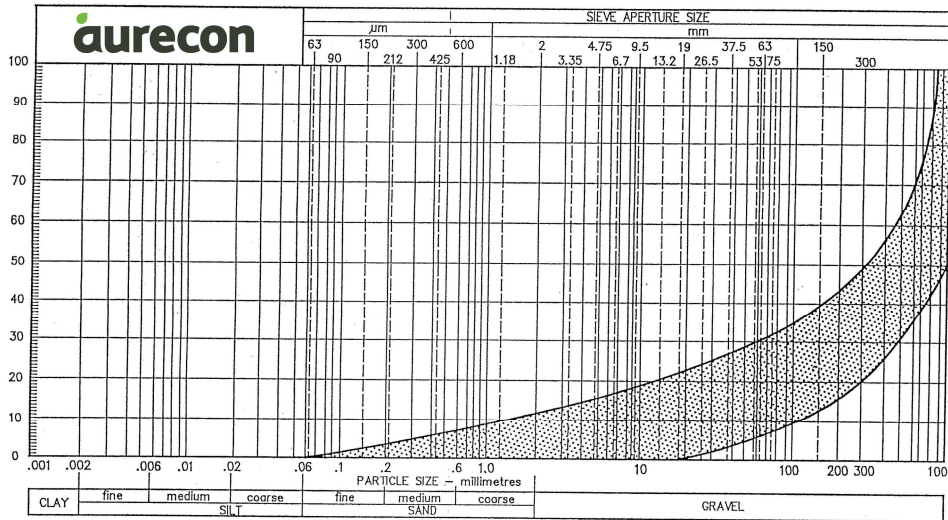
Figure 3 Particle Size Distribution for rock armour on lake edges

- i. A maximum particle size of 600mm, preferably quarry run rock and lie within the grading envelope in Figure 3.
- ii. The Strength classification shall be R3 to R6 as defined in attached Table 2
- iii. Degree of weathering classification shall be SW to UW as defined in attached Table 3

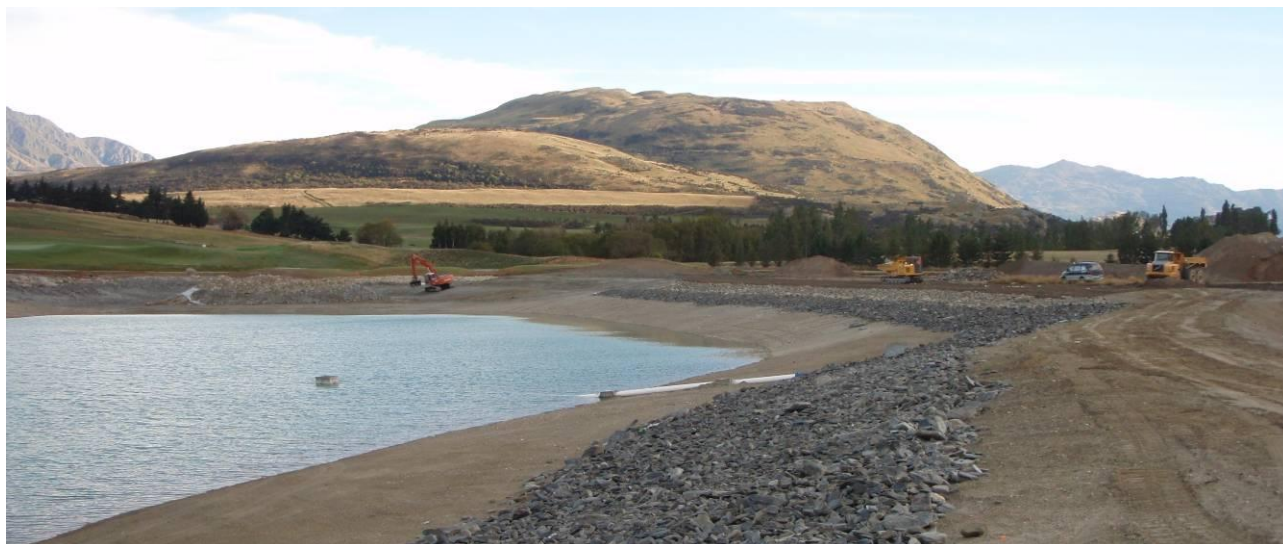
Photo 3: View along the modular lake edge and partially filled lake.

The seepage losses to date are negligible and the GCL appears to perform as designed and intended. Photo 3 shows the lake being partly filled. The modular lake edge is shown with confining cover soil, wave protection armouring and an exposed recirculation pipe.
