Past and Current Construction Projects on Swan River Soft Soils

Doug Stewart

Australian Geomechanics Society
Soft Soils Seminar 14 November 2014

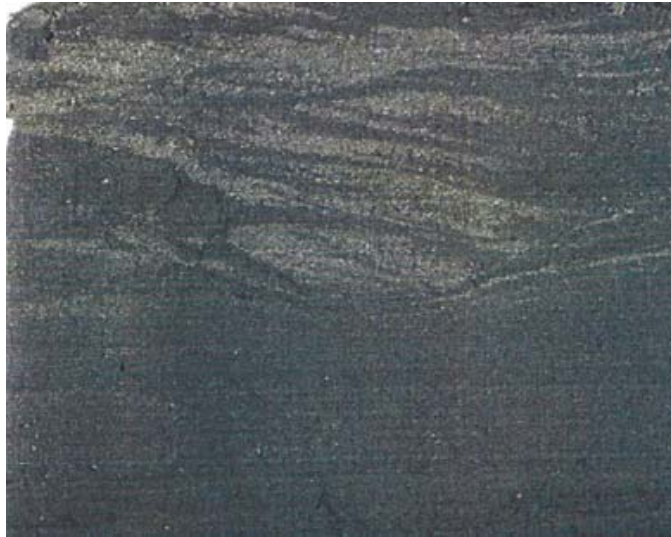
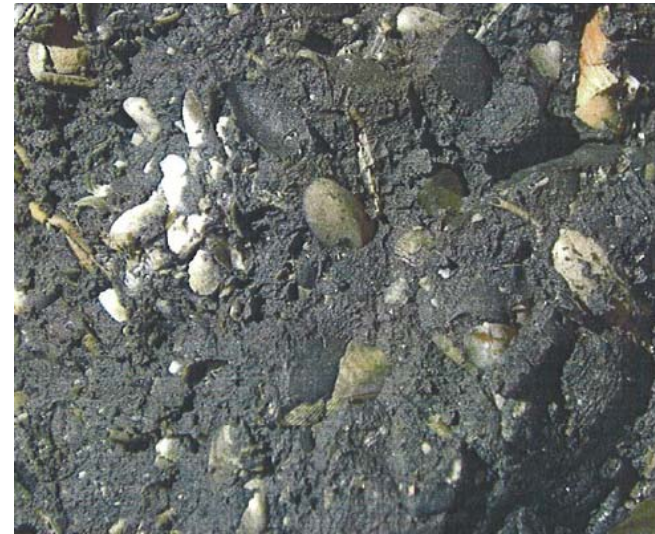
Fine bedding

Concave upwards and downwards shells

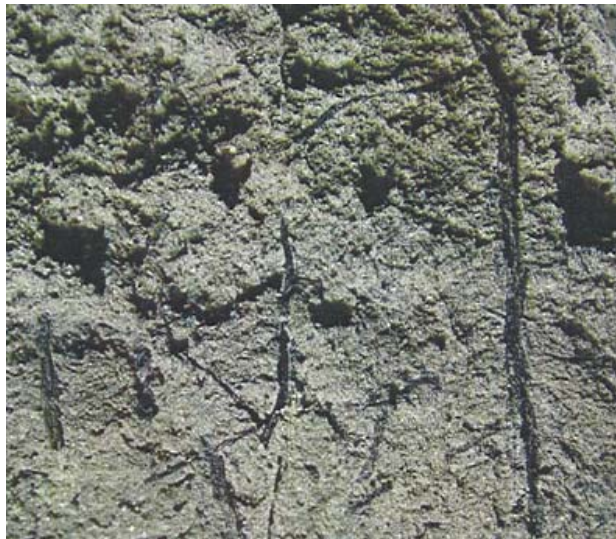
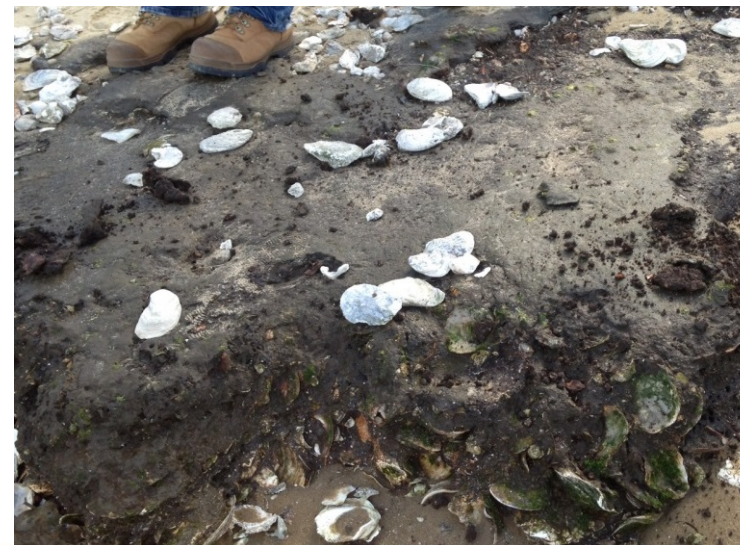
Sub-vertical roots

Oyster shell beds exposed on river bank

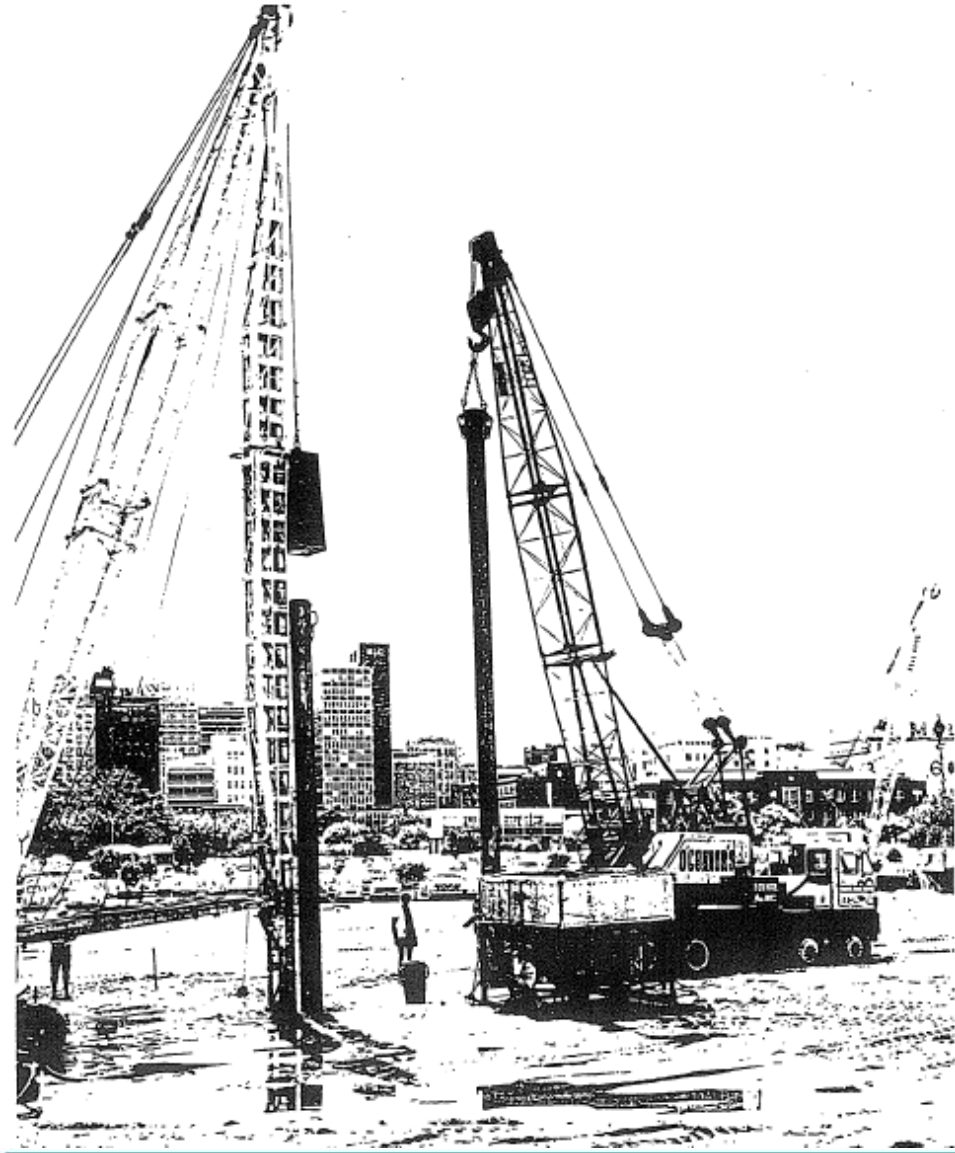
Sand Drain Installation

- Mandrel with end flap driven with drop hammer.
- Mandrel filled with sand and extracted.
- Typical mandrel diameter = 380 mm
- Typical constructed drain diameter = 450 mm
- Drain spacing = 1.4 m to 2.4 m
- 43,000 drains installed
- On average 30 drains/day installed to 18 m depth

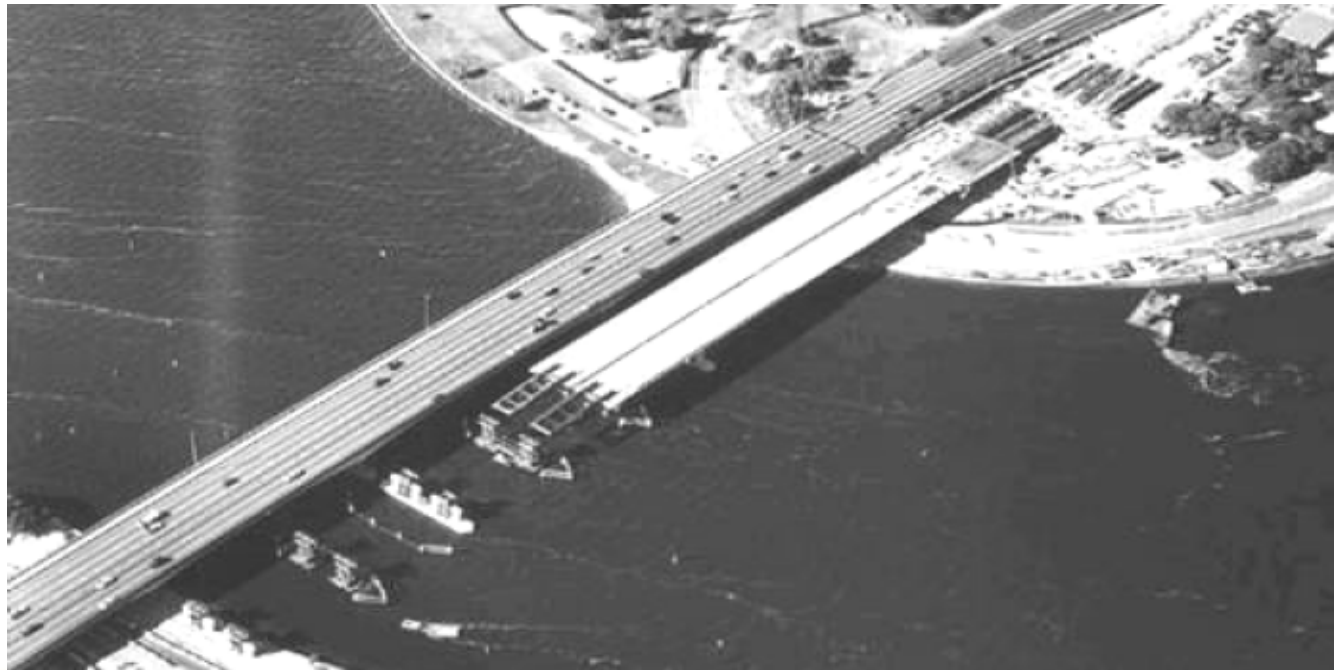
Narrows Bridge Duplication

- Requirement to cause no adverse effect on existing bridge
- New bridge abutments allowable horizontal movement = 40 mm over 7 years and 150 mm over 100 years
- Fill placement limited 63 m from north abutment and 118 m from south abutment
- Piled approach slabs

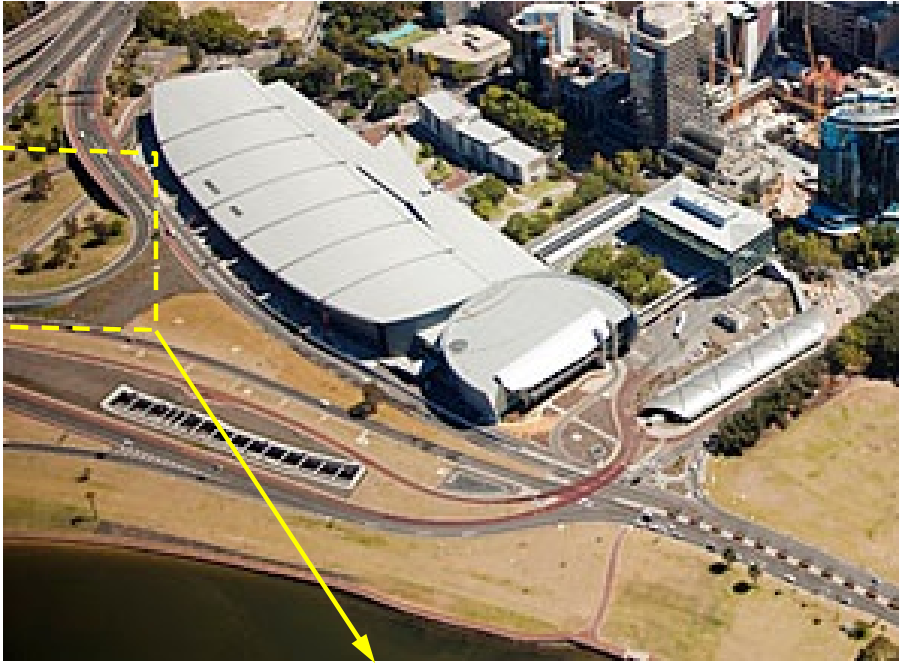
PCEC

Perth Convention and Exhibition Centre
Included loop bridge on freeway off-ramp.
Constructed 2001 to 2004.

Located within Narrows Interchange reclamation.

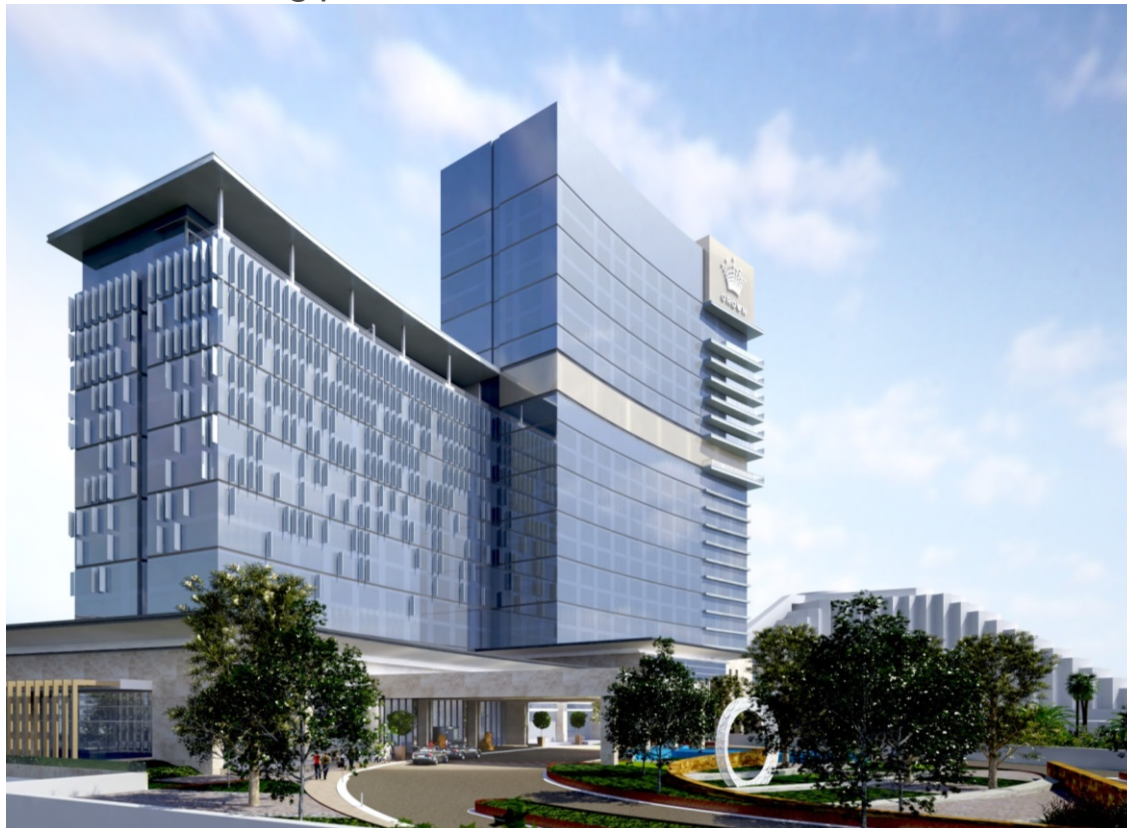
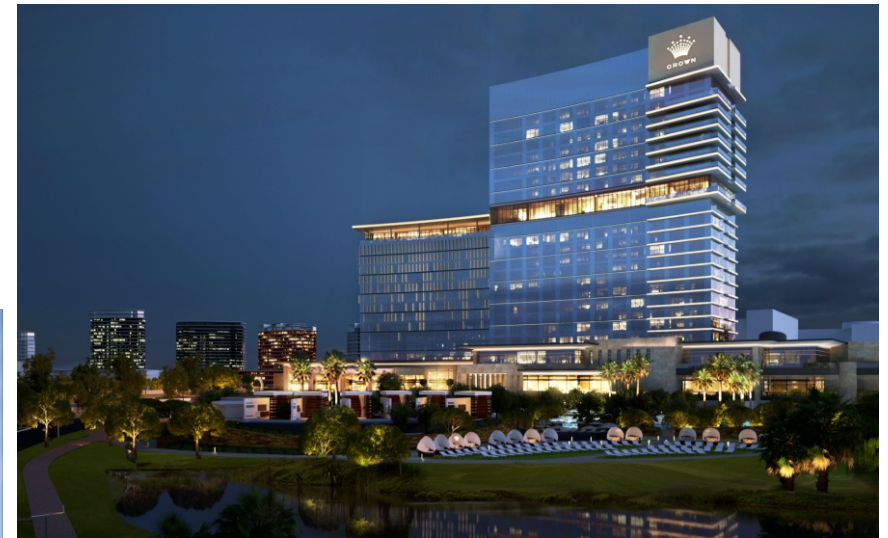
Crown Towers Perth

- 500 room 6-star hotel with 25 storey main tower
- Entry road rises from ~RL 2 m AHD on Camfield Drive, crossing an existing lake
- Elevated porte cochere at RL 7 m AHD
- Swimming pool
