B U T L E R
P A R T N E R S

Our involvement began by assisting with improving the embankment design and speed the rate of consolidation

Embankment Design and Improvement

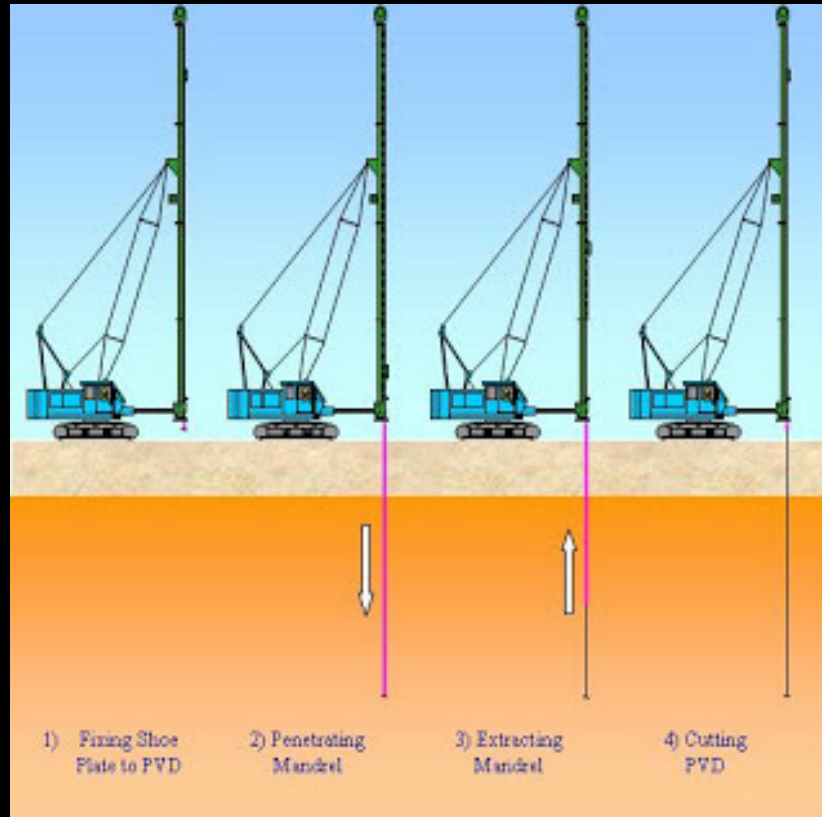
Wick Drains

Prefabricated Vertical Drains (PVD):

- Reduce settlement of soft clay
- Allow excess pore water pressure to dissipate
- 90% Consolidation during .

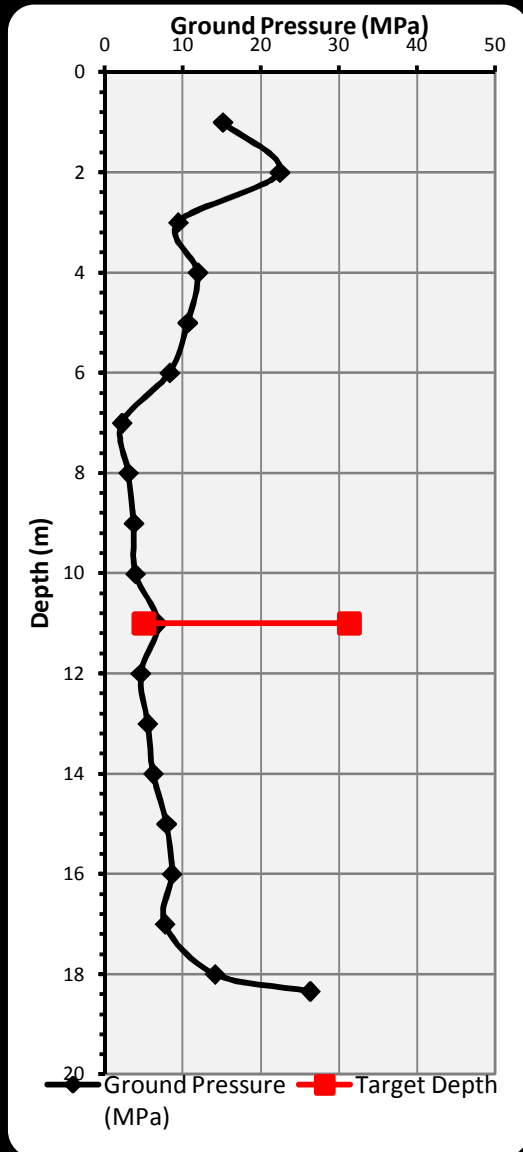
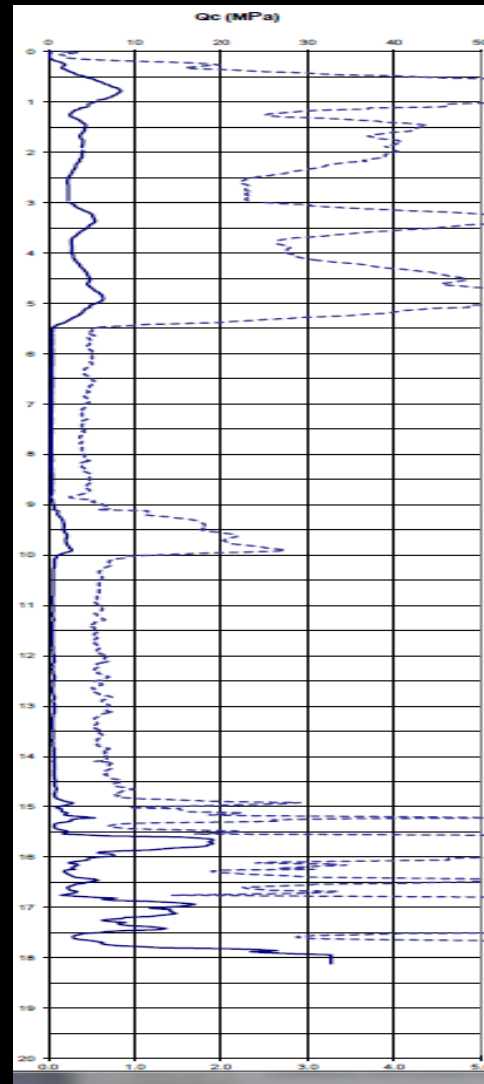
CPT Investigation

- Comparison between Wick Drain and CPT results

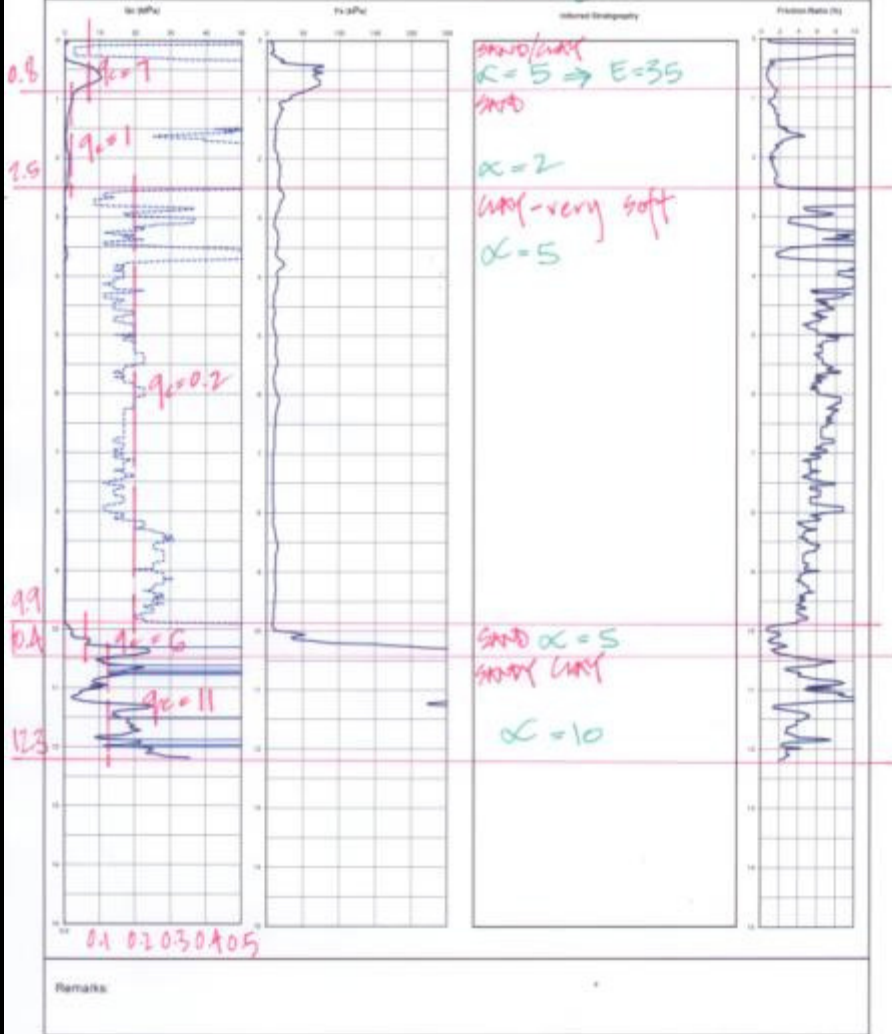
CPT: BP 1-9

CONE PENETROMETER TEST REPORT

$E = \alpha q_c$

$M_v = \frac{0.75}{E}$

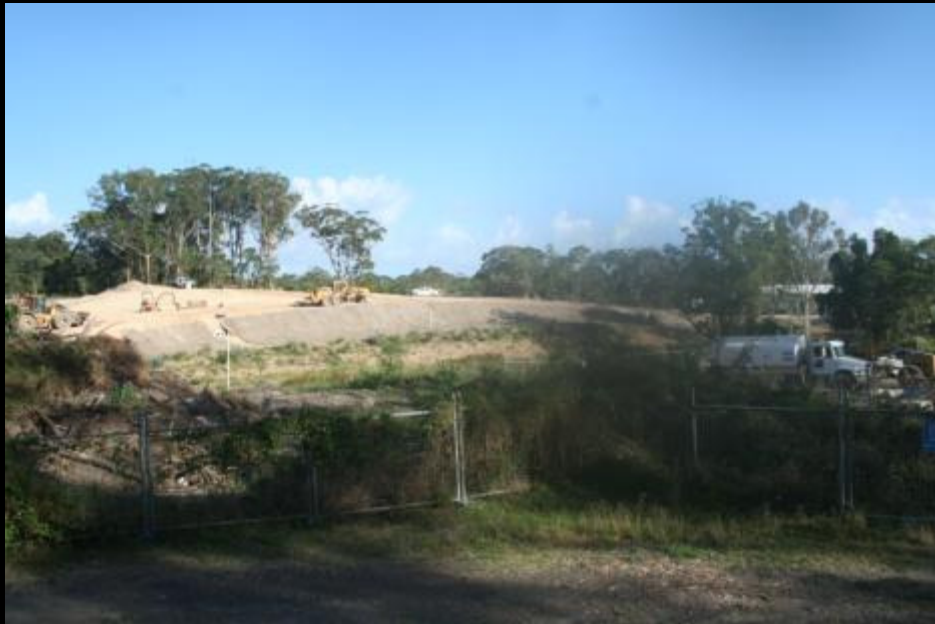
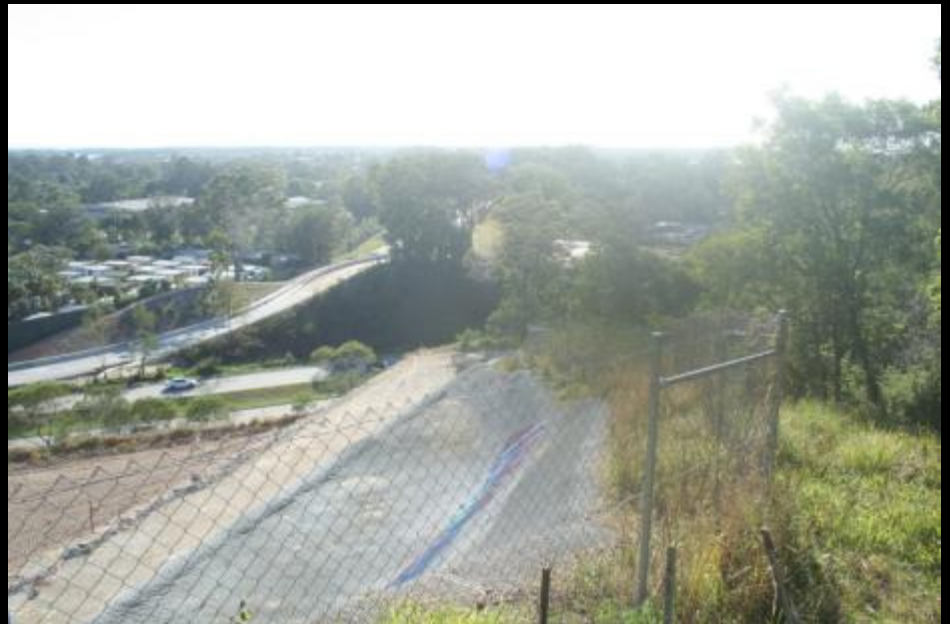
Stability number – N

$$N = \frac{c_u}{\gamma H}$$
