PROCEEDINGS OF THE 10TH YOUNG GEOTECHNICAL PROFESSIONALS CONFERENCE (10YGPC)

**10 – 12 SEPTEMBER 2014
NOOSA, QUEENSLAND, AUSTRALIA**

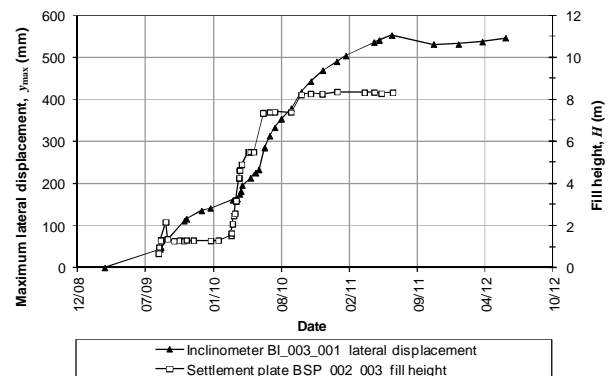
Figure 3. Example plot of embankment height and maximum horizontal displacement at the western approach to the bridge at Emigrant Creek South.

For instrumented embankments constructed on soft ground, it is usual practice to plot embankment height and the maximum lateral displacement at the toe of the embankment (as measured by inclinometer) over time. An example of this from the Ballina Bypass Alliance Project, at the western approach to the bridge at Emigrant Creek South, is shown in Figure 3.

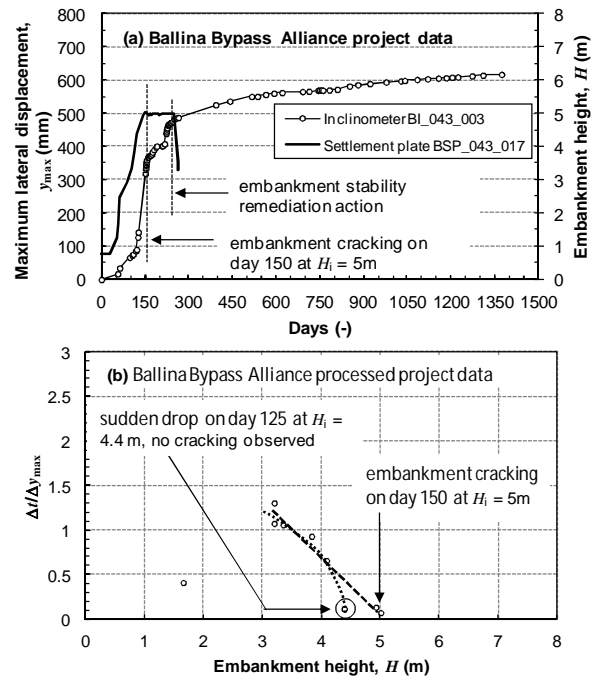
Figure 4. (a) Ballina Bypass Alliance project data at an embankment in North Sandy Flat, and (b) inverse rate approaching the horizontal axis at embankment imminent failure with embankment heights of 4.4 m (lighter broken line) and 5 m (darker broken line).

failure after reaching an embankment height of 4.4 m. At this embankment lift stage, the rate of lateral movement was just above 8 mm/day and no embankment cracking was observed. A second trend line represented by a darker broken line links the data points up to when embankment cracking was actually observed when the embankment height of 5 m was reached.

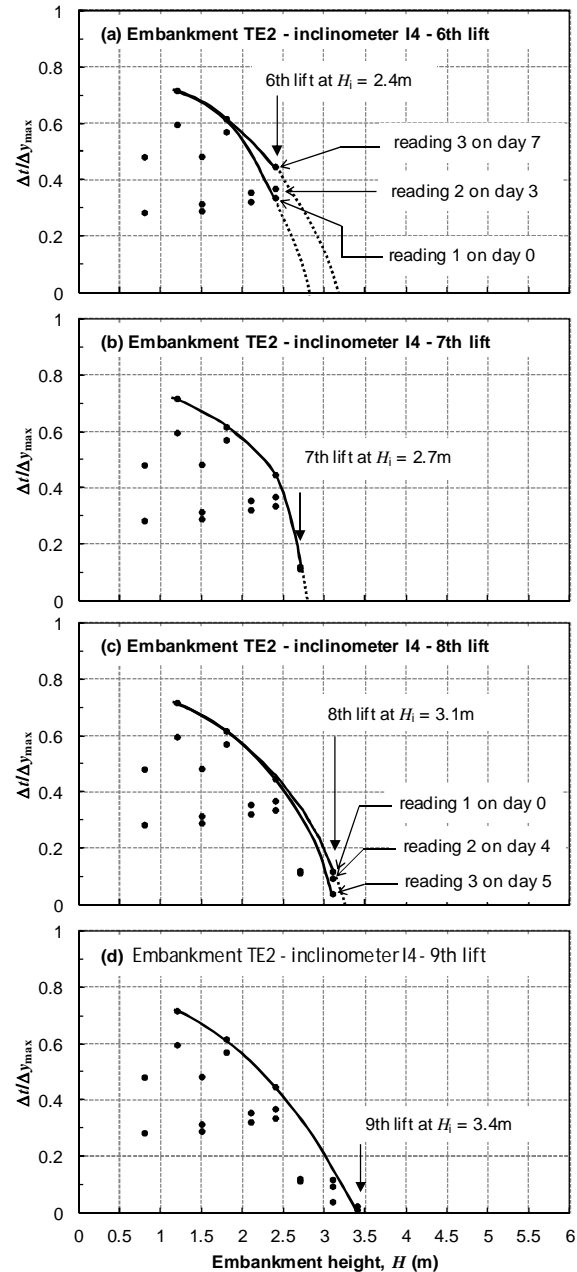
Figure 5. Iterations made to assess instability of the trial embankment TE2 (a) after completing lift 6, (b) after completing lift 7, (c) after completing lift 8, and (d) at failure after completing lift 9.

Figure 5(b) represents the next iteration updating the previous iteration with the inclinometer reading taken 2 days after the lift was completed. This iteration shows a dramatic drop of $(\Delta y/\Delta t)^{-1}$ to 0.12 day/mm and the predicted H_f is estimated to be 2.8m implying that $H_i > 0.9 H_f$. As such, Step 5 could be adhered and the ratio $(\Delta y/\Delta t)^{-1}$ should be kept above 0.05 day/mm.

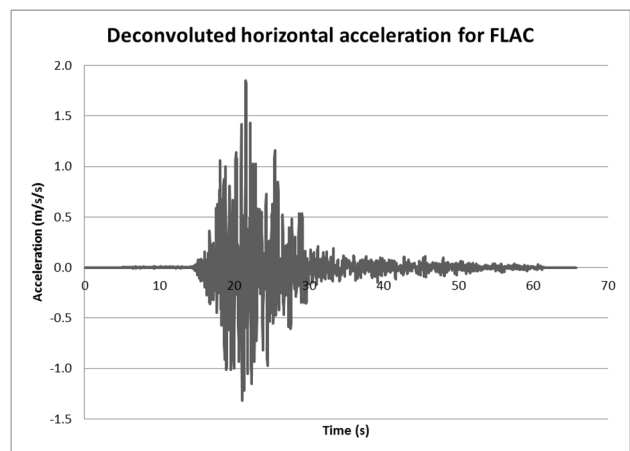
Figure 3. Deconvoluted horizontal acceleration for input into FLAC

Seismic records from Riccarton High School (RHSC) station were considered to be suitable because no liquefaction was observed here. As the ground motion recorded at the RHSC station was recorded at the ground surface, where the input motion in the FLAC numerical model is at the base of the model, a Deconvolution analysis is required in order to model the representative motion at the base of the mode. The strong motion record was corrected into the direction perpendicular to the cross section and deconvoluted to the depth of engineering rock using a 1-D wave propagation programme Strata (University of Texas, 2009) prior to input to the numerical model. Figure 3 shows the input motion for the numerical analyses.

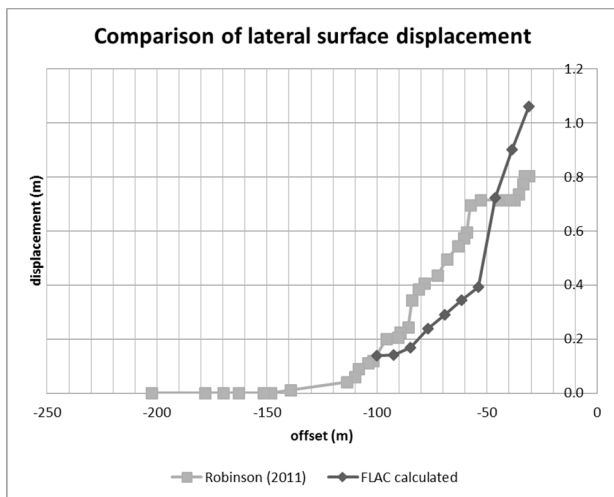
Figure 4. Comparison of lateral surface displacement between Robinson (2011) field measurements and FLAC calculated displacements with distance away from river centre line.

Figure 4 illustrates the calculated surface displacements by the FLAC numerical model and the measured cumulative lateral displacements at transect CH_DAL_15 by Robinson et al. (2011). The figure shows that there is a similar 'exponential decay' distribution where the lateral spreading displacements rapidly decrease with the distance from the waterway. This is consistent with the conventional liquefaction induced lateral spread mechanism where the lateral spreading displacements reduce exponentially away from the riverbank. The calculated surface lateral displacements by FLAC were compared to the field measurements by Robinson (2011). The magnitude of lateral spread between the field measurements and the FLAC calculations at the crest off the bank differed by about 20%. This could be due to the stream bank in FLAC being modelled on the loose silty GRAVEL, where in real life the bank may be supported by vegetation or small man-made structures. The difference in lateral displacements between the calculated and measured values reduces to zero at approximately 100m away from the centre line of the river. Such difference is considered acceptable and comparable considering the displacement trend is reasonably similar.

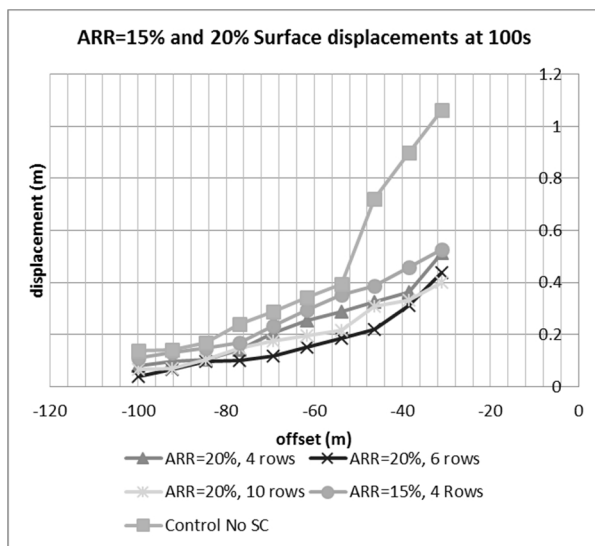
Figure 6. Comparison of lateral surface displacement along the cross section with an ARR=15 and 20% and varying the improvement zones with distance away from river centre line.

The distributions of lateral surface displacement along the cross section showed a similar trend to the ARR=15% case. An increase in the number of stone columns, results in a greater rate of decrease in lateral displacements with respect to distance away from the crest. At 20m from the crest, the model with 6 rows and 10 rows of columns showed lateral displacements of 0.26m and 0.20m respectively.

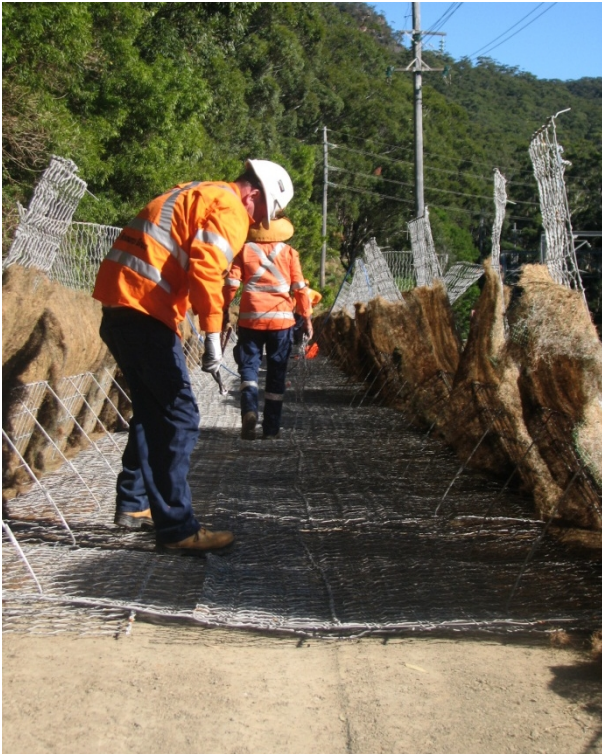
Figure 14. Assembly of Green Terramesh units

The construction began with the foundation layer which was prepared in order to ensure adequate load-bearing and vertical alignment of the embankment. The Green Terramesh reinforcing elements were installed, taking care to place 300 mm thick of seeded topsoil next to the facing lined with MacJute, a bio-degradable erosion blanket to promote plant growth. The embankment fill consisted of good quality, free draining, granular material (with a high internal angle of friction) compacted in layers to 95% Standard Proctor using conventional compaction equipment (rollers, vibrating plate etc.).

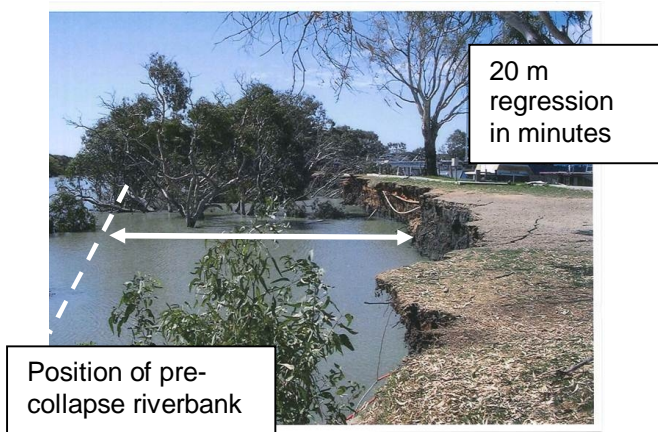
Photograph 1. Riverbank Collapse at Long Island Marina, Murray Bridge.

River bank collapses (landslides) were first recorded in 2008 in the lower reaches of the River Murray (below Lock 1) following a prolonged period of drought. River bank collapses and evidence of instability continued for a number of years whilst river levels remained low. Photograph 1 shows one of the most dramatic collapses that occurred in this period. Individual collapses up to at least 5,000 m³ involving river bank retreats of 20 m occurred in places. From eye witness accounts it appeared failures occurred in tens of seconds to a few minutes.

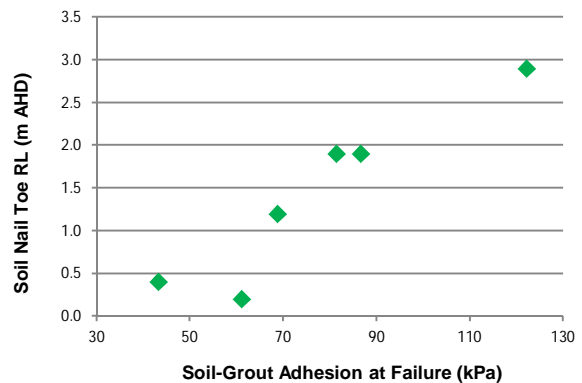
Figure 11. Nail toe RL v soil-grout adhesion – Maribyrnong viaduct

Six pull-out tests were undertaken at various levels along the length of the wall, with all nails comprising a 15 degree declination, 3 m bond length and 0.125 m hole diameter. Figure 11 presents the soil nail toe level plotted against the achieved soil-grout adhesion.

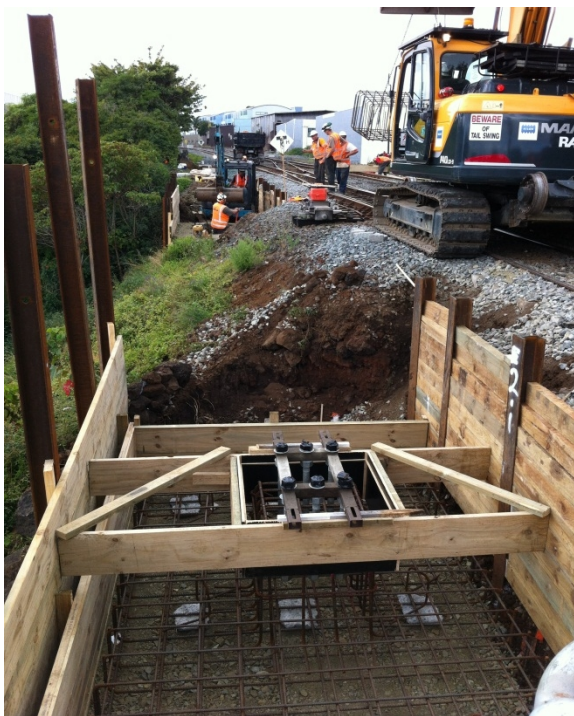
Figure 2. A pad foundation being constructed in a basalt gravel embankment near Morningside.

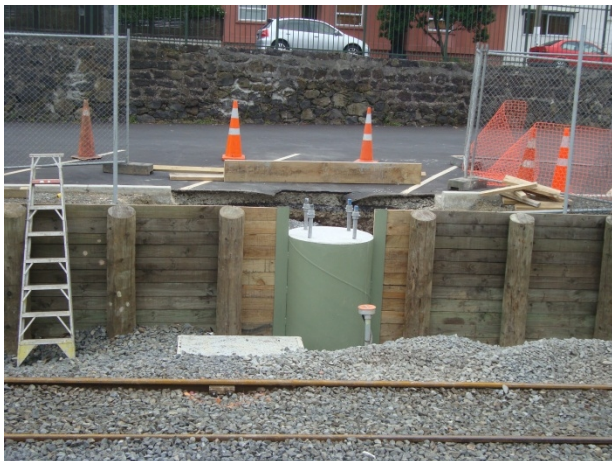
Figure 3. A twin-track cantilever mast foundation at Mt Eden.

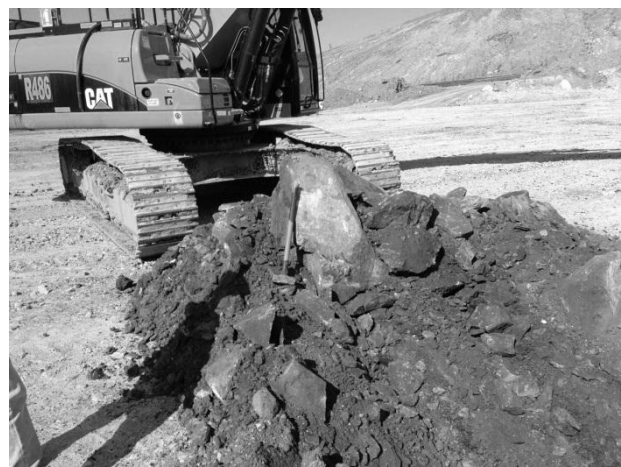
Figure 2. Typical excavated mine spoil, including oversize material. A ten-pound sledge hammer can be seen at centre as a scale reference

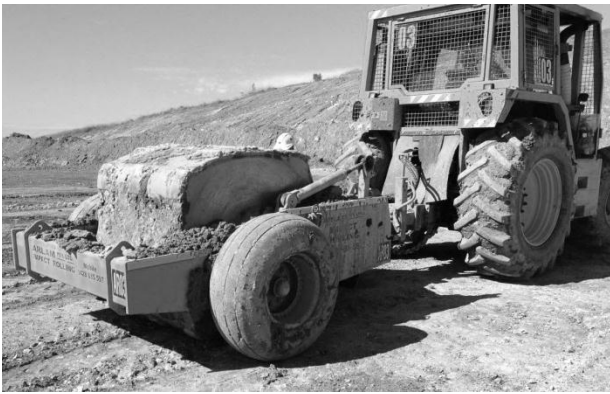
Figure 3. Four-sided impact roller pulled by mine specification agricultural tractor

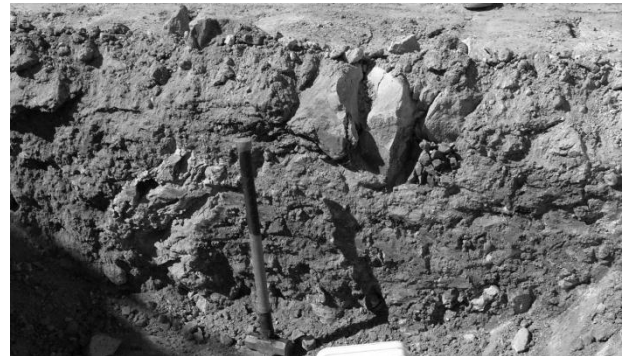
Figure 4. Side wall of test pit showing typical mine spoil material. A ten pound sledge hammer has been placed in the foreground for scale
