MINE SUBSIDENCE ASSESSMENTS AND REVIEW OF SELECTED GROUTING REMEDIATION PROJECTS IN THE NEWCASTLE AREA

T. Cairnes

Douglas Partners Pty Ltd, 15 Callistemon Close, Warabrook NSW 2310

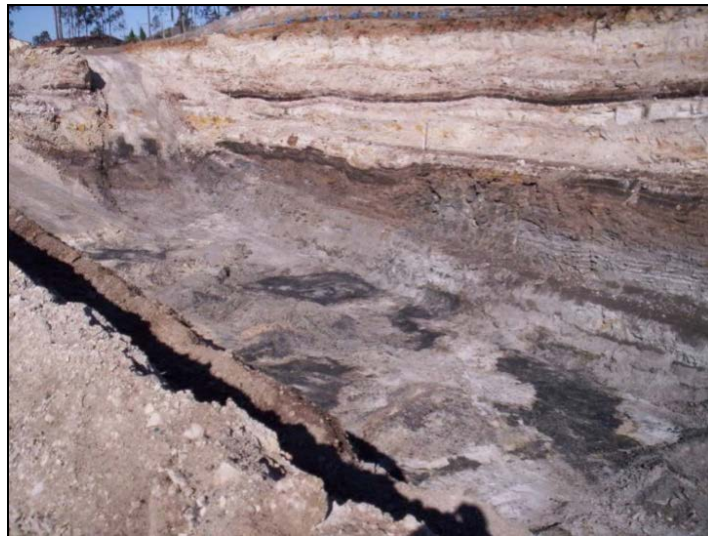
Figure 1: Earthworks remediation of shallow mining to the west of Newcastle. Note the undulations in upper seams in cut batters due to subsidence, and remnant coal pillars exposed in the floor of the excavation

- Earthworks – where shallow mining is present (typically less than 10 m), earthworks can be an economical option to reduce the mine subsidence risk. Overburden material is removed down to mine level (refer Figure 1), and material is then re-placed and compacted in layers back to the design level;
- Grouting – where the mine workings are too deep, or site conditions (such as adjacent developments) make it impractical to undertake earthworks, grouting of the old mine workings is commonly undertaken (refer Figure 2). This option is the focus of this paper.

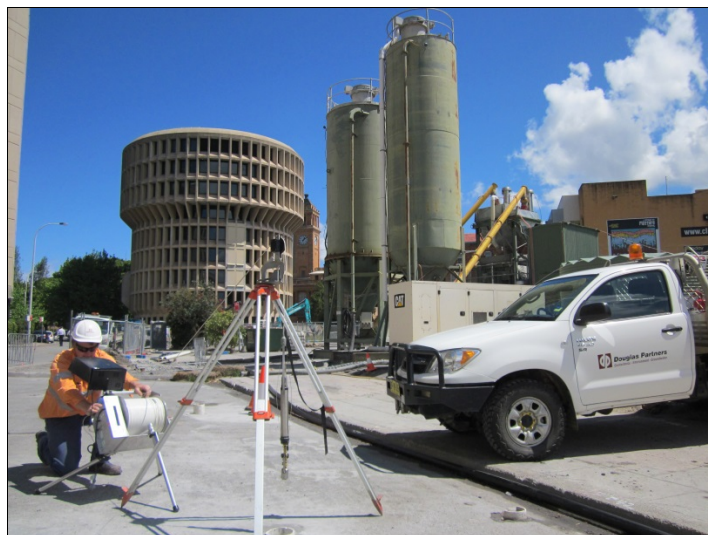
Figure 2: Grout plant set up in Newcastle CBD, with downhole camera being deployed in to a bore to assess the grouting operations

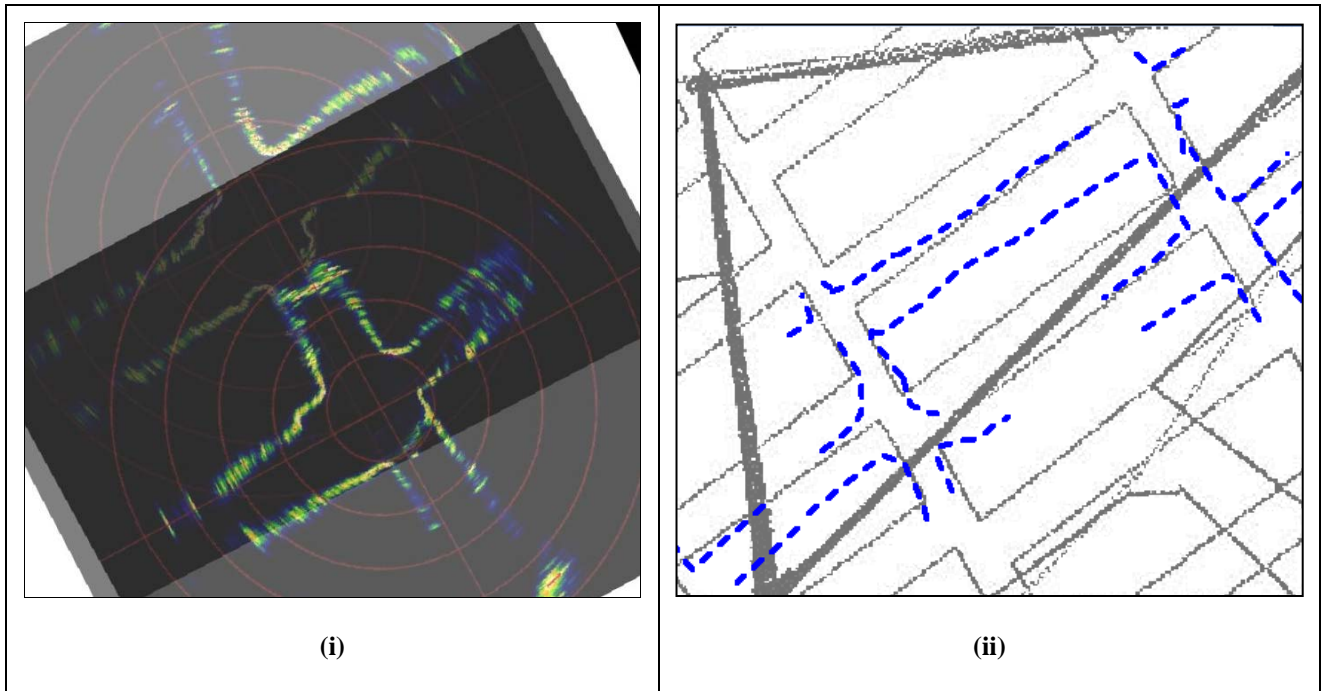
Figure 3: (i) Superimposed sonar images of mined roadways (bords) within Borehole seam workings beneath Newcastle (ii) Inferred mining layout from georeferenced sonar images (blue lines) compared to historical mapping

RTs which were prepared by mine surveyors provide the only record of the position of the mine workings. These records have at times proven to be incomplete or may not represent the actual conditions of the workings. Furthermore, depending on the mining era, survey techniques may not have been as accurate as present day methods, and plan locations of mining can be inaccurate. Experience in the Newcastle CBD is that the RTs are generally a reasonable representation of the conditions at mine level, however there are local anomalies. An example is shown in Figure 3(ii), where it can be seen that the measured location of the mine workings (which were measured by downhole sonar profiling) were found to actually be about one mined roadway (bord) width towards the south east compared to the historical mapping.

Some examples of the output of these techniques are shown in Figures 3 and 4 below.

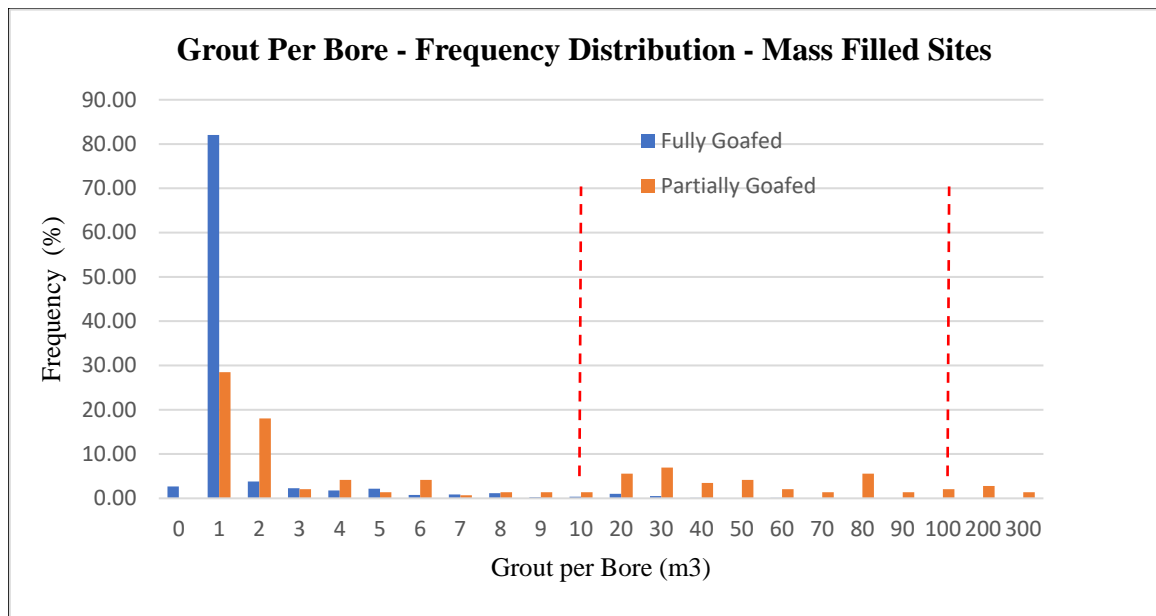
Figure 4: Frequencies of grout take per bore as a percentage of the total number of bores – mass filled sites

Figure 4 shows that the frequency of certain ranges of grout takes varies significantly between “fully goafed” and “partially goafed” sites. For “fully goafed” sites, over 80% of the grout takes are in the range of 1 m³ to 2 m³, compared to less than 30% for the “partially goafed” sites, however grout takes of greater than 20 m³ can be seen to be much more prevalent within bores on the “partially goafed” sites.

Figure 4 shows a frequency distribution of grout takes per bore, for the 930 bores for which this data was available (comprising 786 “fully goafed” site bores and 144 “partially goafed” site bores). The data is divided into “fully goafed” and “partially goafed” sites for comparison purposes.

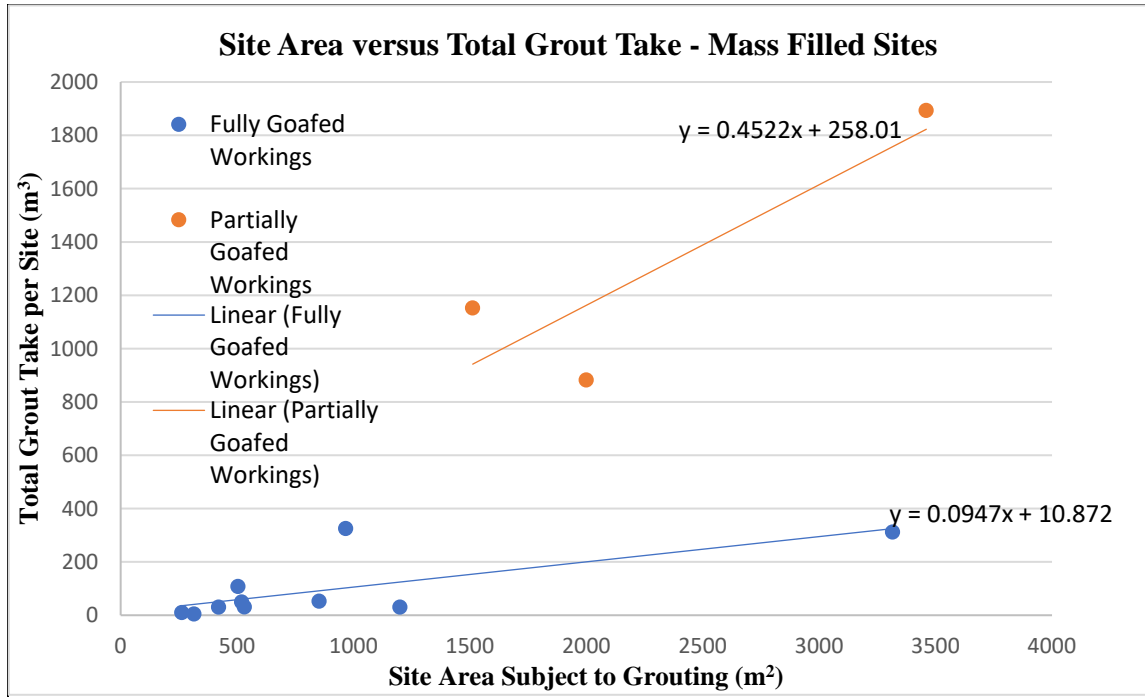
Figure 5: Site area subject to grouting versus total grout take – mass filled sites

From Figure 5, it can be seen that a rough linear relationship exists between the site area and total grout take for both “fully goafed” and “partially goafed” sites, for the data reviewed.

Figure 5 shows the total grout take per site, plotted against site area.
