# Nine YGPC

*9<sup>th</sup> Young Geotechnical Professionals Conference  
11 - 14 July 2012, St Kilda, Victoria, Australia*

## *Conference Proceedings*

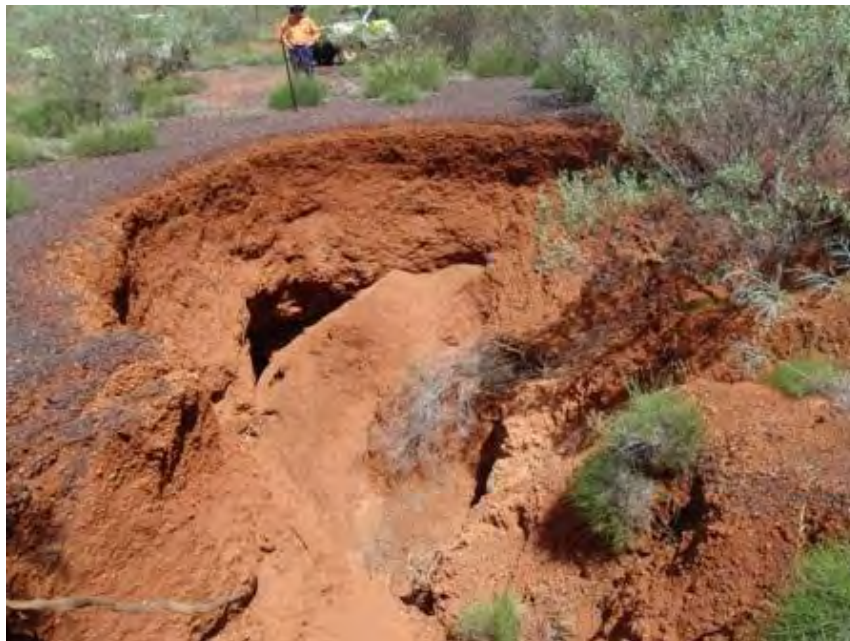
Figure 2: Active drop-out sinkhole located some 15km from the proposed plant site.

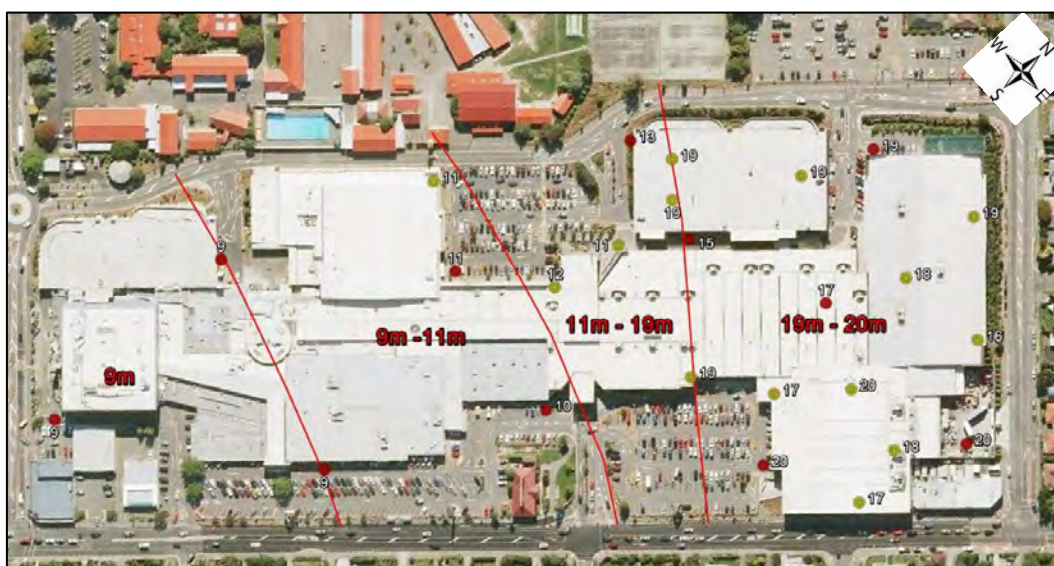
There is a notable abrupt transition in depth to dense gravel across the northern half of the site as shown below in Figure 2, which has significance for the site's liquefaction susceptibility. The soil units overlying the dense gravel are found to be liquefiable in all earthquake scenarios considered. The dense gravels are inferred to be the Riccarton Gravel Unit at the northern end of the site, and as a possible intermediate gravel layer at the southern end of the site. The dense gravel is considered as competent and non-liquefiable under the design earthquake scenarios.

Figure 2: Northlands site plan showing approx. depth to dense gravel

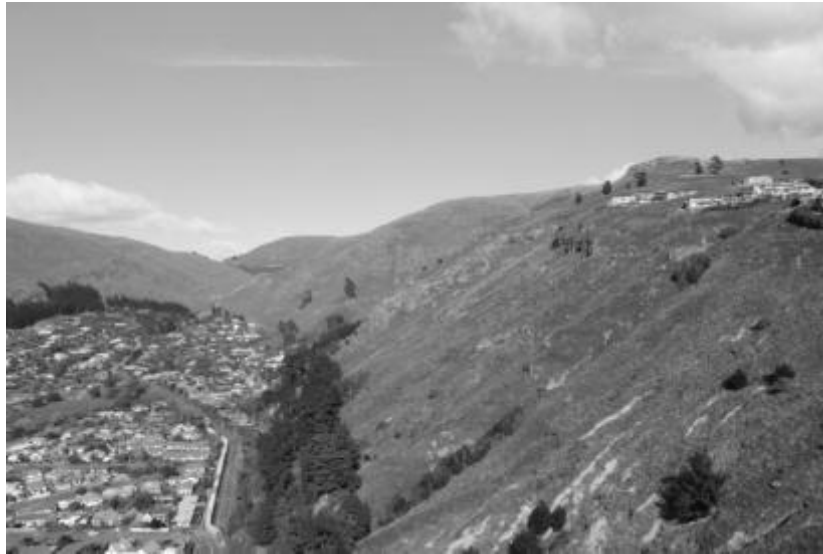
Figure 3, Typical slope profile of Sumner Valley. The source bluff is located near the crest of the slope to the right with Wakefield Avenue and Sumner at the toe of the slope. (Leon Gerrard)

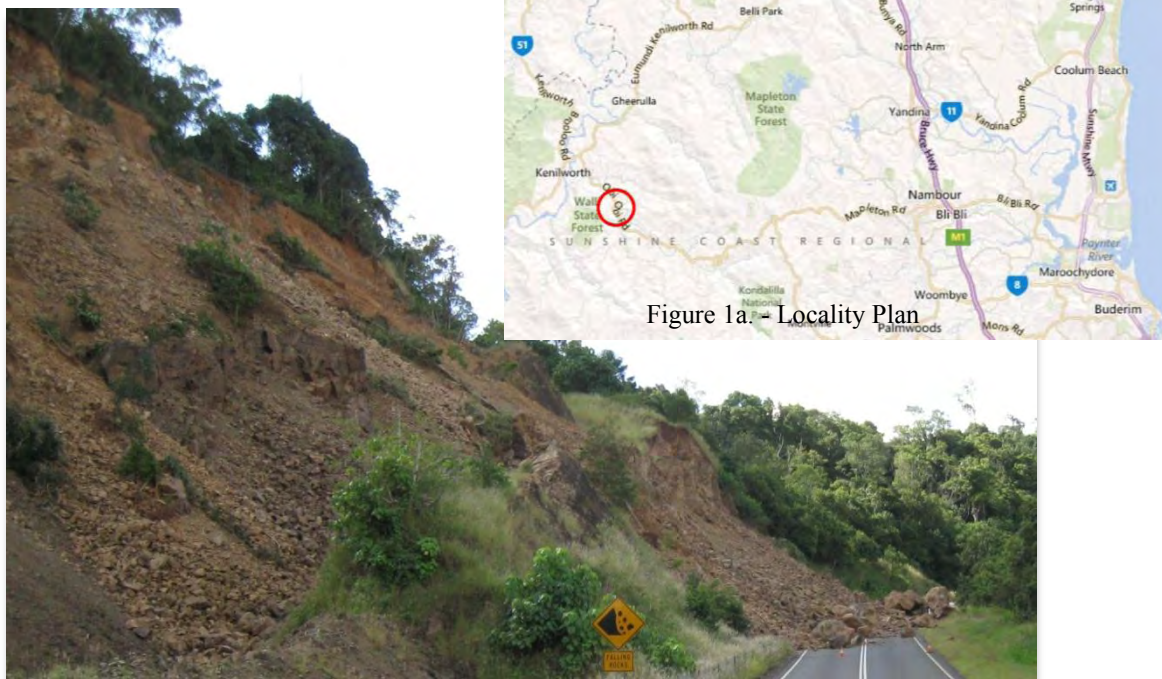
Figure 1b –View of Rockslide looking north

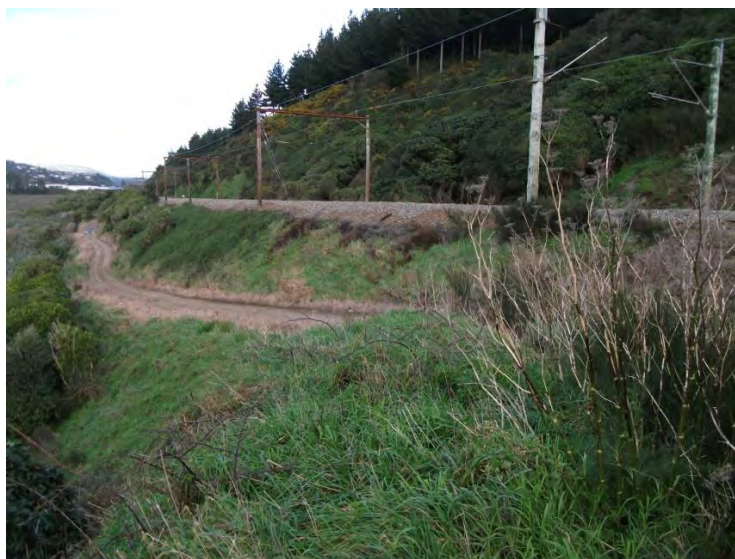
Figure 1: Existing high risk rail embankment

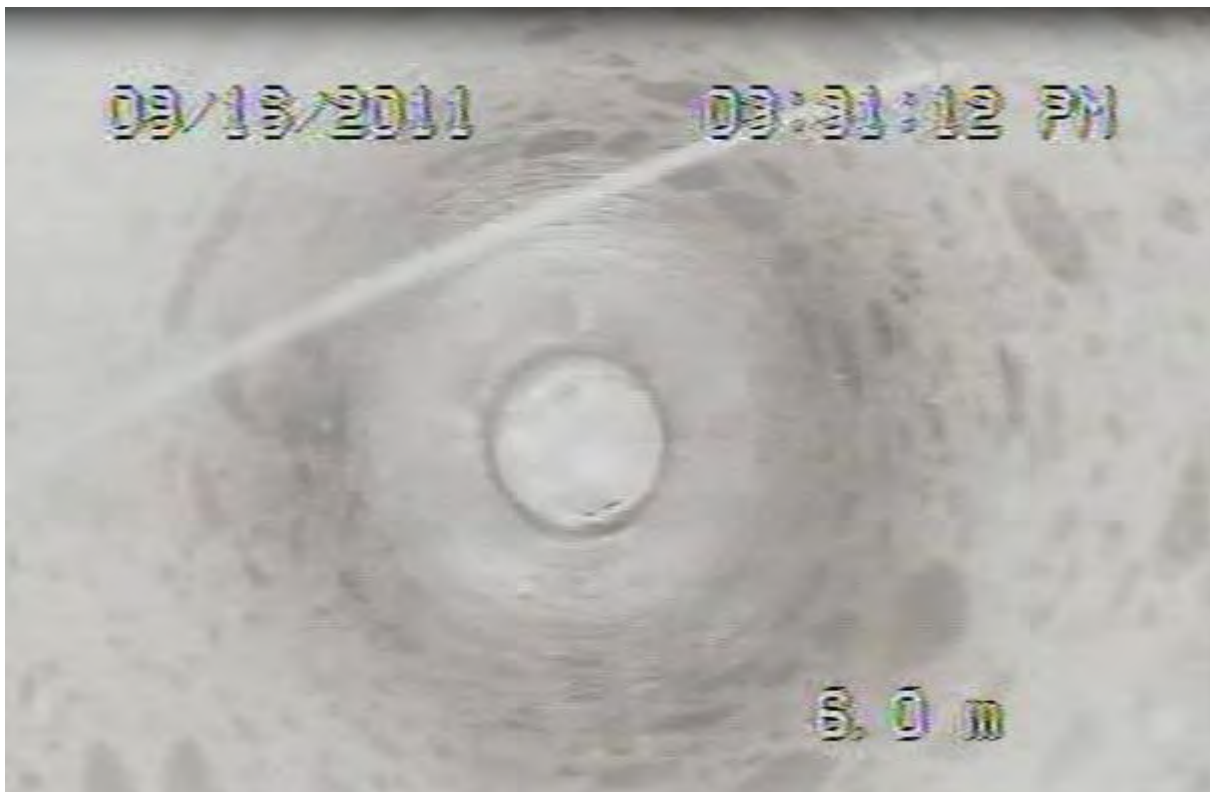
Figure 4. Screenshot from video camera showing location of the jet of water
