15th Young Geotechnical Professionals Conference

6-9 November 2024
Adelaide, South Australia

15TH AUSTRALIA AND NEW ZEALAND YOUNG GEOTECHNICAL PROFESSIONALS CONFERENCE

15YGPC — Adelaide, Australia, November 2024

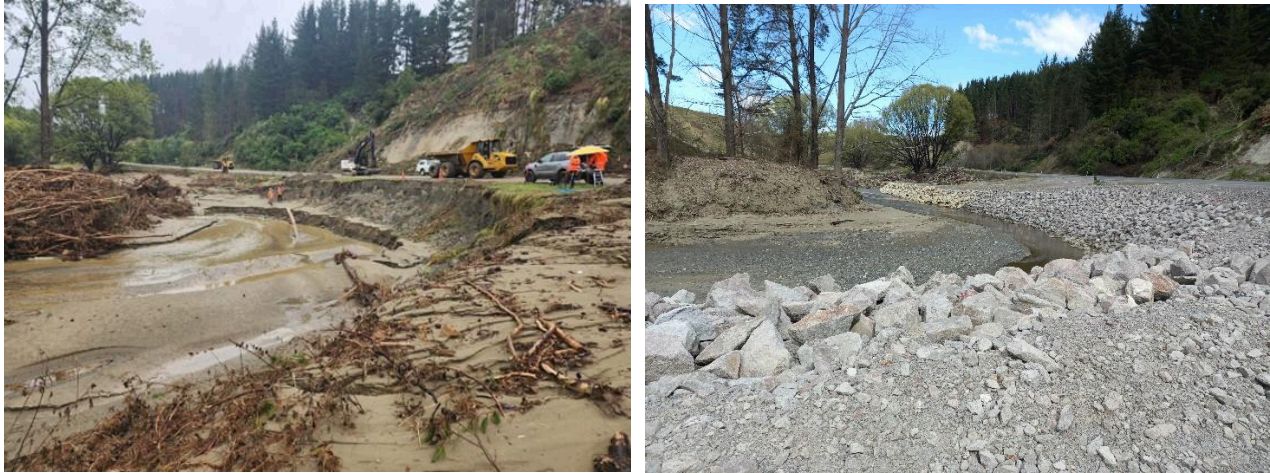
Figure 5: Mangakōpikopiko Stream Scour February - May 2023

An example of this standardised buttress remedial solution implementation was a site on SH5 which had been caused by scour from the Mangakōpikopiko Stream. This was an underslip where the shoulder had been eroded up to the road edgeline and a solution was required to support the road. Through the desktop study and project team discussions it was decided that a Standardised Buttress Type C solution was applicable for this site. Site photos can be seen below in Figure 5.

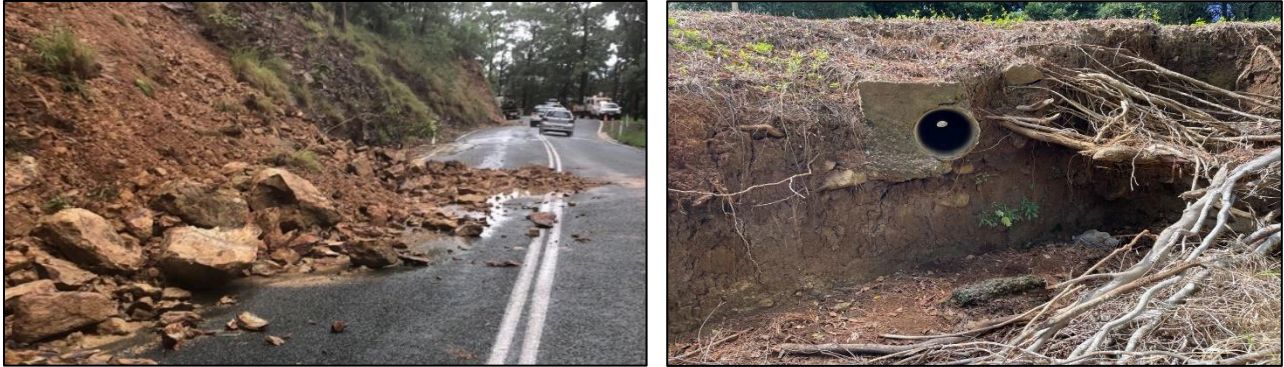
Figure 3: Example failure types
Images from the REPA and Betterment Package, upslope site on left and downslope site on right.

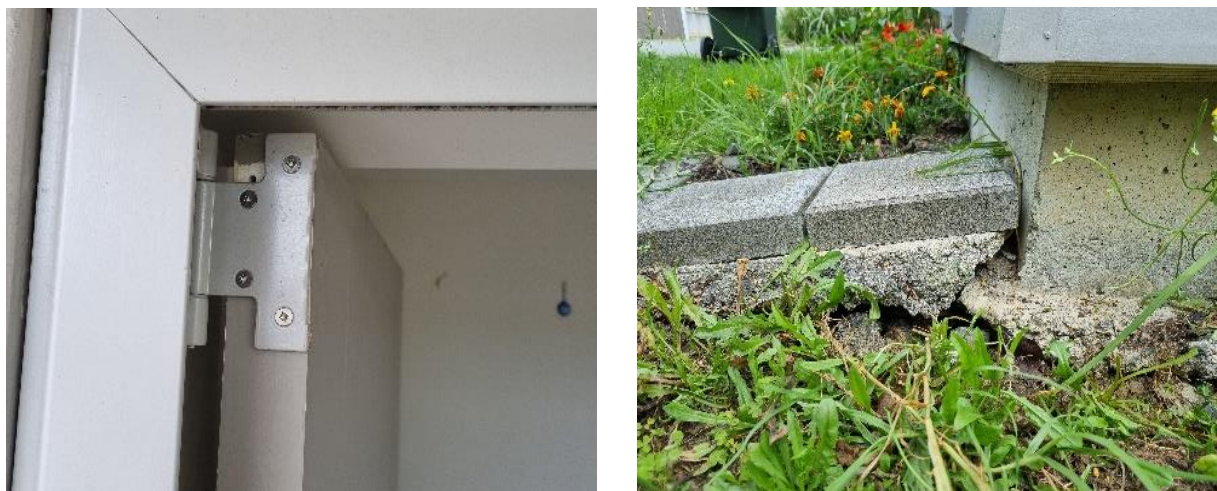
Figure 2: (a) Adjusted door hinge showing clear signs of movement and (b) Garden edging detached from slab and settlement adjacent to pile locations

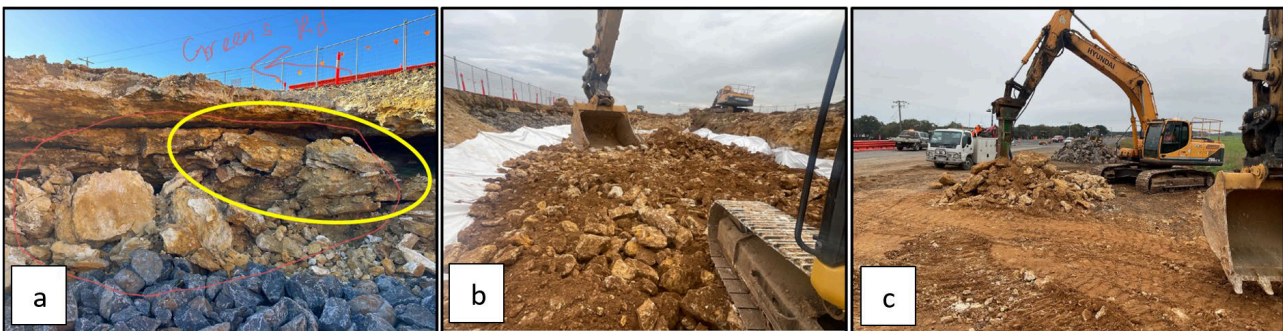
Figure 4: Failing aeolianite blocks (a), Aeolianite and caprock used as the 'plug' backfill (b) and (c)
