MANAGEMENT OF COMPLEX GEOLOGICAL STRUCTURES USING ENGINEERING GEOLOGICAL MODELS DURING TUNNEL CONSTRUCTION: THE LUNA PARK FAULT ZONE, SYDNEY

This paper describes the evolution of an engineering geological model developed as part of Construction Phase Services for the Sydney Metro City & Southwest Tunnel and Station Excavation project.

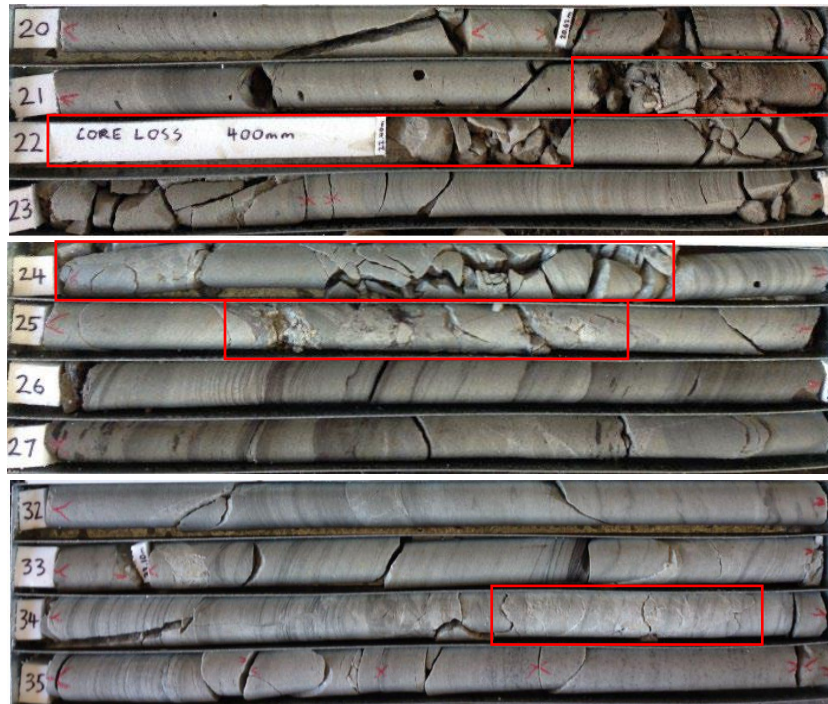
Figure 2: Examples of structurally deformed, fresh Hawkesbury Sandstone from within the published LPFZ as highlighted. Borehole SRT_BH070 completed as part of the projects tender phase site investigation program.

Based on these published observations the LPFZ was anticipated to be encountered by the Barangaroo Cavern excavation. This became a key site investigation target to constrain both site specific extents and expected geotechnical conditions. Six cored boreholes (both vertical and inclined) were drilled within the projected LPFZ lineament corridor as part of the tender and later detailed design phases. Within the proposed excavation profile fresh, high strength sandstone was intersected with localised intervals of increased fracturing. The recovered core was largely unaltered and displayed relatively discrete zones of structural disturbance, Figure 2.

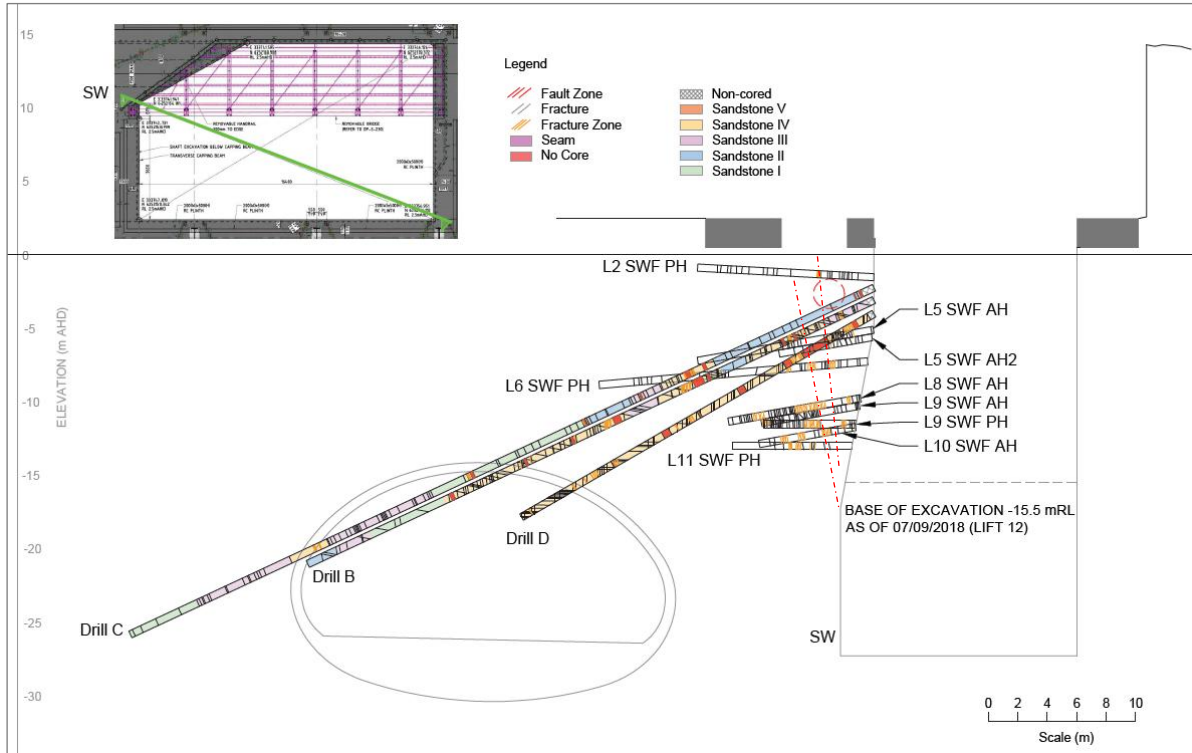
Figure 3: Cross section illustrating cored borehole and probe hole endoscope coverage within the southeast wall of the Hickson Road temporary access shaft. Adversely oriented kinematically sliding planes inferred to intersect at the base overhanging wall.

With close reference to adjacent cored boreholes, defect occurrences were recorded and supplemented by observations relating to gouge/clay infill, hole integrity (wash outs) and visible changes in rock mass weathering. Findings were plotted in cross section (Figure 3) and projected three dimensionally following each excavation lift to interpret the distribution of shearing withing the rock mass. A series of steep, easterly dipping shears were identified and correlated between endoscope inspection and cored boreholes drilled from within the shaft confirming a viable failure mechanism. In response, cable anchors were proactively installed from upper levels to address the identified mechanism which subsequently daylighted within the lower southwest wall.

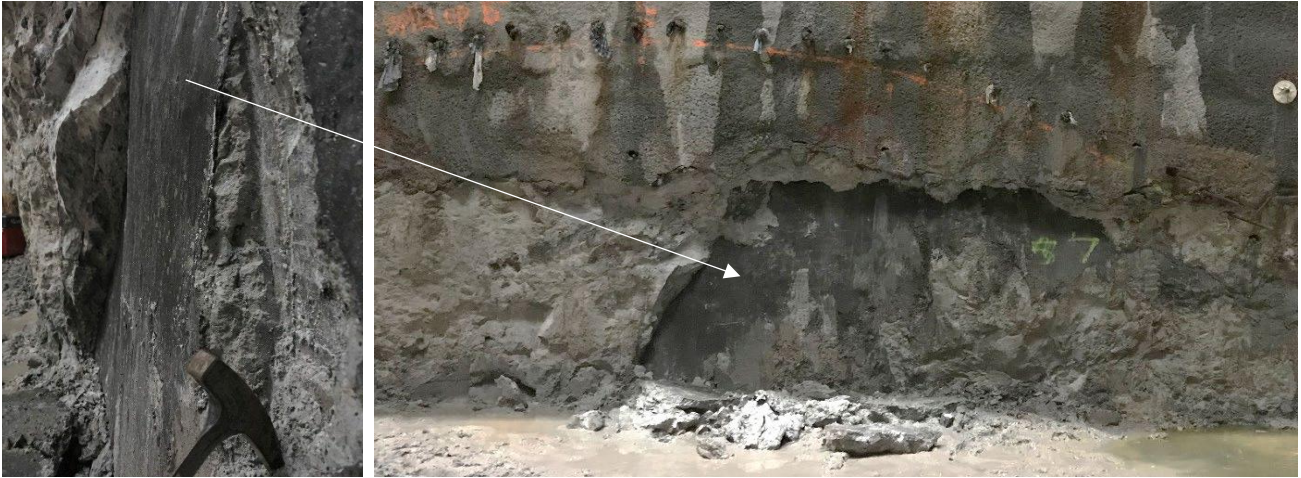
Figure 4: Subvertical shear daylighting in shaft wall at the crown level of the crosscut portal. Highly altered sandy clay breccia and gouge breaking away from the planar, slickensided subvertical shear at rear. Material was readily disaggregated by hand.

Localised instabilities were managed within subsequent excavation lifts beneath the crown level of the crosscut adit portal between -15 and -20 mRL where overbreak was observed up to 800 mm along daylighting shears, Figure 4 and Figure 5.

- **Fault Core** - Three primary shear planes were observed within the central fault core of the LPFZ, orientated 75-85°/125-135° and 65-70°/090-100° (Dip/DipDirection) respectively and diverging with depth. These structures were infilled by up to 300 mm (true thickness) highly altered, soft mottled white and grey, highly plastic, sandy CLAY breccia. A magnesium coating was observed on the bounding slickensided shear surfaces, Figure 4 to Figure 6.

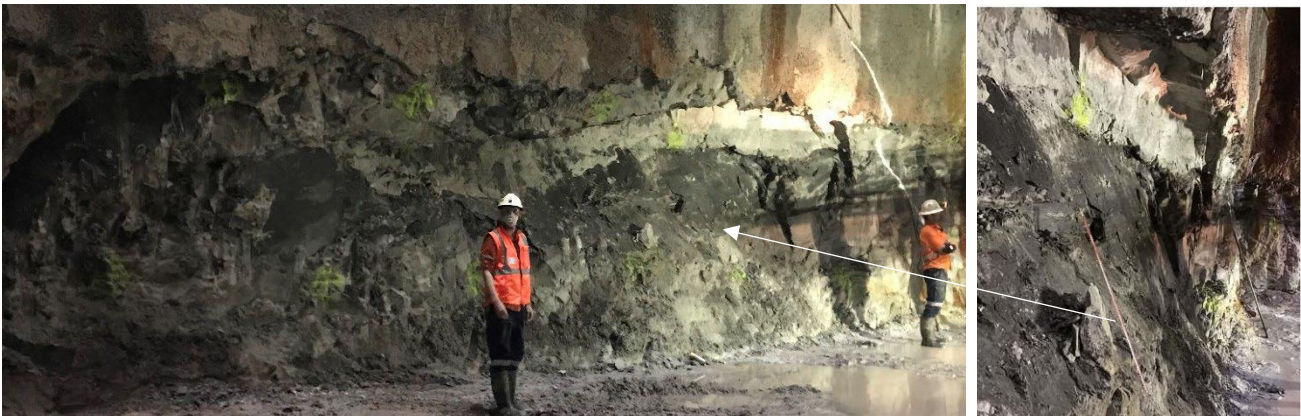
Figure 5: Subsequent excavation lift (approx. -20 mRL) where steeply dipping shears daylighted approximately 2.5 m vertically beneath initial plane. Note undulating defect surface and undercutting of wall along discrete sub horizontal joints

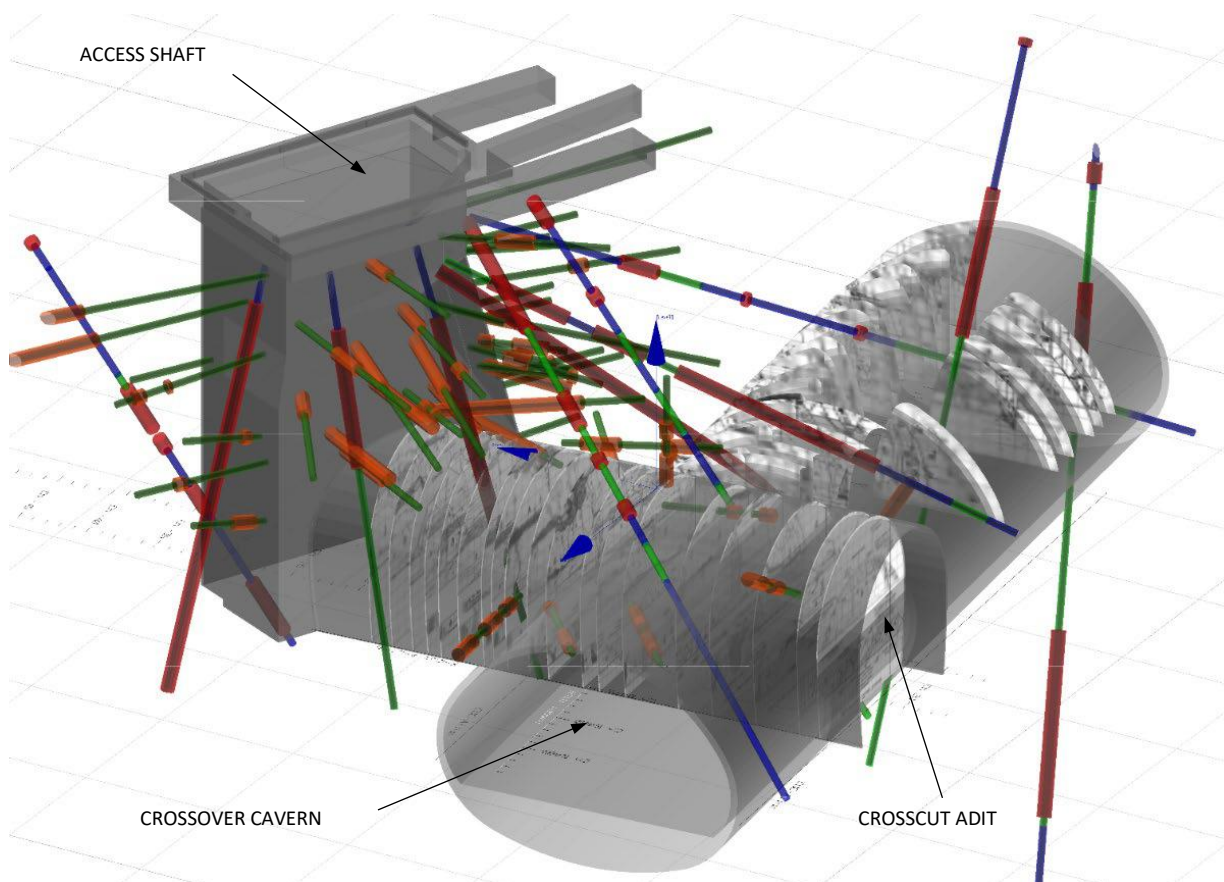
Figure 7: Oblique view showing data density of CPS face mapping, borehole and probe hole inspection records within the LPFZ portion of the Barangaroo crossover cavern looking south east. Boreholes (inclined) are displaying relative to the Pells classification - Blue Class I/II, Green Class III, Red Class IV/V. Probe holes (sub horizontal) presented using project specific classification for faulting - Green – Not fault affected, Orange – Fault affected.

At the time of construction, creation of full digital twins was not standard practice. Instead, face mapping records were georeferenced within the three-dimensional CPS engineering geological model for every advance within the LPFZ. Detailed mapping observations, combined with borehole and probe hole data, helped verify and refine the design geotechnical model, Figure 7.

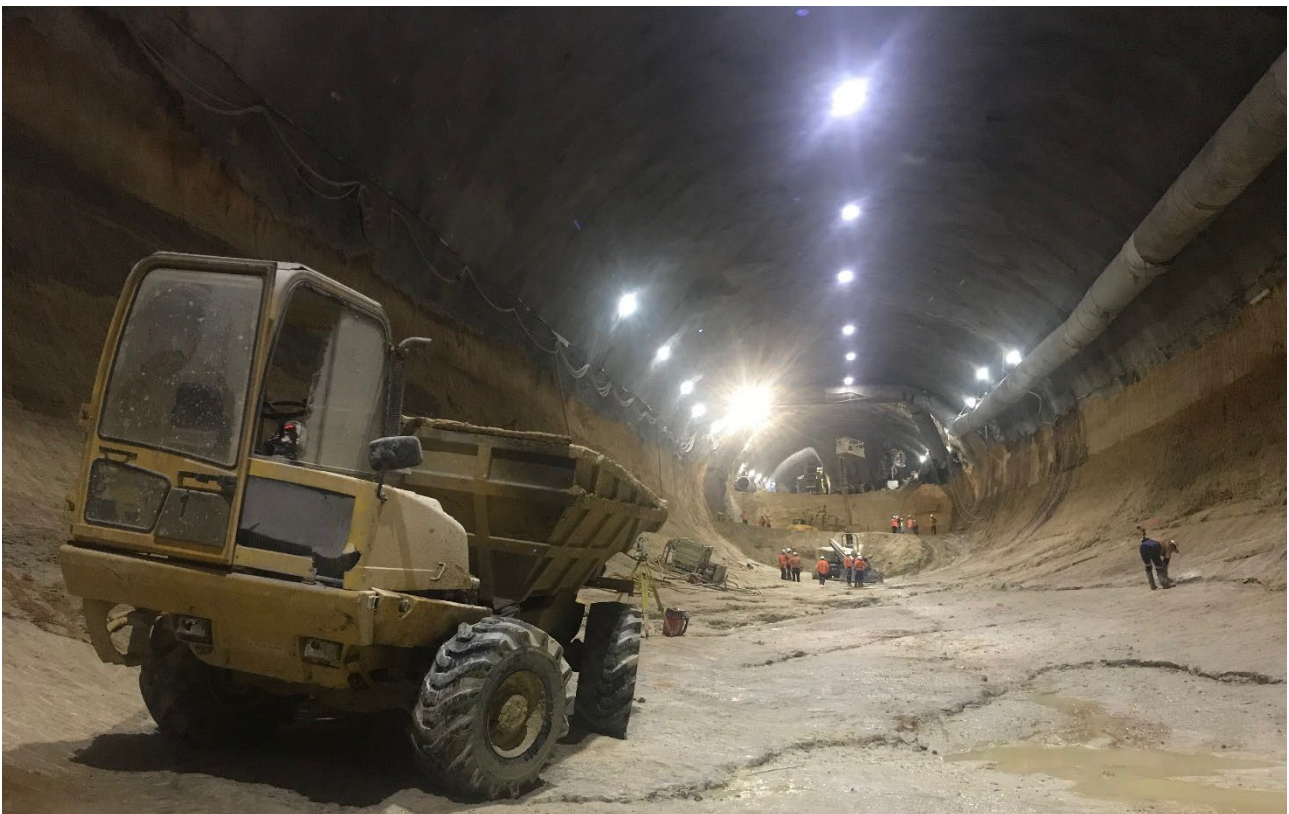
Figure 11: View of the final excavation profile of the Barangaroo crossover cavern.

Further appreciation is extended to the construction and management team from John Holland CPB Ghella Joint Venture for their collegial approach and valued contributions as we progressed through some of Sydney more structurally complex tunnelling conditions. A perspective of the completed northern half of the cavern excavation is included in Figure 11.
