SUSCEPTIBILITY AND MITIGATION OF DEBRIS FLOODS AND FLOWS IN THE JENOLAN KARST CONSERVATION RESERVE, NSW, AUSTRALIA: BUSHFIRE AND LA NIÑA IMPACTS

Adam Irvine & Richard Brehaut
Pells Sullivan Meynink

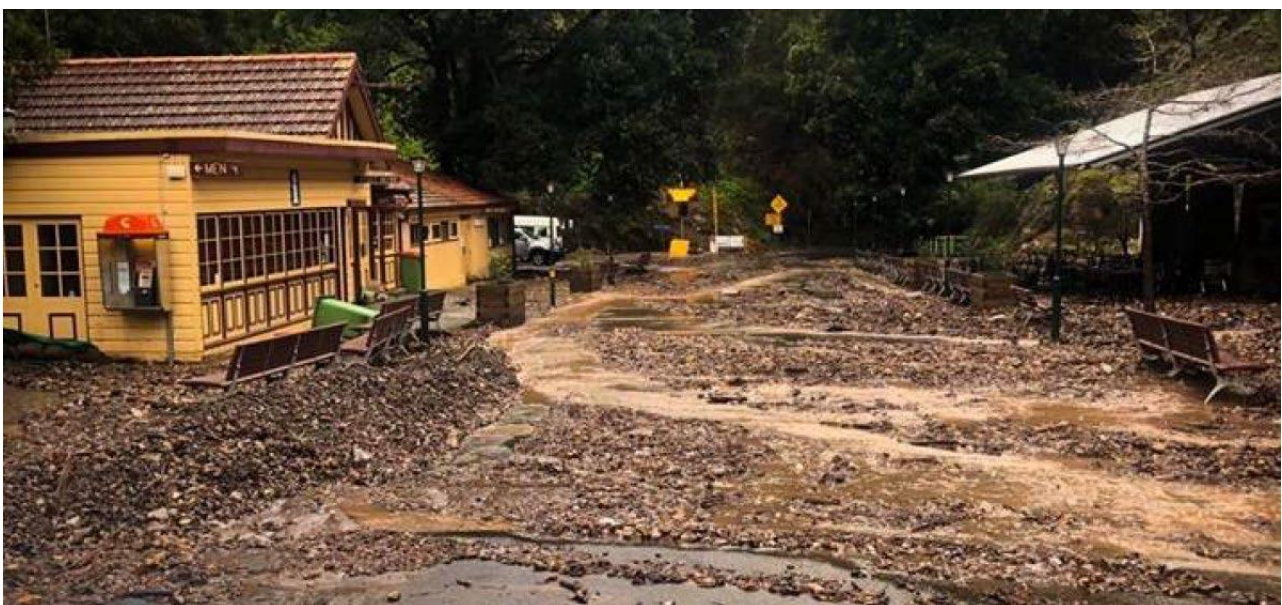
Figure 2 shows the February 2020 debris event that affected Caves House, the Grand Arch, and nearby buildings, as reported by the Canberra Times. It is understood sand, gravel, cobbles, and boulders were transported by debris floods from all three Jenolan River tributaries, including Surveyors Creek.

Figure 2: Flooding at Jenolan Caves in February 2020 looking towards the western side of the Grand Arch

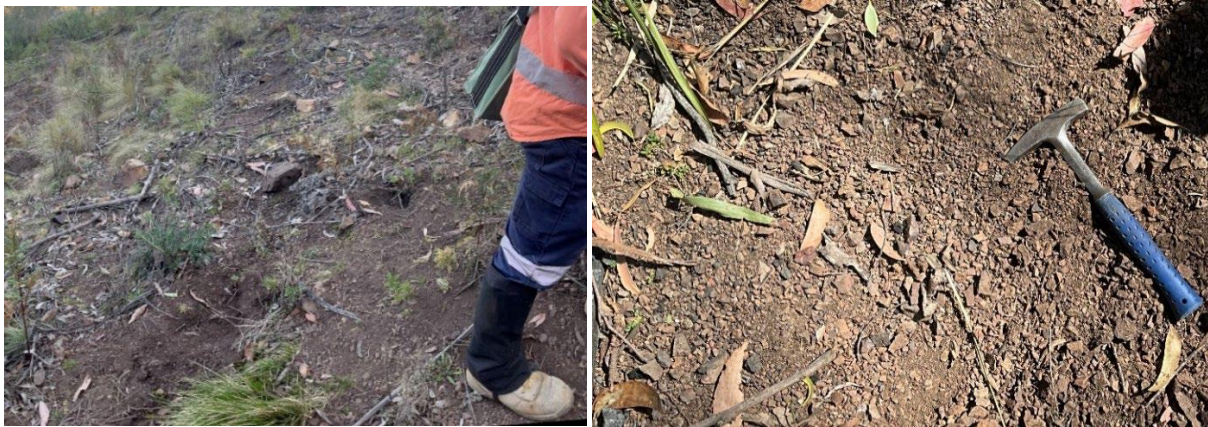
A typical feature of the JKCR topography is the presence of a thin surficial layer of colluvium overlying bedrock, Figure 6. The surficial layer is typically loose, angular, sandy fine to coarse gravel with silt, trace cobbles and is estimated to be less than one metre thick in most cases. It is interpreted to be the primary source of sediment in storage. Development of the thin, granular colluvium is attributed to several factors including:

Figure 6: Examples of loose colluvium present on the hill slopes

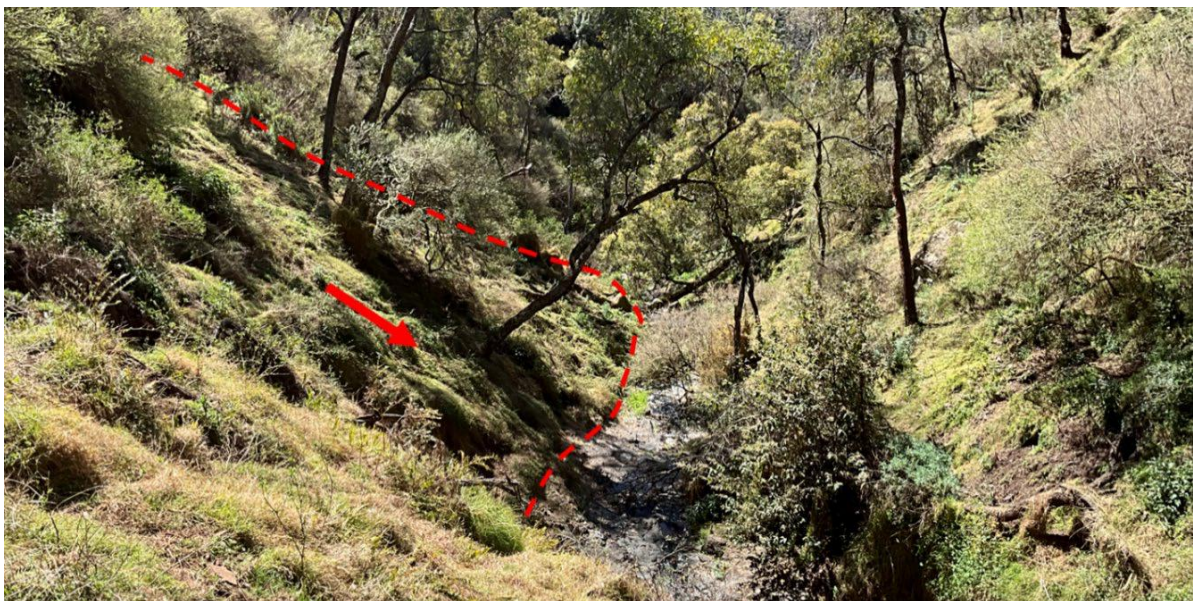
Colluvial aprons are formed along the flanks of Surveyors Creek which is actively eroding and over steepening portions of the lower valley slopes, Figure 7. Material accumulation is interpreted to be a product of gravity driven, slope wash processes (such as landsliding) that deposit near the source and provides a source of sediment in storage. Due to the relatively steep gradient of Surveyors Creek and the resulting erosive force, the stream bed has incised down into bedrock resulting in only isolated deposits of alluvium.

Figure 7: Colluvial apron formed through landsliding along the flank of Surveyors Creek
