LANDSLIDE RISK ASSESSMENT IN COASTAL SETTINGS – RECOGNIZING THE CHALLENGES AND UNCERTAINTY

Andrew Hunter and Tony Miner

GHD

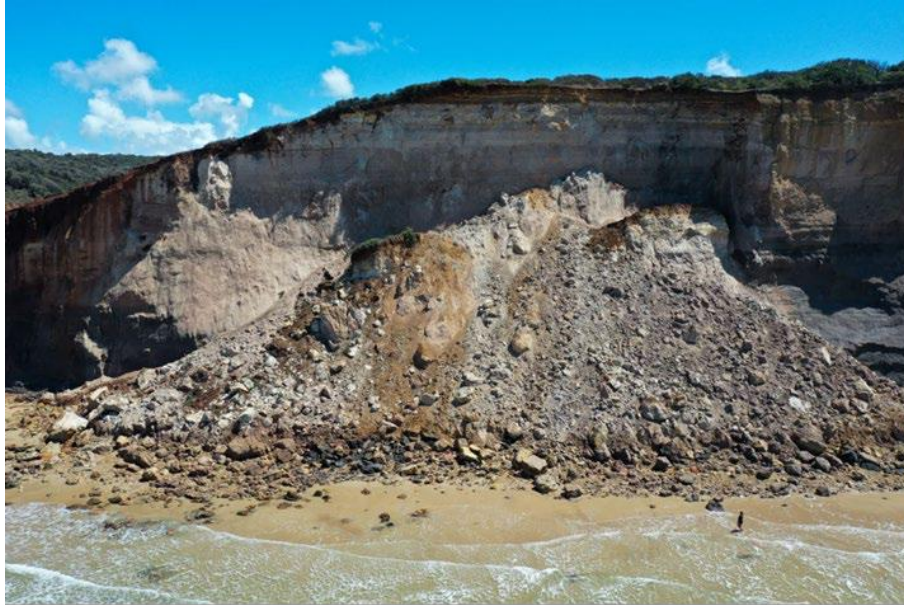
Figure 2: A very large coastal cliff collapse / rockslide of approximately 40,000 m³ occurred at Jarosite Headland in Victoria. Only 100 m to the southwest of the site of a fatal rockfall of only 2 m³ occurred killing 1 person and injuring 2 others just a month earlier.

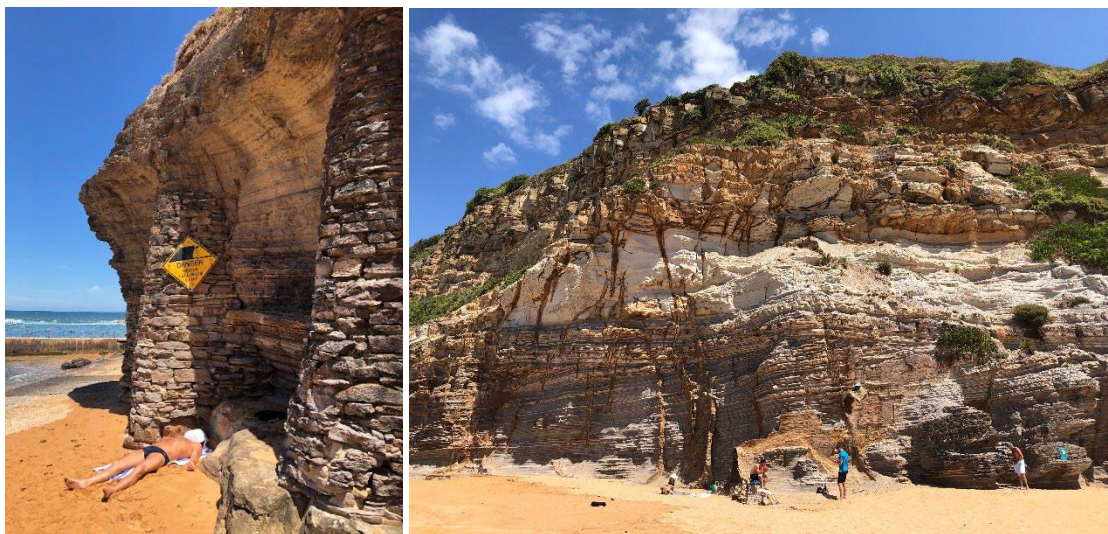
Figure 8: Examples of apparent disregard or unawareness of rockfall hazards, despite signage.

Despite signage at many coastal cliff locations our observations suggest that there is a sense of public unfamiliarity with coastal hazards and perhaps also a disregard for signage (Figure 8). Insights into the psychology of the public’s beliefs about rockfalls and associated high risk behaviour, and public interpretation of coastal rockfall hazard warning signage is offered by Aucote et al. (2010, 2012). The study found that many people doubt the validity of warning signs. Approximately two thirds of participants in the study thought that warning signs were erected even when there was only a small chance of injury, about one third thought that warning signs were erected even if rocks were not falling on a regular basis, and about 40 % thought that the main reason authorities put up warning signs was to avoid being sued. Aucote et al. (2012) also found that interpretation of warning signage was also variable with less than 40% of participants correctly interpreting the messaging to keep a clear distance from the cliffs (Figure 9).

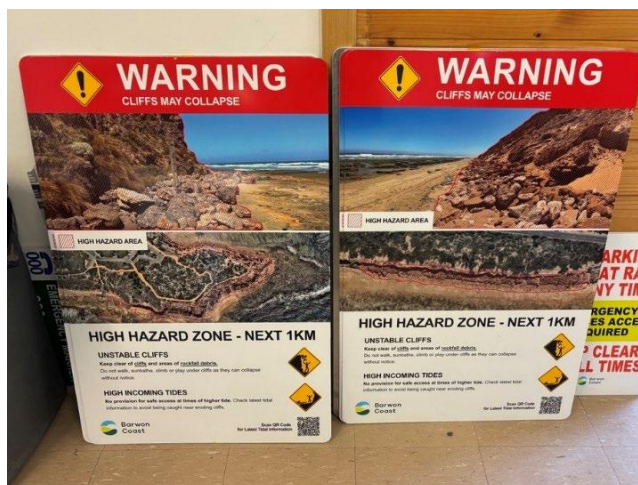
Figure 10: Examples of recent rockfall warning signage.

issues, recently installed signage at some coastal sites the authors are involved with have been designed to include; actual photographs of the site and rockfalls, annotated hazard zones, QR codes and additional instructional information (Figure 10).
