ASSESSING THE GEOTECHNICAL SUSCEPTIBILITY OF CAVES IN PILBARA IRON FORMATIONS TO INSTABILITY

Duncan Noble, James Watton, Mark Eggers and Mark Fowler
PSM

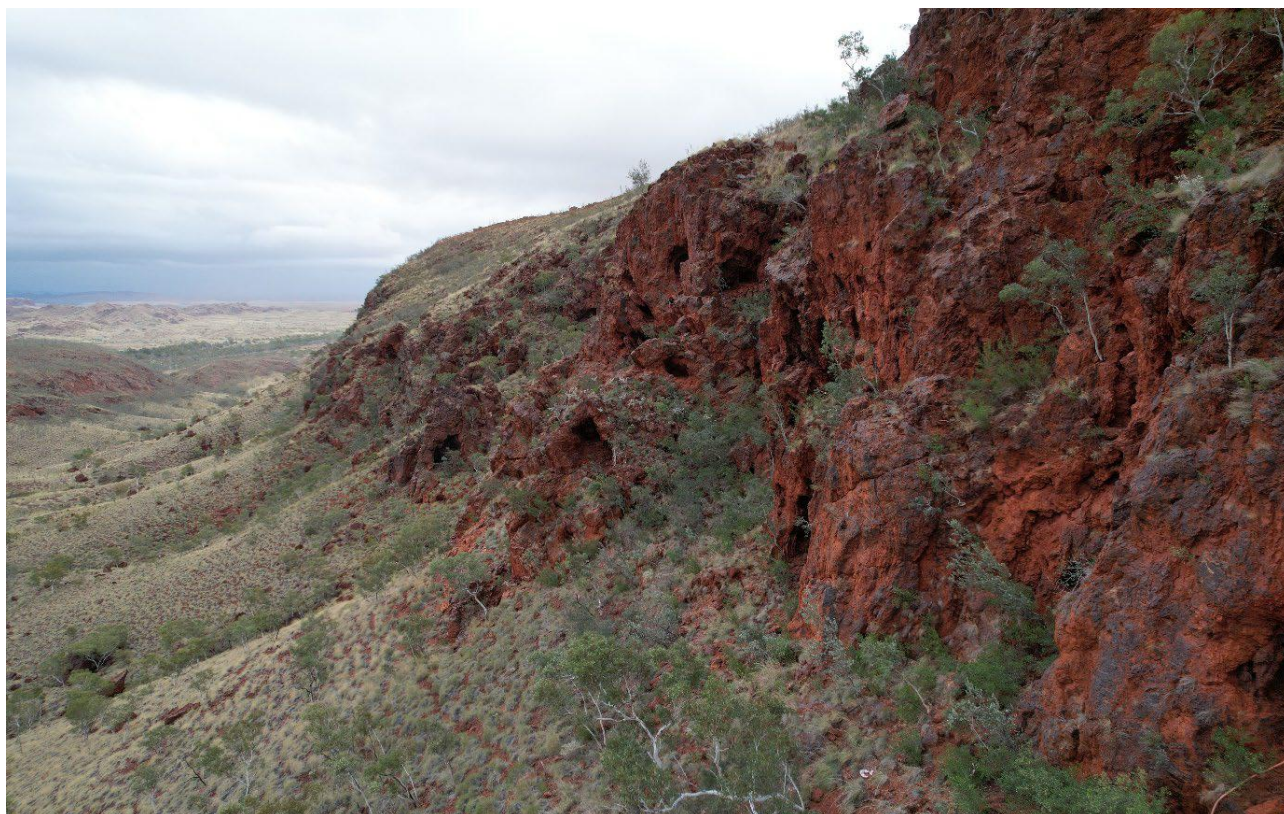
Figure 1 - A typical Pilbara iron formation escarpment hosting numerous caves

Prominent escarpments are a common feature along the BIF strike ridges, both at the contacts with the adjacent erodible units, and where surface water drainage has cut deep gullies through the bedrock. These escarpments can be very steep to overhanging and may be tens of metres high. The base of these escarpments is typically covered by an apron of colluvium. An example of a typical cave-hosting BIF escarpment is shown in Figure 1.

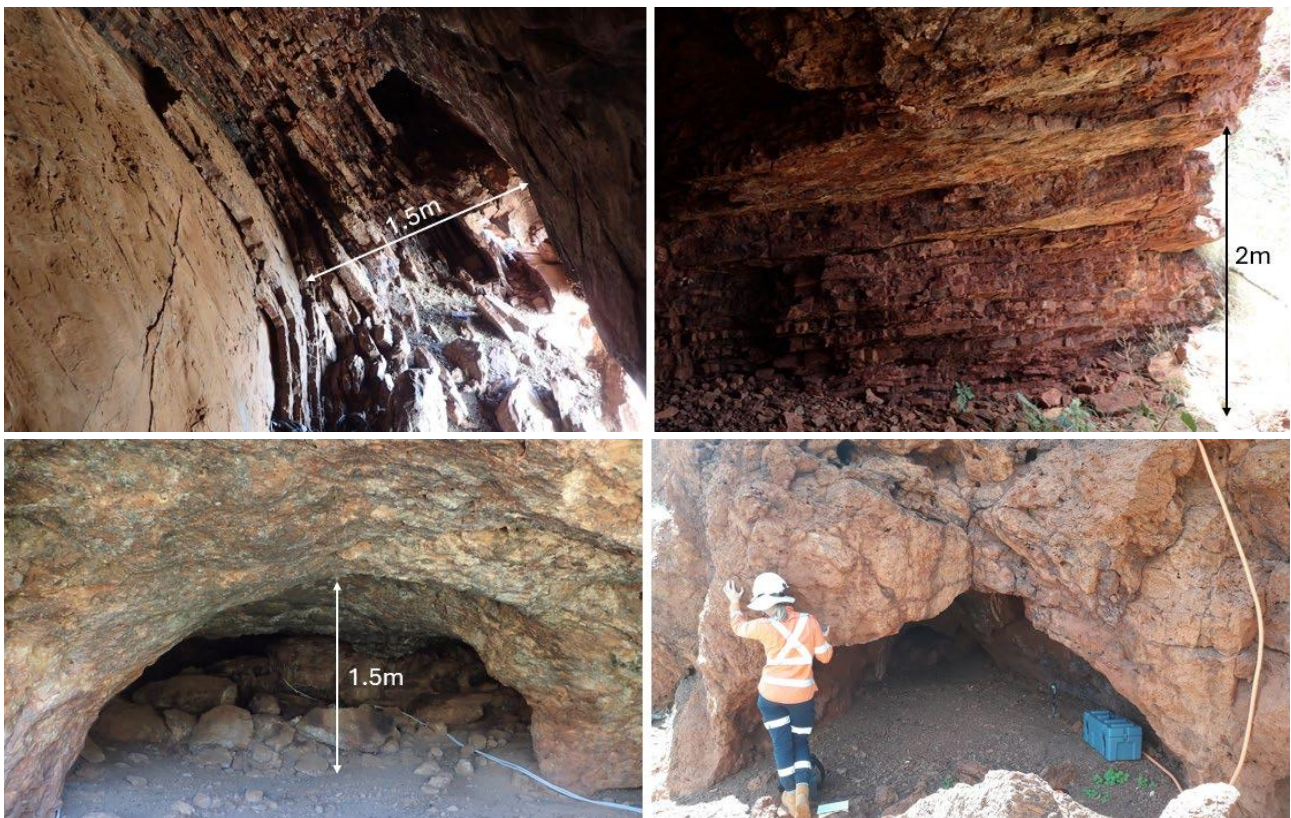
Figure 2 - Top: Examples of caves formed on steeply (left) and shallowly (right) dipping bedding. Bottom: Examples of caves formed in hydrated BIF rock mass.

Each of these cases can have different features susceptible to instability, associated rockfall mechanisms, and hazards. Examples of these two typical cave morphologies are presented in Figure 2. Features common to both cave types are shown schematically in Figure 3, including some of the susceptible features discussed later in this paper.

example, the distinctive tabular morphology of the roof profile in the examples in Figure 2 (top), indicating formation and/or growth by repeated tabular rockfall from bedding partings.

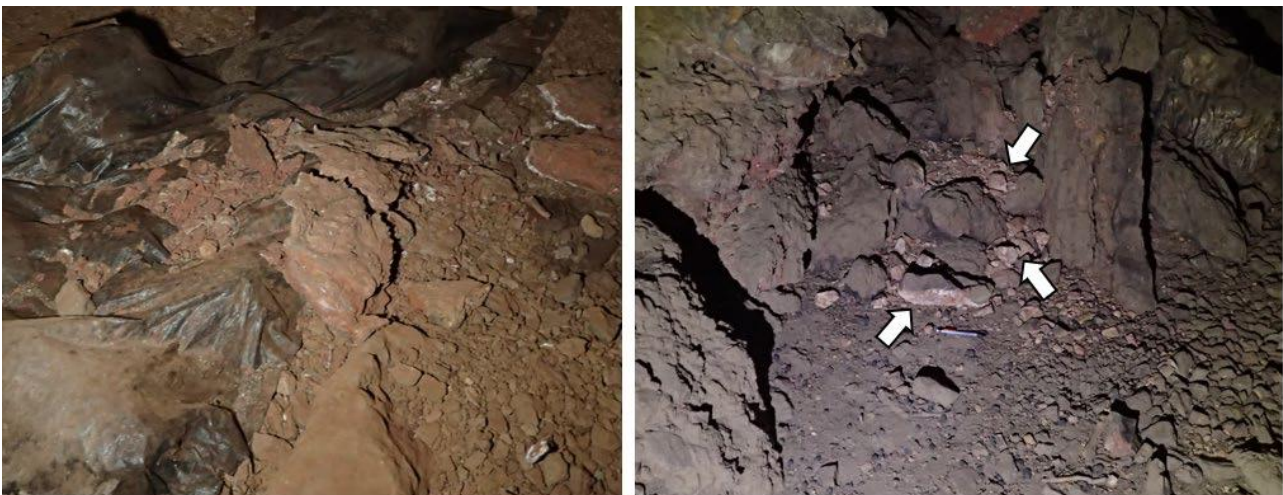
Figure 4 - Examples of inferred recent (approximately within the past year) rockfall debris on a plastic scat sheet (left) and on top of older debris (right).

Evidence of trigger events leading to rockfall is typically more difficult to interpret. In some cases where the timing of the rockfall event can be estimated to within a period of weeks or months it may be possible to infer a trigger event such as a nearby blast, drilling activity, earthquake, or significant weather event. Comparison of photographs from previous site visits, or debris found on 'scat sheets' used in some environmental surveys can be very helpful in estimating the timing of a rockfall event. In other cases, it may be possible to infer a trigger from observations within the cave, such as evidence of recent water flow, or roots growing from the source defect. Figure 4 shows examples of recent rockfall events inside caves, including rockfall onto a scat sheet and relatively 'fresh', clean surfaces indicating recently broken rock debris.

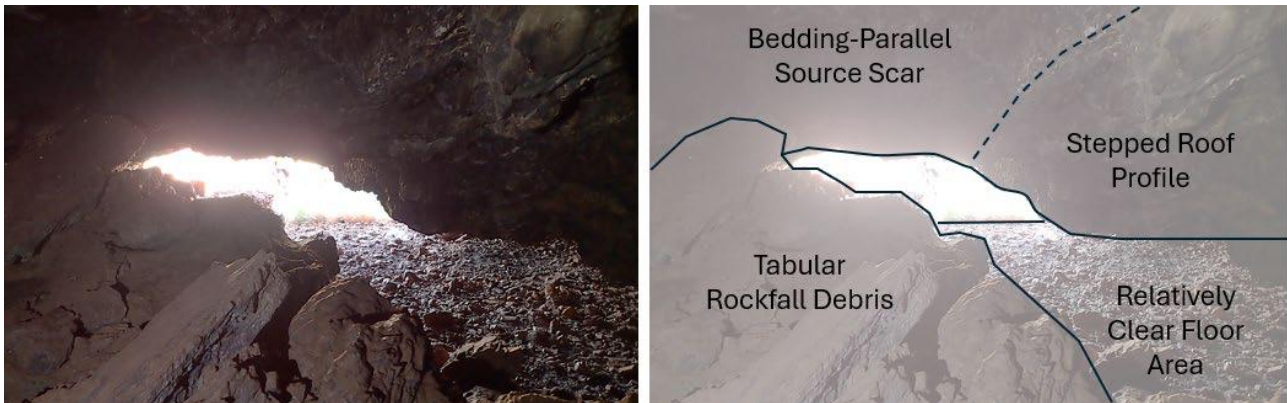
Figure 5 - Left: a photo of the interior of a cave showing significant rockfall debris on one side, coincident with a rockfall source area defined by bedding planes. Right: an interpretation of the same photo; rockfall debris is inferred to be the result of a partial roof collapse event along bedding partings on the left side of the photo.

Morphology of past rockfall scars and rockfall debris can also provide evidence for possible mechanisms. The example in Figure 5 shows a large pile of rockfall debris interpreted to have fallen during a roof-collapse event, evidenced by the tabular shape of the blocks, the surfaces of which match the source scars along bedding. In addition, the roof morphology includes a significant step between the area of large rockfall debris and an area relatively free of large blocks, indicating that roof collapse has not yet occurred in this part of the cave.

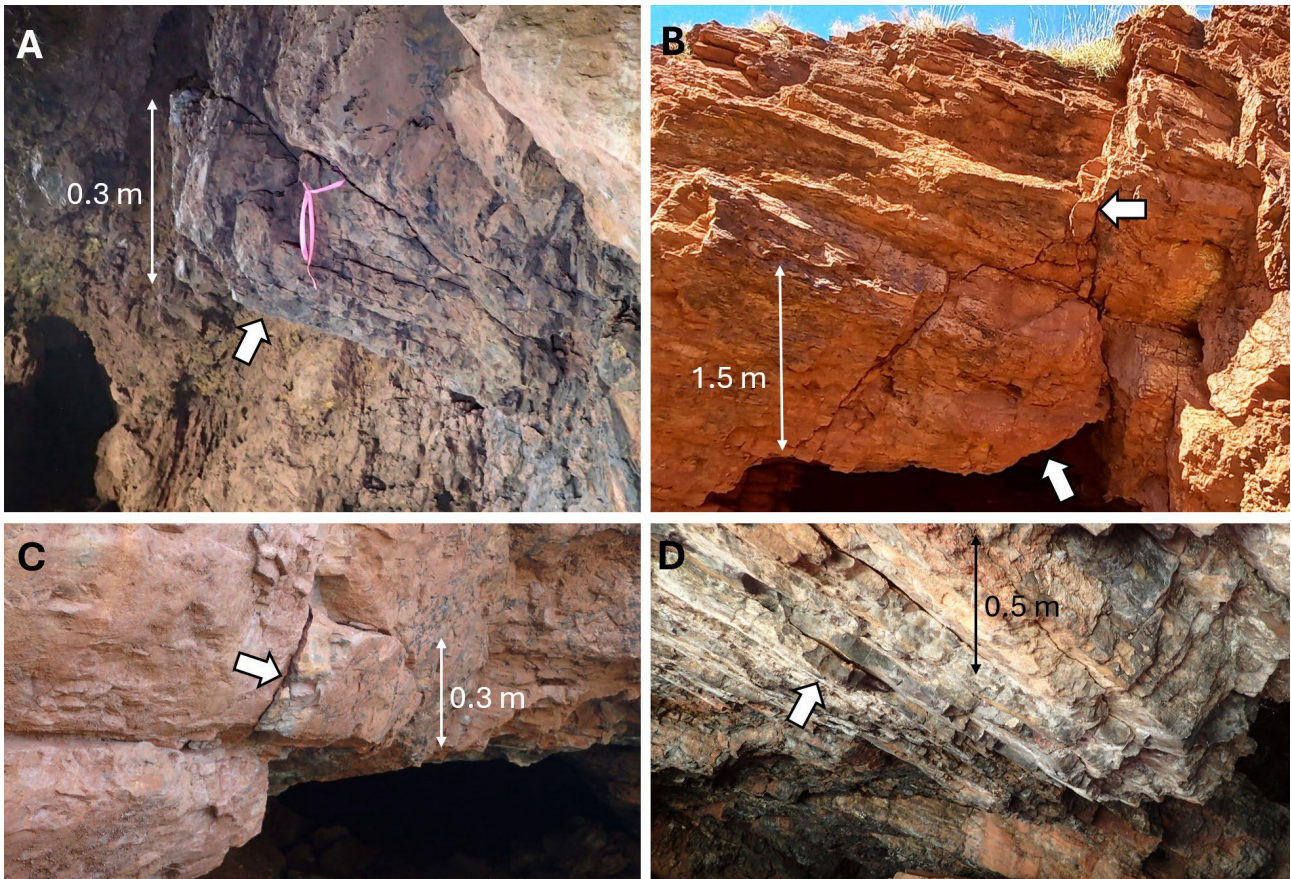
Figure 6 - Examples of hanging blocks bounded by open defects. A) A block hanging on an open joint within a cave. B and C) Hanging blocks in the cave brow. D) Tabular hanging blocks on bedding in the roof of a cave.

Some examples of hanging blocks are presented in Figure 6.

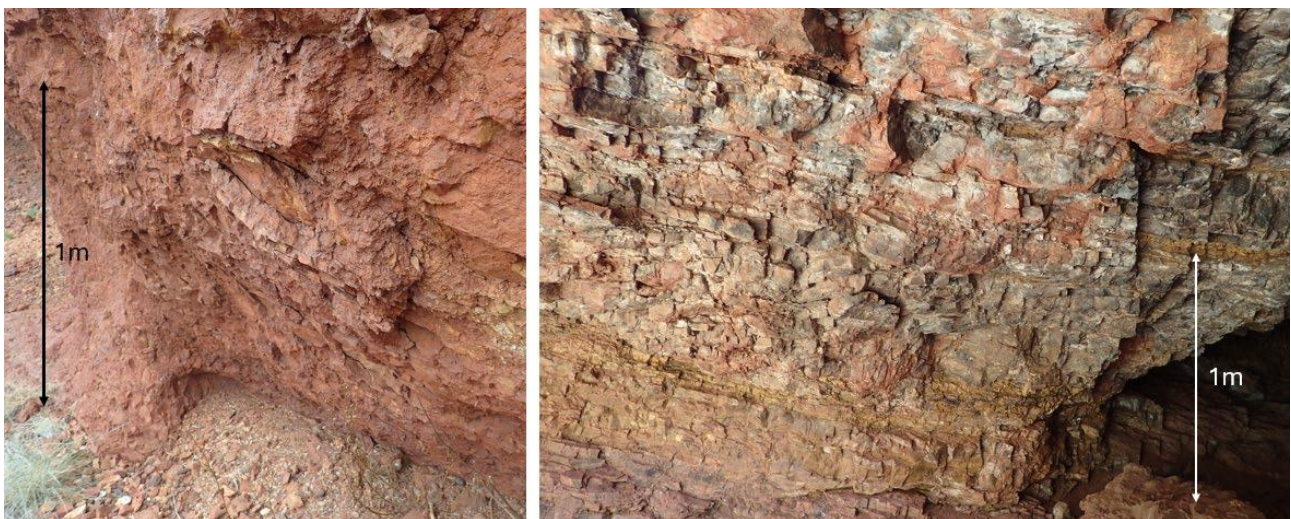
Figure 7 - Examples of blocky, friable rock mass outside (left) and inside (right) caves.

Areas of lower rock strength or highly fractured, dilated rock mass can be susceptible to fretting and rockfall. These features often occur in isolated areas of a site and may be associated with increased rockfall debris. Defects may be randomly oriented fractures, or repeated structures such as intersecting joint sets, closely spaced bedding partings or fault damaged rock mass, Figure 7. Lower strength, friable rock mass is more common within shale lithologies.

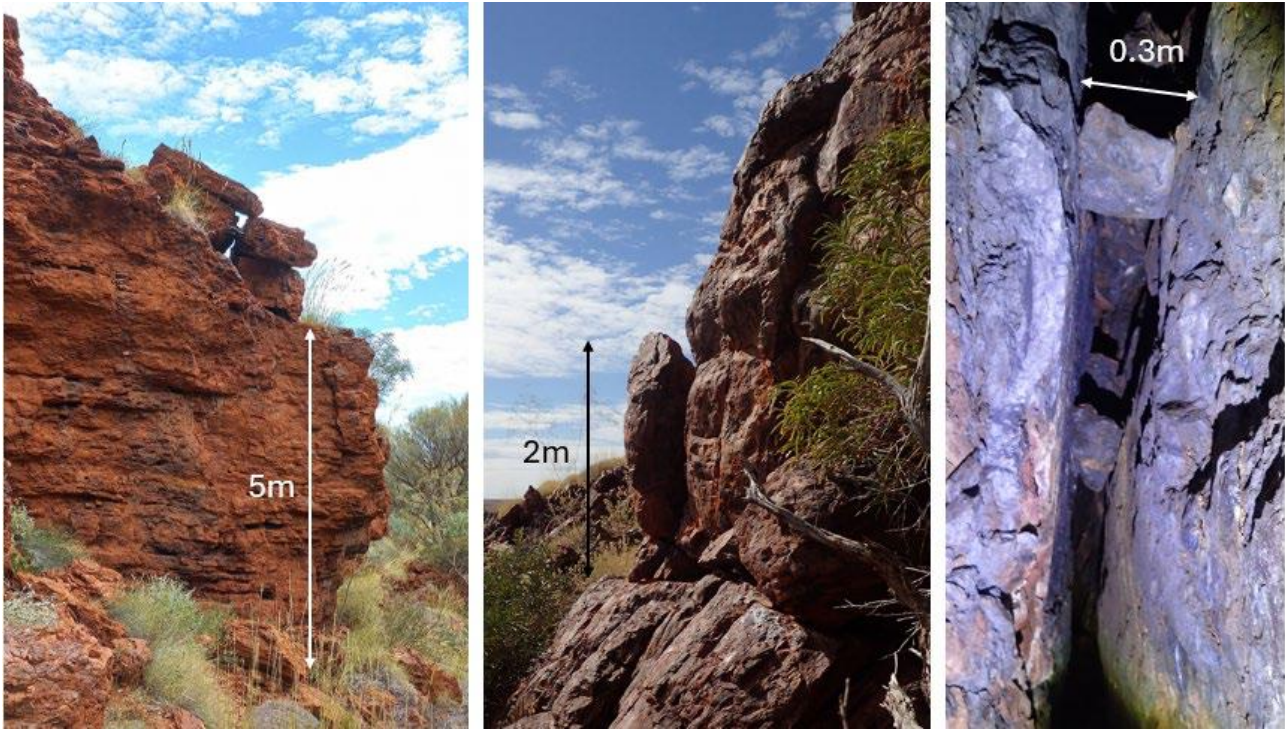
Figure 8 - Examples of loose or perched rocks on escarpments and within a vertical crack in the roof of a cave.

Loose or perched boulders are often found on the escarpment or brow (Figure 3) but can also be found on internal or external ledges, or wedged within cracks in the roof or walls, Figure 8. Observations should include size and location of the rocks, and angle and condition of the supporting surface. The interpreted impact zone, including possible runout area should also be noted.

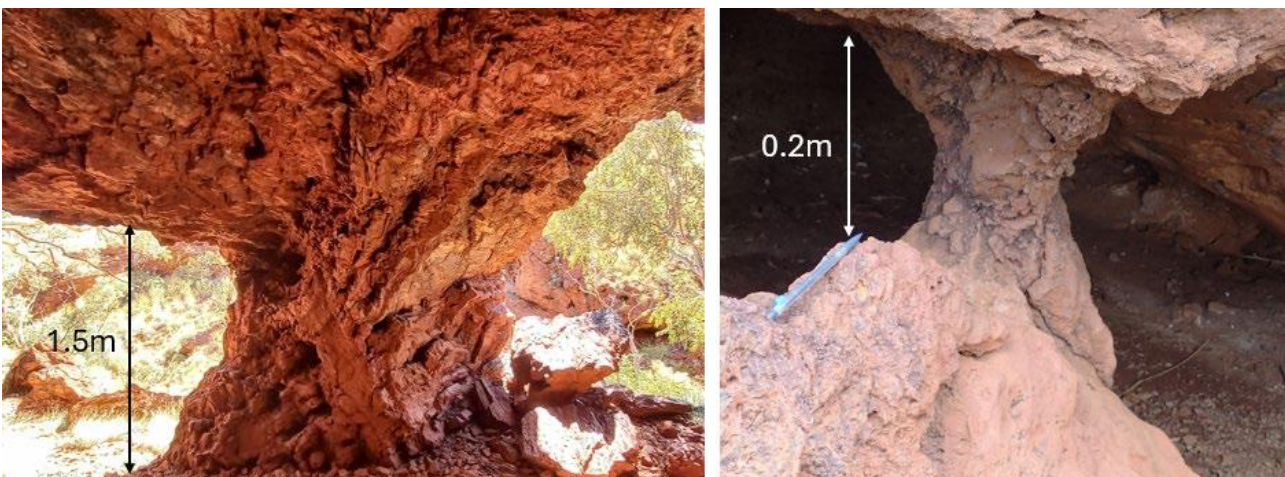
Figure 9 -Examples of structurally controlled (left) and rock mass controlled (right) pillar development

Pillars can form between entrances to a cave, or within smaller entrances termed 'windows'. They are narrow columns of rock remaining after the surrounding rock mass has collapsed or eroded away. Examples shown in Figure 9 include a large pillar formed along bedding partings between two entrances, and a pillar between windows eroded in a relatively weak rock mass.

Along with location and size of the pillar, the estimated strength of the intact rock and presence of any defects through the pillar are important observations to make when assessing susceptibility. The pillar may also be supporting blocks or sections of the cave roof, which may be an additional hazard if the pillar were to collapse.

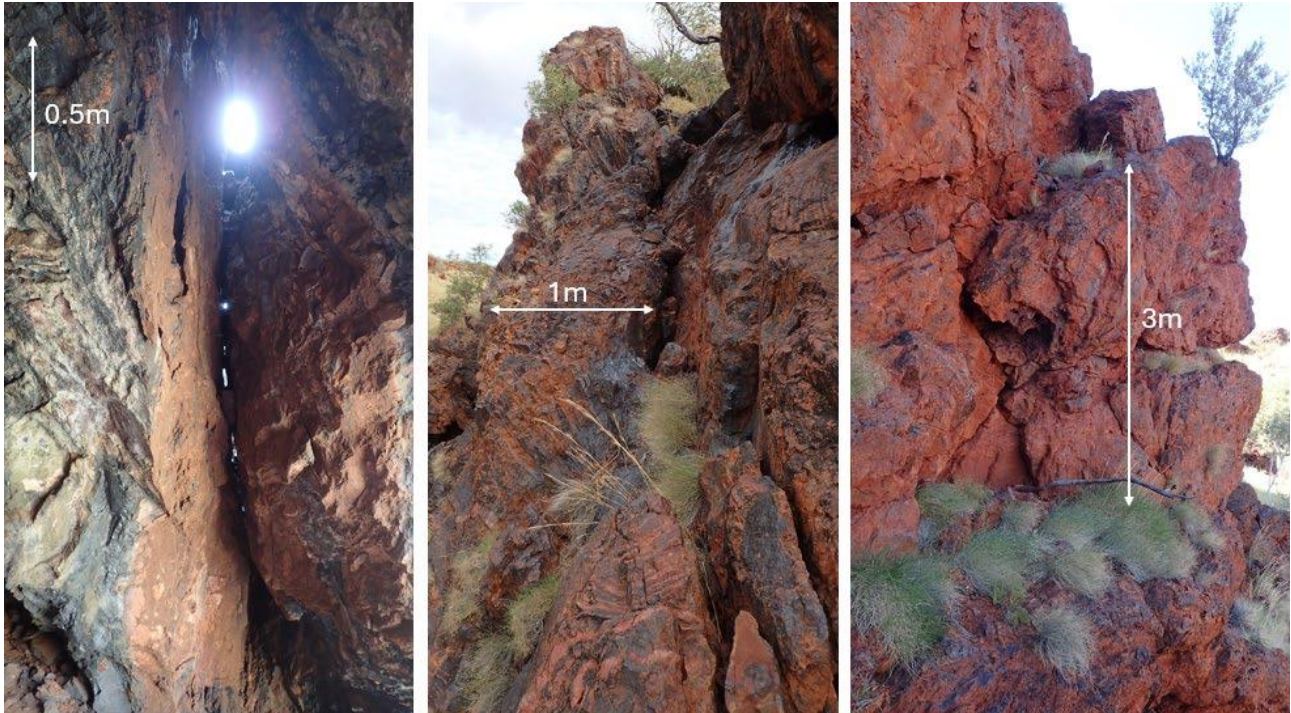
Figure 10 – Examples of separated arches. The left and centre photos are the same separating defect, viewed from the inside (left) and the outside above the cave entrance (centre). In the centre photo the cave entrance is below and to the left. The right photo is another separating defect, viewed from the side of the cave with the entrance around the outcrop to the right.

These features are large sections of the roof arch or overhang that are separated from the escarpment or outcrop by a persistent defect or multiple, intersecting defects. Separated arches (Figure 3) can tilt away from the rock formation over time, presenting a significant rockfall hazard. The examples shown in Figure 10 also include loose rocks wedged in the bounding defect.

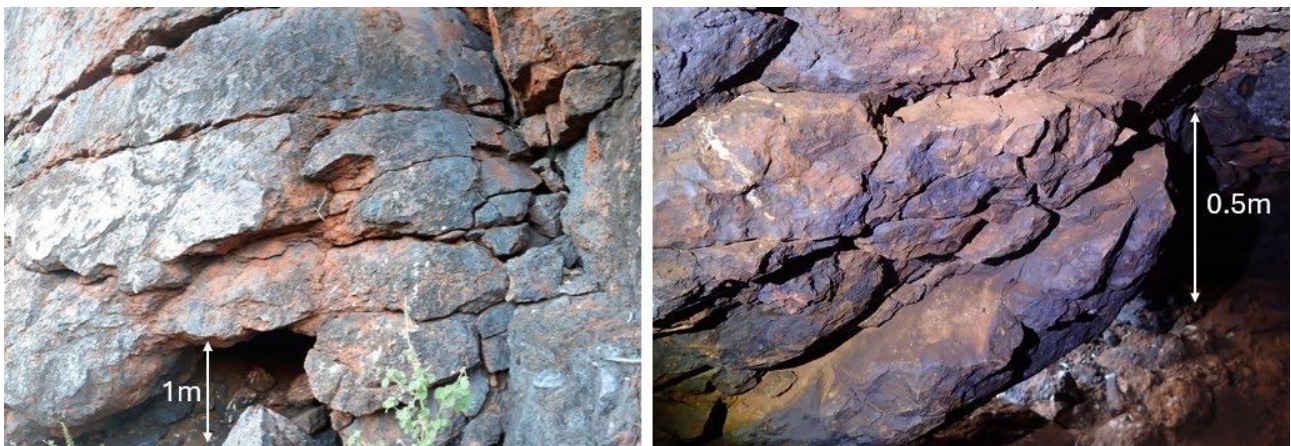
Figure 11 - A cave entrance viewed from outside and inside, showing dilated, blocky, loosened rock mass. Daylight was visible through the defects from the inside.

- Loosened, blocky, dilated rock mass such as a rock mass cut by many open, intersecting defects, resulting in relatively little contact between blocks. Although in-situ, the rock mass may have the appearance of a pile of loosely stacked rocks, Figure 11
- Roof or escarpment sub-parallel, persistent defects, usually bedding partings or a pervasive joint set, Figure 12

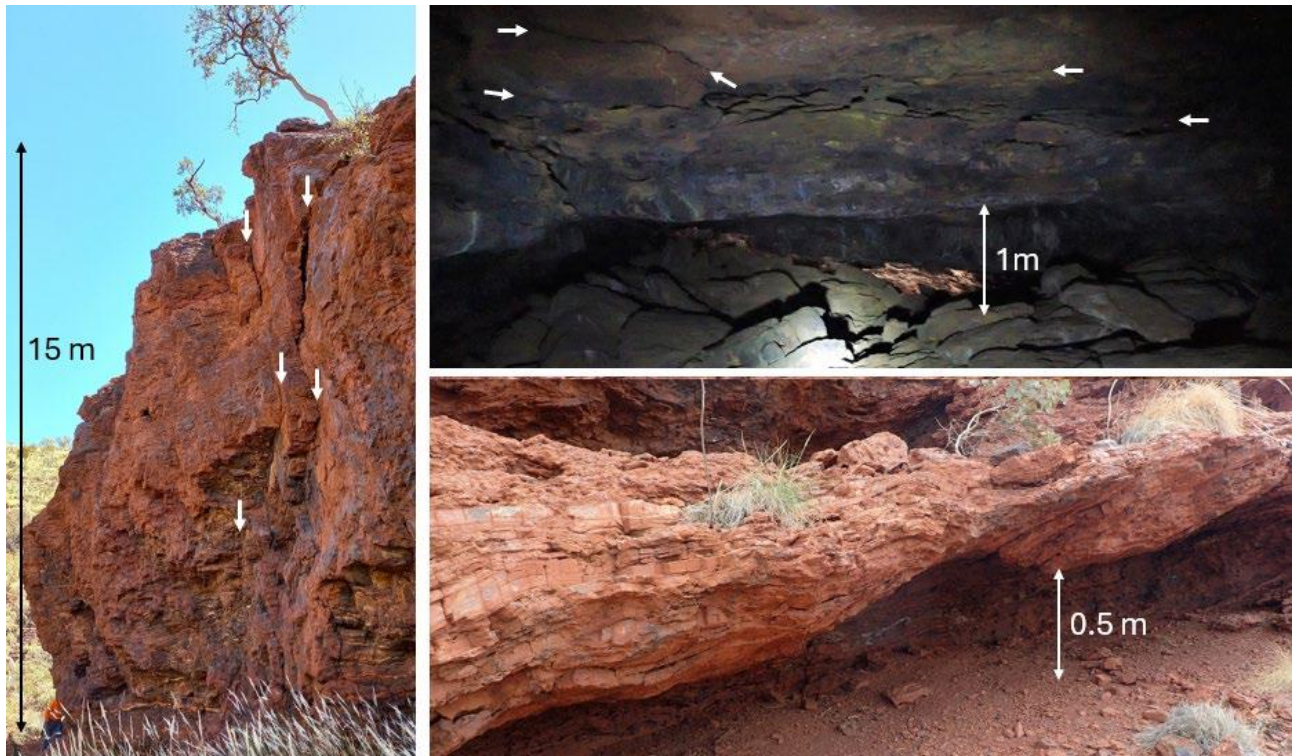
Figure 12 - Examples of potential collapse hazards including escarpment-parallel joints (left), and roof-parallel open joints (top right) and bedding partings (bottom right)
