Project Phoenix Pumped Hydro Energy Storage Project - successful implementation of the Engineering Geological Model approach in support of the energy transition

Alistair Schofield

GHD

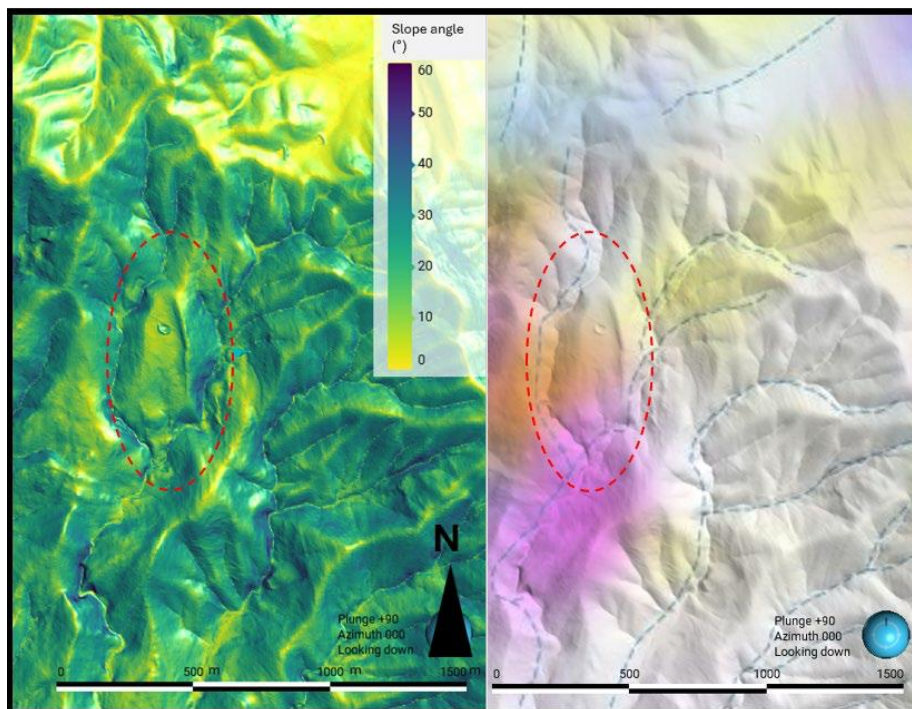
Figure 2: Geomorphological (left) and radiometric anomaly (right)

High quality, 1m resolution lidar data was available for the site. Using this data colluvium and alluvium was identified which is not shown on the published geological maps. The lidar data also revealed bedding or foliation structure of the metasedimentary rock across the landscape and an interpretation of the regional scale structural geology was completed. This interpretation indicated the presence of at least four major folds and smaller scale parasitic folding on these main fold limbs, and several short fault strands across the project area. Based on this structural interpretation it was identified that the bedding dip and lithology would be variable across the project area, and that the folded structures may have also lead to the presence of bedding parallel shears and ramp flat thrust, wedge and hinge faulting associated with stresses induced during the folding process.

As surface instability in the form of landslides is a key hazard to surface penstocks (with the exact configuration yet to be decided at the time), a geomorphological assessment was undertaken along the waterway route to identify possible landslides. Although areas of instability, in the form of translational earthflows and rockslides, were identified, these were away from the waterway route. An anomalous feature, of uncertain origin, was also identified in the topography. This feature coincided with a regional geophysical anomaly noted in the airborne radiometric survey data as shown in Figure 2. This radiometric anomaly was similar to one that coincided with a diorite outcrop on the published geological map. The Merrions Formation is also clearly visible in the radiometric data. The radiometric mapping overlaid on the geological mapping with key components of the project and geological features labelled is presented in Figure 3. The areas of landsliding and this geomorphological and geophysical anomaly were added to the itinerary for the geological reconnaissance mapping stage.

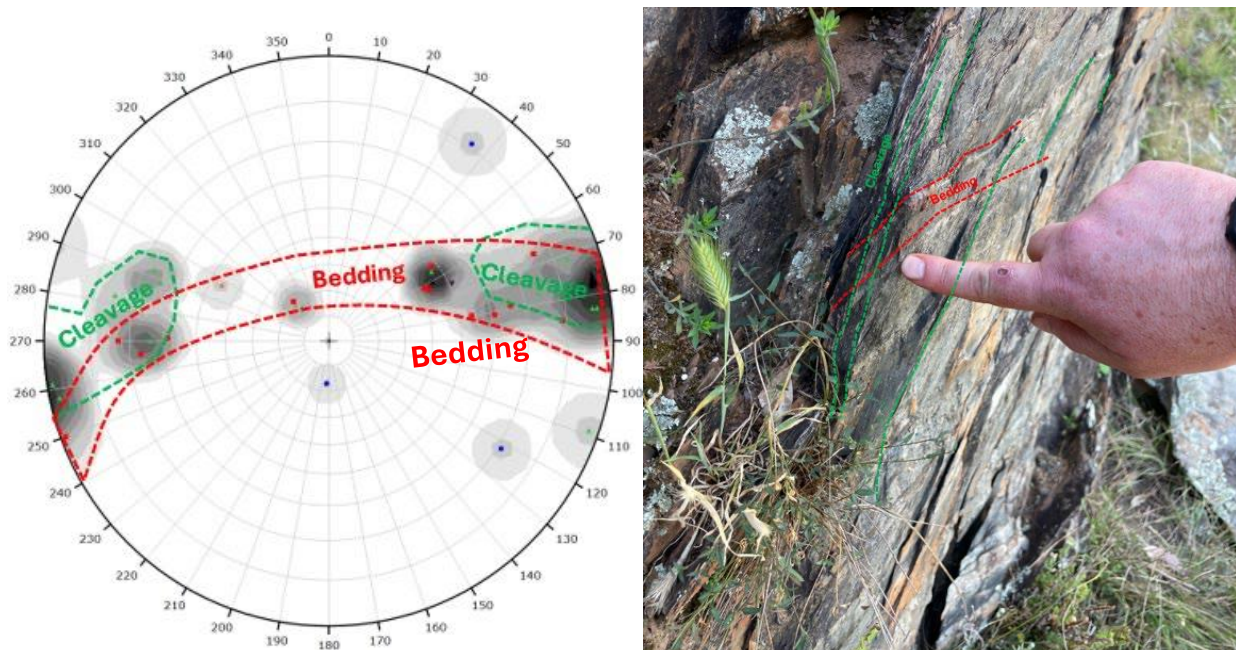
Figure 4: Stereo plot showing results of mapping across the project area (orientated towards true North) (left) and image of site rock showing relationship between cleavage and bedding (right)

The mapping suggested that the foliation in the metasedimentary rock is broadly aligned in a north south direction. The collected measurement data is presented graphically as a stereo plot in Figure 4. The concentration of poles representing the subvertical north-south striking cleavage and the variable bedding dip (from 20° to the south east to 80-90° to the west and east) and a southerly plunging fold have been marked in the figure. This geological structure is consistent with the Geological Survey of NSW mapping data and the structural mapping completed using the lidar data.

Bedding was difficult to ascertain in many outcrops and is therefore underrepresented in the dataset. The difference between cleavage foliation and bedding in an outcrop on the right abutment of the lower dam is illustrated in a photograph taken during the inspection presented in Figure 4.

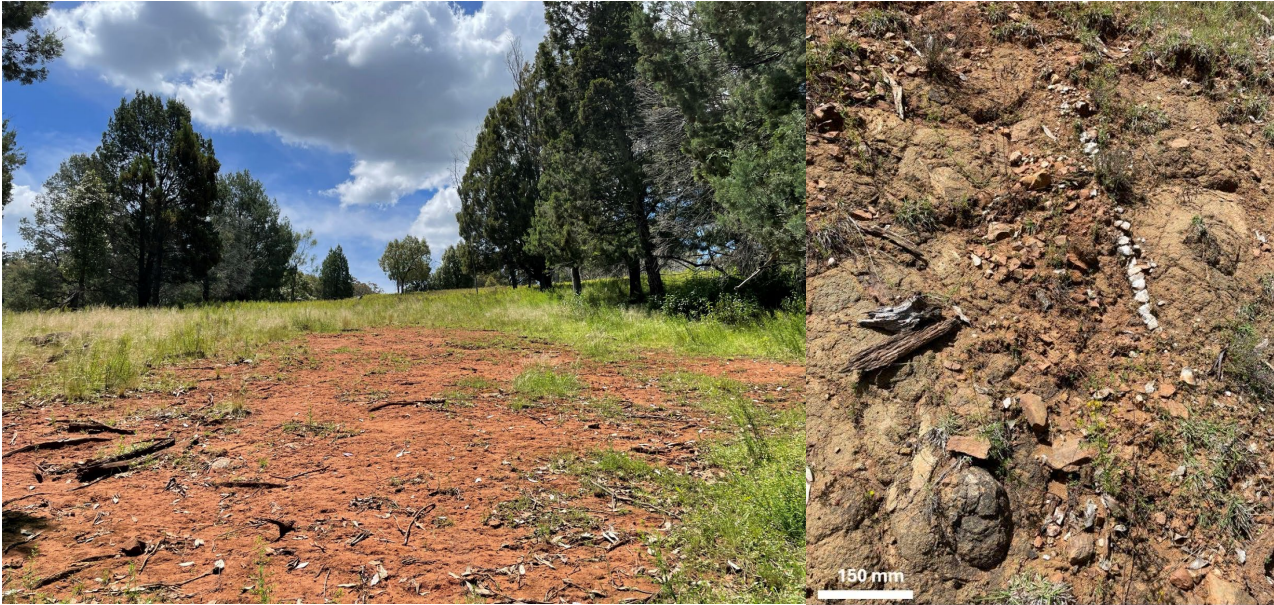
Figure 5: Reddish orange clay associated with weathering of igneous rock (left) and gabbro and concentric weathering and quartz vein (right)

Upon field examination of the anomalous area of geomorphology identified during the desktop stage, a reddish orange clay soil and differing vegetation was observed. A weathered rock outcrop was identified in a farm dam excavated in the centre of the feature. The rock identified was an extremely weathered to highly weathered mafic medium grained igneous rock that had developed characteristic “onion skin” concentric weathering. Quartz veins were observed within the exposure with an approximate north to south strike. Subsequent petrographic testing completed on hand specimens identified the rock to be a greenschist grade metamorphosed dolerite and gabbro. The highly weathered gabbro rock was

low to medium strength. These features are shown in Figure 5. Hand held radiometric equipment could have been utilised to help identify the location of the anomaly but was not considered necessary at this early stage of the project.

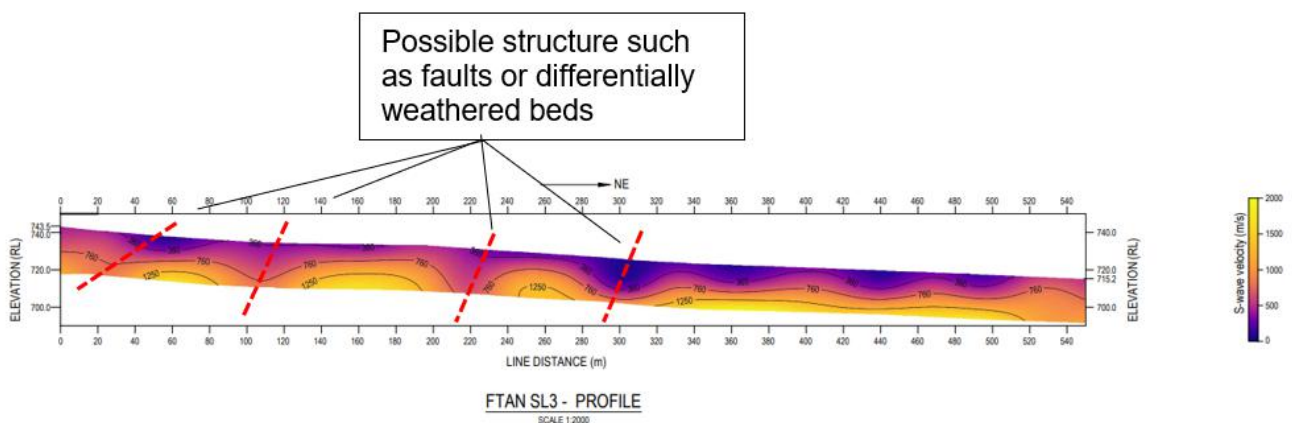
Figure 6: Geophysical survey results presented as FTAN

Seismic refraction tomography surveys and subsequent Frequency Time Analysis (FTAN) of surface waves (Rayleigh and Love) was completed by the GHD geophysics team to provide both a P-wave and S-wave velocity profile (Natale et al, 2004). The geophysical surveys were completed predominantly at the location of dams in the upper and lower storage but also at the proposed powerhouse location. They allowed for identification of features possibly associated with differentially weathered bedding and/or geological structures such as bedding parallel faults. The orientation of the possible structure was checked against the regional geological and reconnaissance mapping and found to generally agree. An example of the geophysical survey results is presented in Figure 6.

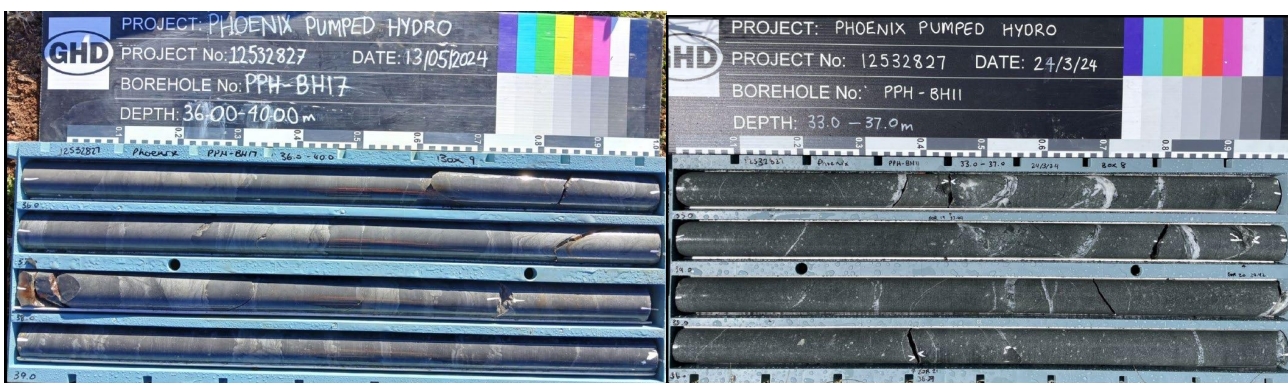
Figure 8: Typical interbedded metasilstone and sandstone (left) and dolerite (right)

The intrusive investigations identified that the predominant lithology was a fine grained metapelite/metasedimentary rock with occasional beds of fine to medium grained quartzose sandstone that varied in thickness from laminations to medium beds. XRD testing of the sandstones identified that they are quartzose with some carbonate cement and pyrite mineralisation. The sandstone also appeared to be less subjected to metamorphism than the metapelite. Where possible, laboratory testing was targeted at either beds of metapelite or the sandstone to provide information on the range of possible geotechnical properties that could be encountered.

Photographs of core from the metasedimentary unit and the dolerite are presented in Figure 8 and Figure 9.

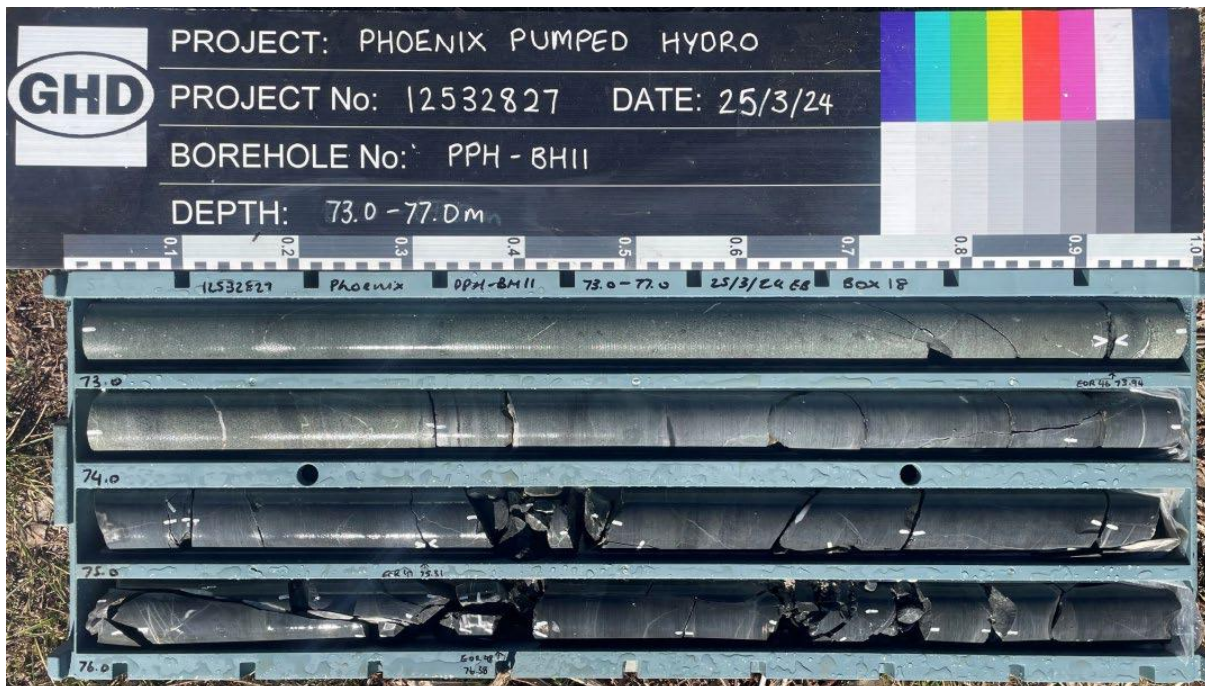
Figure 9: Core through base of sill at 73.95m

Two boreholes targeted the igneous rock with the results indicating that this was a folded intrusive sill. A zone of silicified hornfels was encountered at the contact between the dolerite sill and the country rock.

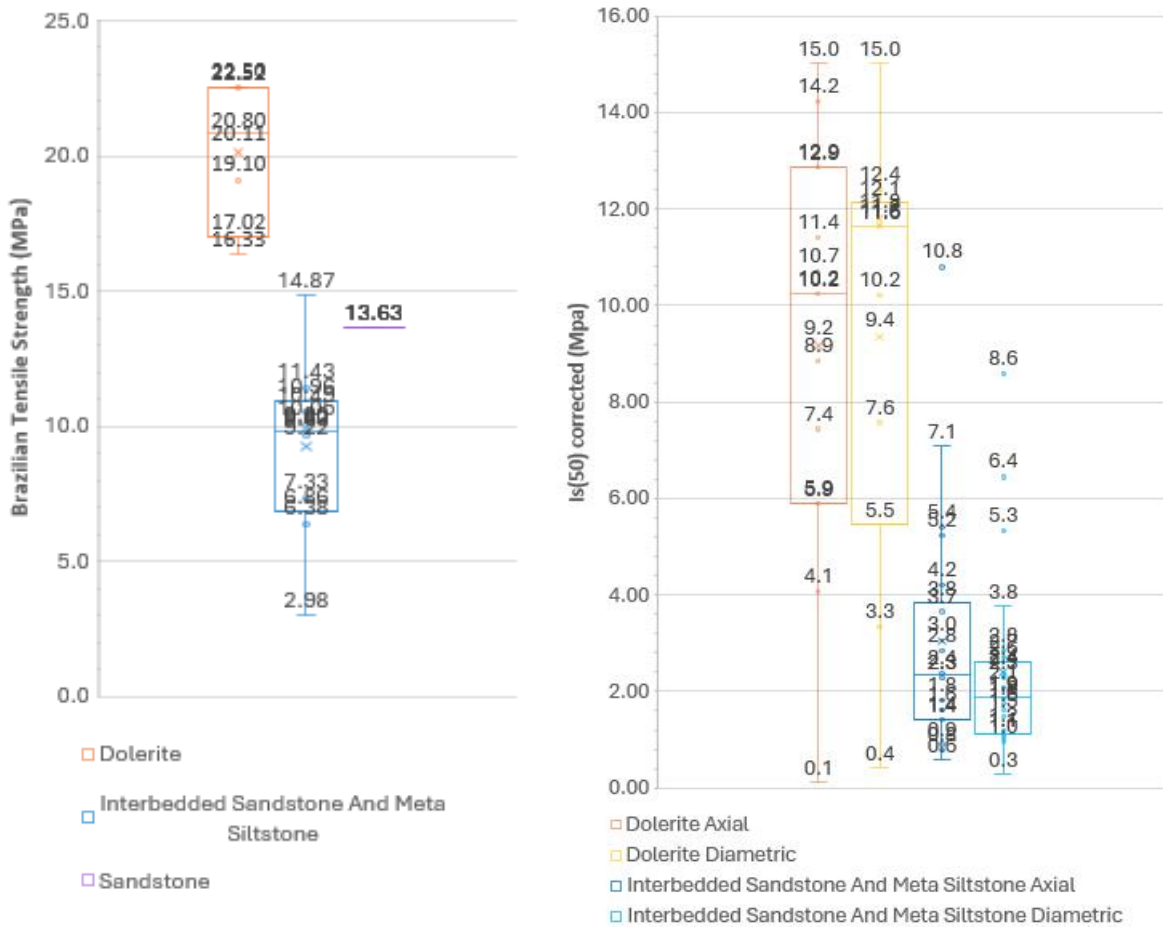
Figure 10: Brazilian tensile strength (left) and point load testing results (right)

PLT results are presented in Figure 10 showing the large scatter of testing results in the dolerite, and overall lower strength results in the metasedimentary rock. In general, the metasiltsone was medium to high strength and the dolerite was very high to extremely high strength.
