GEOLOGICAL CHALLENGES OF BRISBANE'S CROSS RIVER RAIL PROJECT

Ralph Cammack
PSM

The Cross River Rail project includes a new rail line in Brisbane, comprising surface rail and station upgrades, twin running tunnels and four new underground stations at Boggo Road, Woolloongabba, Albert Street, and Roma Street. This project has provided valuable insights into the geological conditions of the Brisbane CBD through large-scale investigation and construction activities. This paper presents case studies of particularly challenging ground conditions encountered during the project, emphasizing the need to consider geotechnical variability and uncertainty in the design phase, as well as the verification of these conditions during construction. The findings presented may serve as a reference for future ground engineering projects in Brisbane.

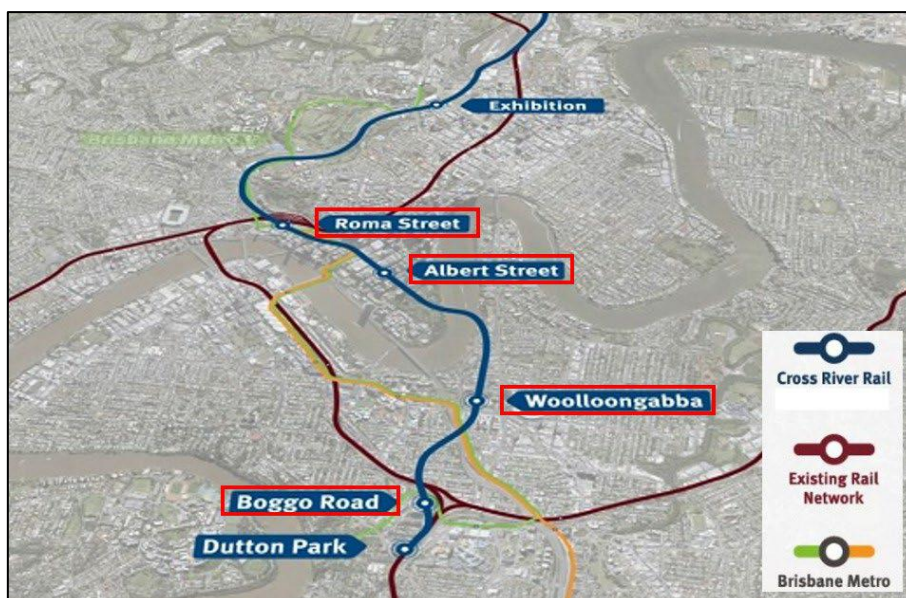
Figure 1: CRR alignment showing the location of the underground stations (www.crossriverrail.qld.gov.au).

Cross River Rail (CRR) is a new 10.2 km rail line in Brisbane, Australia. It extends from Dutton Park south of the CBD to Bowen Hills in the north comprising 5.9 km of twin running tunnels and four new underground stations at Boggo Road, Woolloongabba, Albert Street and Roma Street, Figure 1. The Pulse consortium which included the joint venture of CPB Contractors, BAM International Australia, Ghella and UGL (CBGU JV) was awarded the contract to design, construct and maintain the Tunnels, Stations and Development (TSD) works.

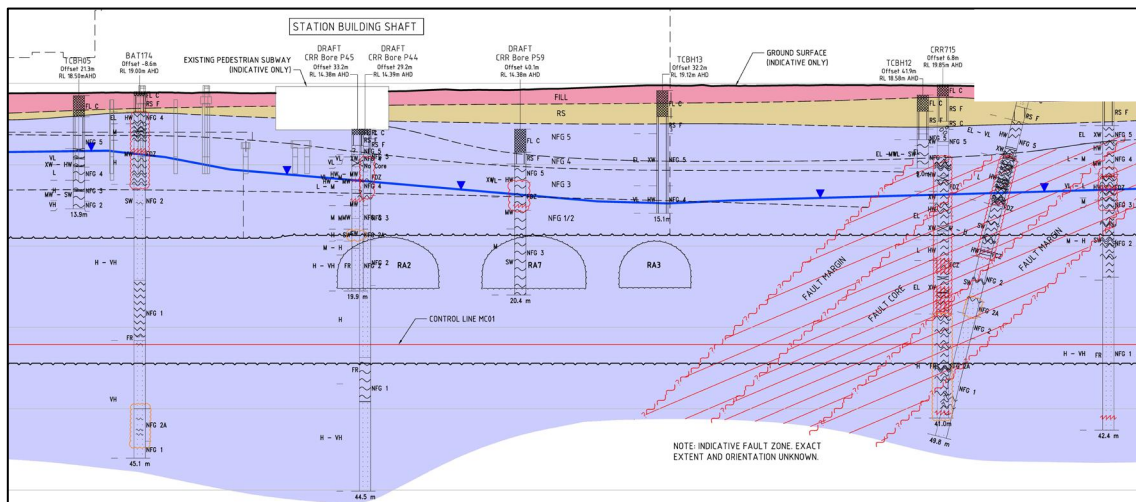
Figure 4: Roma Street Station geotechnical section – showing inferred fault zone intersecting the cavern.

including the adit and cavern intersections. However, the boreholes were not able to be completed due to surface constraints including the operating railway station, Inner Northern Busway and other buildings. The location and extent of the fault zone was therefore inferred based on the available information, and was interpreted to intersect the cavern, adits and main shaft Figures 3 and 4. The rock mass was classified into NFG1 to NFG5 (fresh to weathered) units, and fault zone materials including Fault Disturbed Zone (FDZ) and Fault Crush Zone (FCZ). The fault zone materials were assessed to be of significantly lower strength and stiffness compared to the surrounding high strength NFG rocks and were considered to have potential implications for the cavern and shaft stability, ground loading and founding conditions.

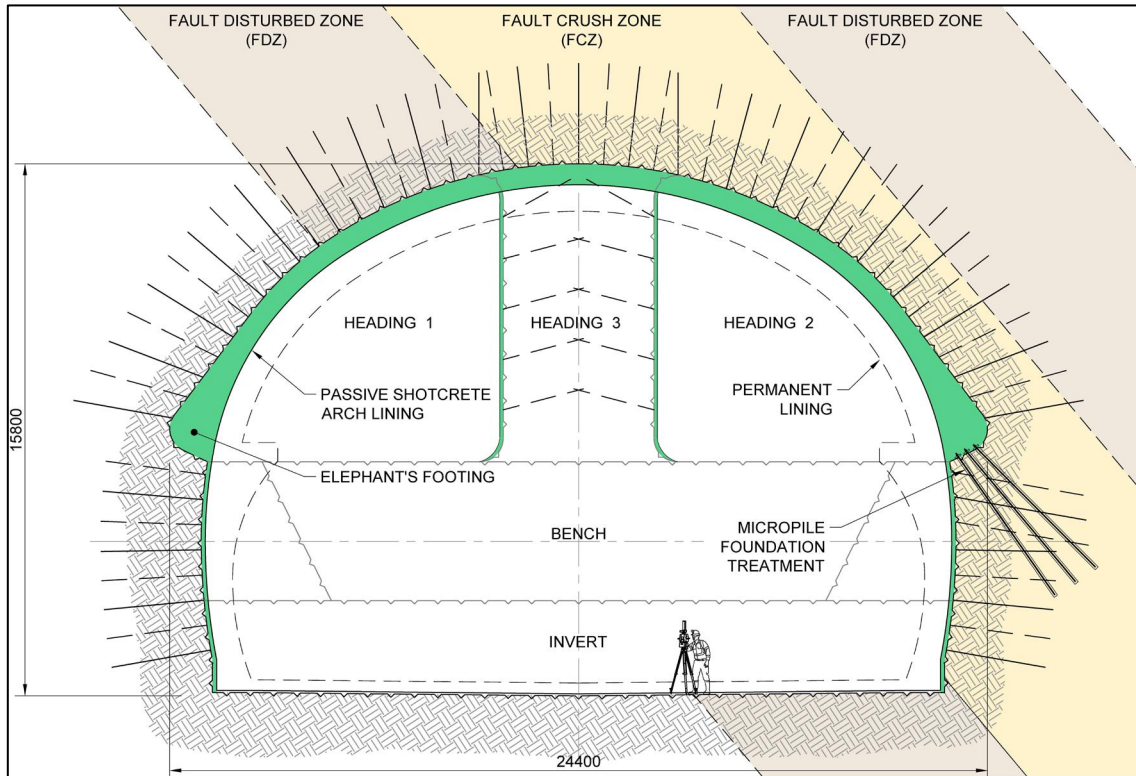
Figure 5: Roma Street Station cavern – showing passive shotcrete arch lining and micropiles at the elephant's footing foundation (Shen et. al. 2022).

- A passive shotcrete lining primary cavern crown support type, combined with a three-heading excavation sequence to minimise span width and allow verification of ground conditions in the lead heading, Figure 5.
- A heavily bar reinforced passive shotcrete primary lining support and temporary collar structure if a fault zone was encountered at the intersection of the cavern and adits.

- A widened elephant's foot foundation for the shotcrete arch primary lining, with micropiles and wall support under the footing in the fault zone, Figure 5.
- Removal and concrete replacement of fault zone materials in the cavern invert, Figure 6.
- A permanent concrete lining with thickness and reinforcement which catered for ground loading from the fault zone.

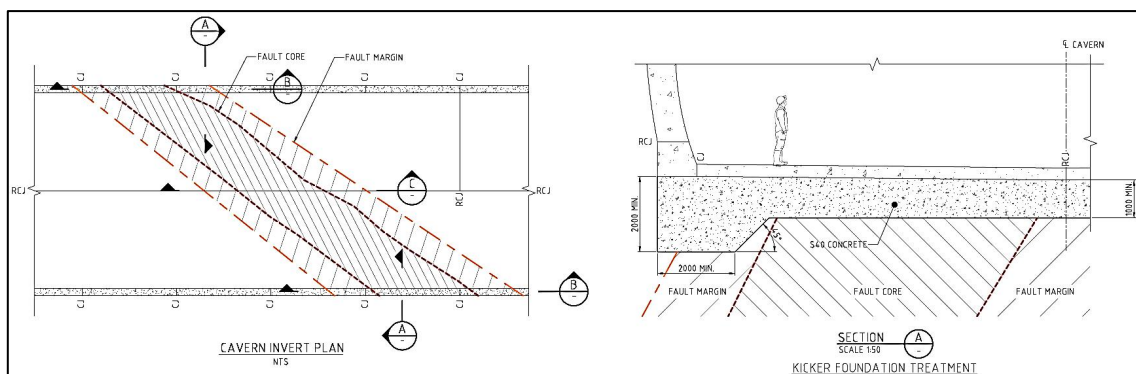
Figure 6: Roma Street Station cavern invert foundation treatment.

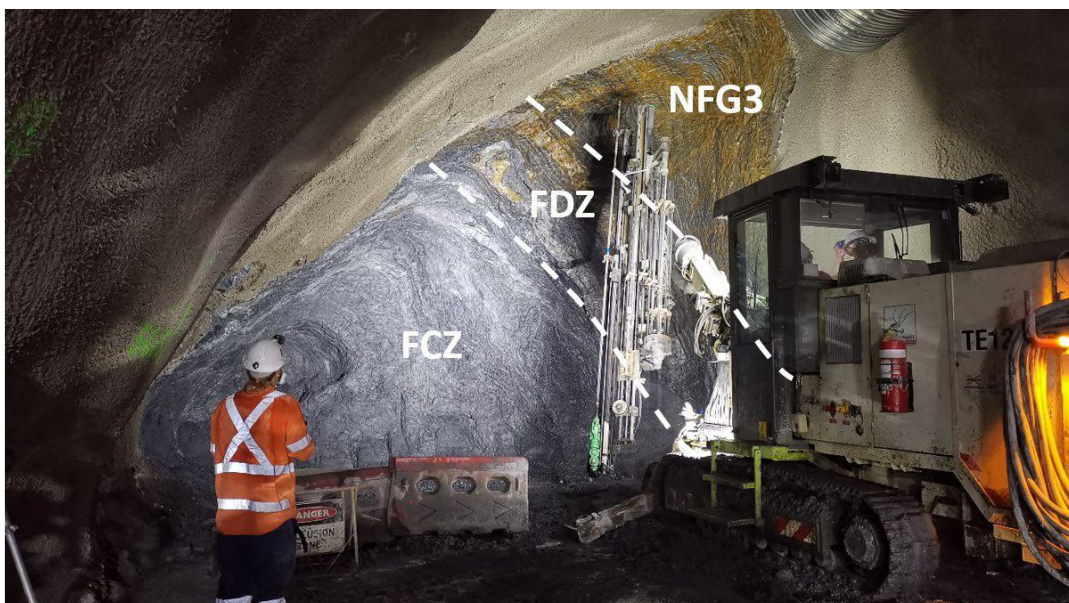
Figure 8: Fault zone encountered in the Roma Street Station cavern heading during construction.

Verification of the fault zone was undertaken during construction via geotechnical mapping, endoscopes, piling inspections, plate load testing and monitoring. Mapping of the cavern and adits detailed a 5m to 10m wide fault core comprising variable FCZ (typically 1m to 4m wide) and FDZ (typically 2m to 5m wide), steeply dipping to the northeast. The FCZ materials comprised fault brecciated rock with seams of fault gouge material, ranging from matrix to clast supported and soil to very low rock strength. The FDZ materials comprised highly disturbed and brecciated rock with frequent crush and shear zones, generally clast supported and ranging from very low to medium rock strength. The core was surrounded by a fault margin zone comprising NFG and FDZ materials, around 5m to 10m in thickness either side. A zone of increased rock mass disturbance was observed adjacent to the fault margin in places, characterised by increased jointing, minor warping and folding of foliation and increased weathering of geological structures. Figure 7 presents the fault zone as mapped in the crown of the cavern and adits. The encountered fault zone extent and characteristics were generally consistent with the design assumptions, and the design solutions were implemented without delay or modification. Figure 8 presents a photograph of the fault zone in the cavern heading. Figure 9 presents the removal of the fault zone in the cavern invert. The fault did not occur at the cavern intersection with the adits and therefore the bar reinforced concrete collar was not required.

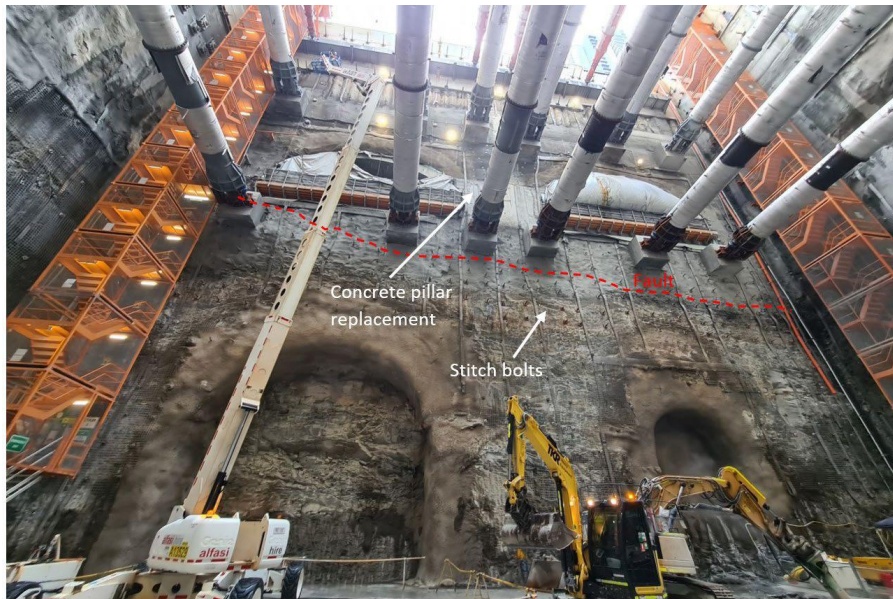
Figure 15: Albert Street Station Lot 1 shaft showing cavern adits, temporary props, stitching bolts, concrete pillar replacement and approximate location of the low-angle fault.

Verification of the low-angle fault was undertaken during construction via geotechnical mapping, endoscopes, and monitoring. The fault was persistent as expected and was variable in character along its strike. Figure 15 shows the approximate location of the fault intersecting the Albert Street Station Lot 1 shaft. It varied from a 2m thick zone of FCZ and FDZ, with anastomosing fault splays, Figure 16, to a discrete single fault with around 100mm of brecciated rock infill, Figure 17. The fault was wider than expected in the cavern invert, with a broad crushed zone requiring treatment in the floor, Figure 18. However, in the critical zones (i.e. the shaft walls and pillar) the fault conditions and location were within the design expectations therefore construction was able to continue with no significant delay or design change. This fault is expected to extend into the surrounding properties around the Albert Street Station project site and may need to be considered for future basement excavations or underground works in this area.

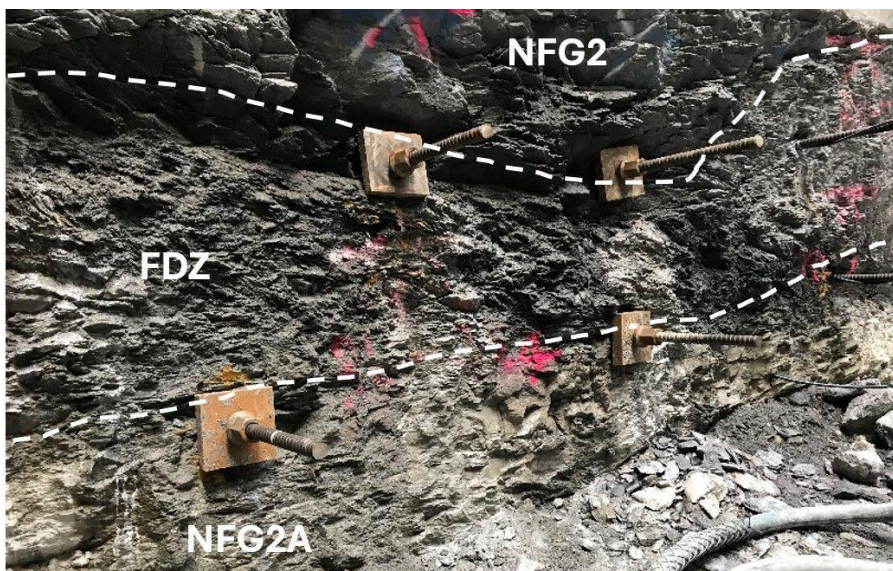
Figure 16: Pillar stitch bolts in low-angle fault at Albert Street Station.

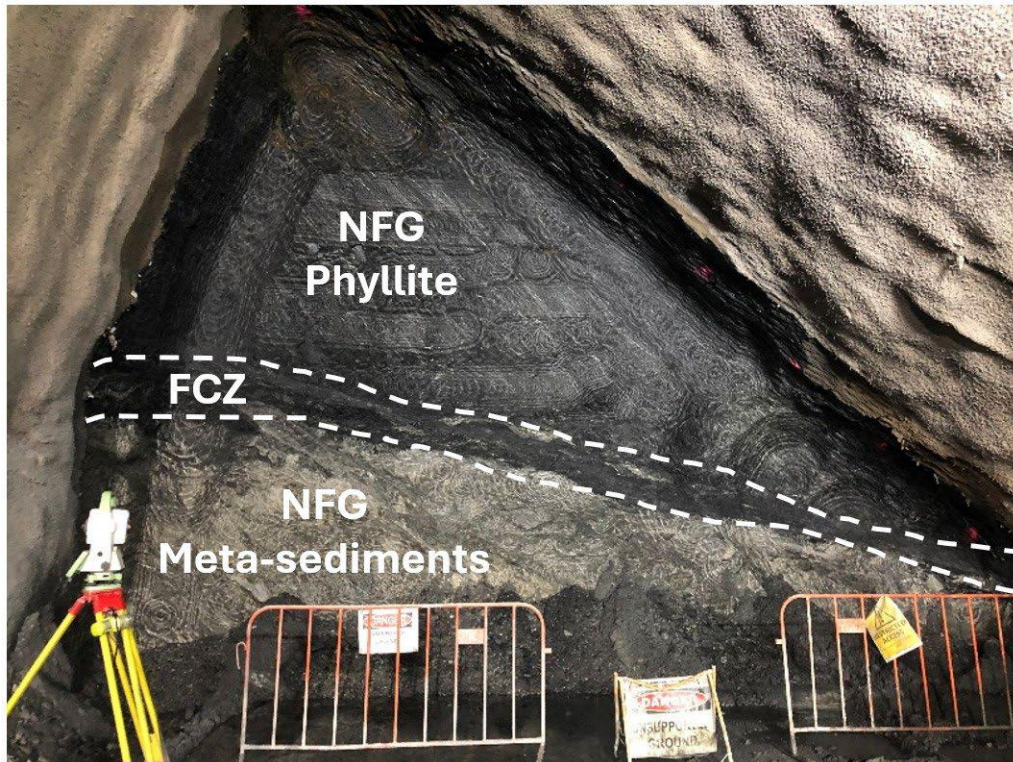
Figure 17: Low-angle fault encountered in the Albert Street Station cavern heading during construction.

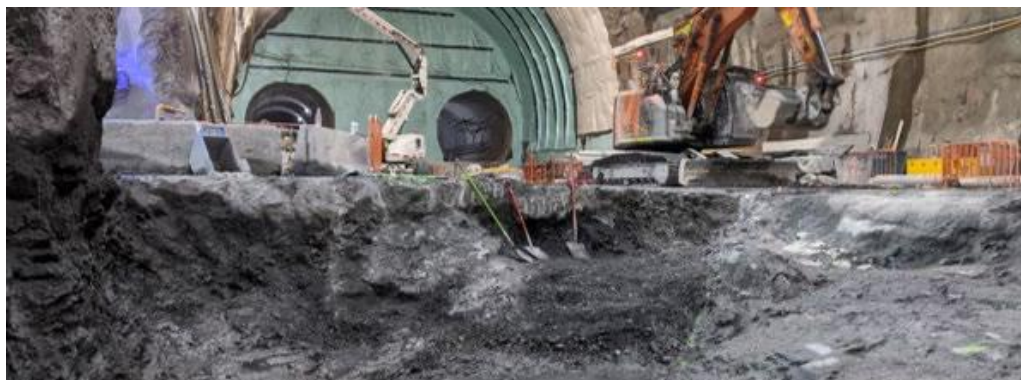
Figure 18: Excavation of fault materials for the Albert Street Station cavern invert floor treatment.

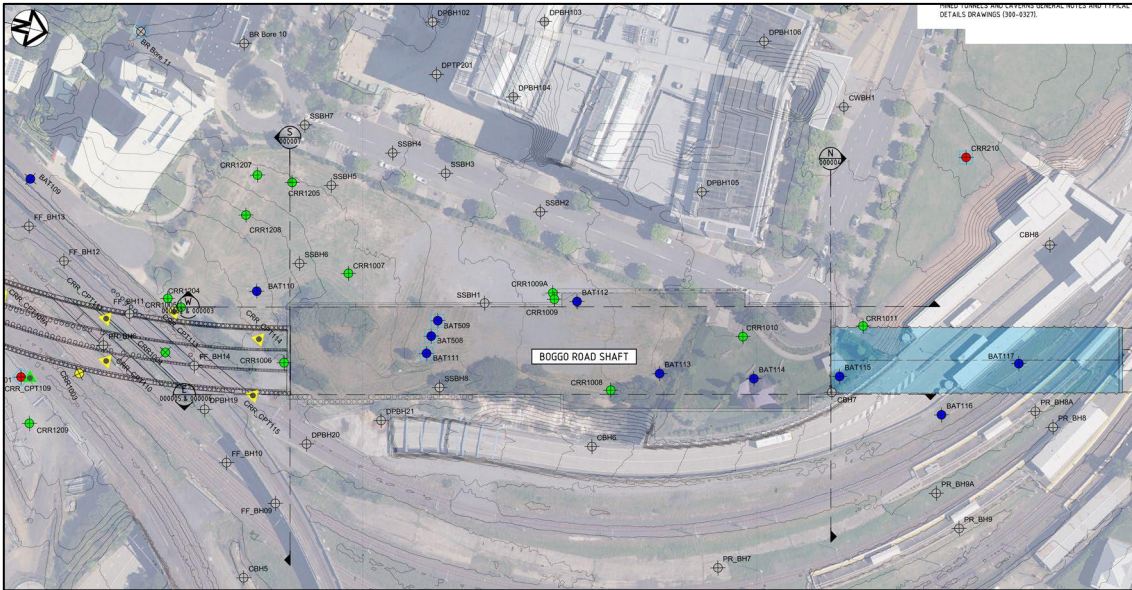
Figure 19: Boggo Road Station borehole plan (refer to Figure 2 for legend).

Bogga Road Station is located within the Aspley Formation and Brisbane Tuff geological units to the south of the Brisbane CBD. The initial investigation boreholes encountered an Unconformity Zone (UZ) between the overlying Tuff and underlying Aspley units, located close to the invert level of the shaft for the proposed station box building, Figures 19 and 20. The UZ was assessed to be highly variable, ranging from a good quality rock-to-rock contact, to low shear strength and low stiffness brecciated and sheared rock and soil materials up to 1m thick. The UZ was considered to have potential implications for shaft stability, ground loading, founding conditions, and as a potential source of displacement which could impact exiting infrastructure. Additional geotechnical boreholes were drilled from within the shaft excavation during the construction phase to improve understanding of this feature at critical locations where large structural loads or spans were identified in the station box design.

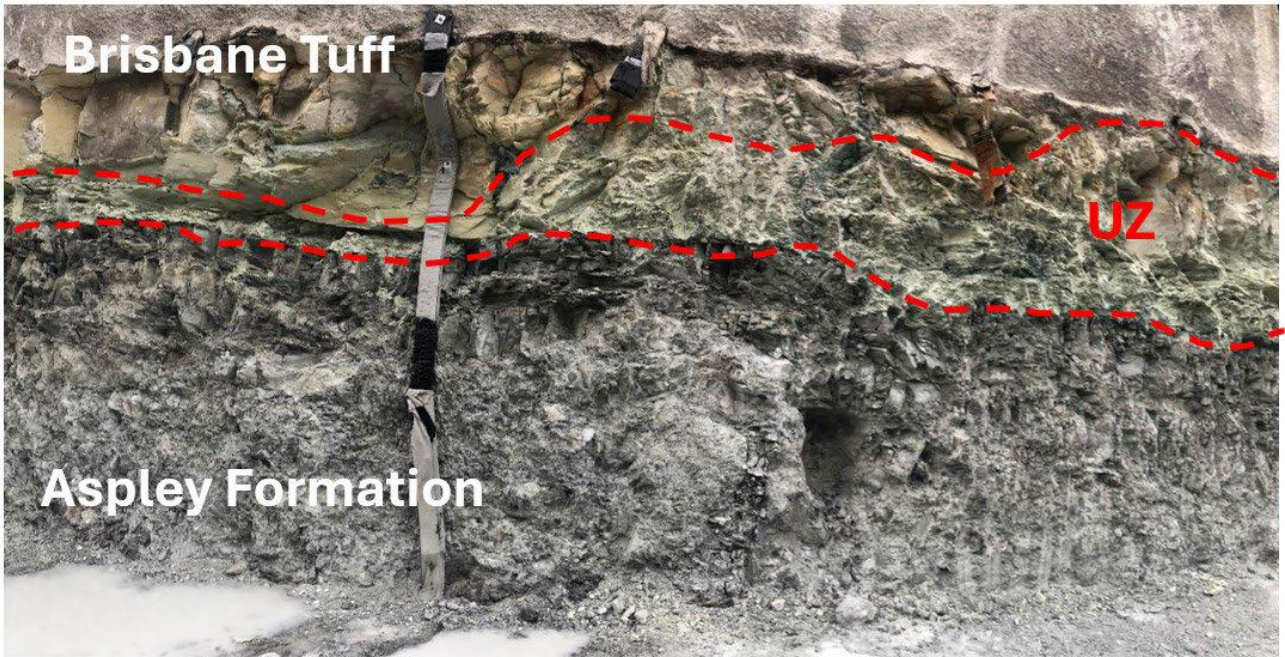
Figure 22: Unconformity Zone between the overlying Brisbane Tuff and underlying Aspley Formation geological units encountered in the Boggo Road Station shaft excavation during construction.

Verification of the UZ was undertaken during construction via additional boreholes with televiewer imaging, geotechnical mapping, endoscopes, piling inspections and monitoring. The UZ was persistent and observed to be undulating in shape over short distances, inferred to be associated with the paleo-erosion surface prior to deposition of the overlying volcanic tuff materials. It was variable in character along its strike, ranging from a clean rock-to-rock contact to a 1m thick zone of clast or matrix supported brecciated rock with zones of soil, including high plasticity clay, up to 0.5m thick, Figure 22. Slickensides and other signs of shearing were observed in places. Significant groundwater seepage occurred at some locations. Removal and replacement of the UZ materials was undertaken in the Boggo Road Station shaft invert, Figure 23.

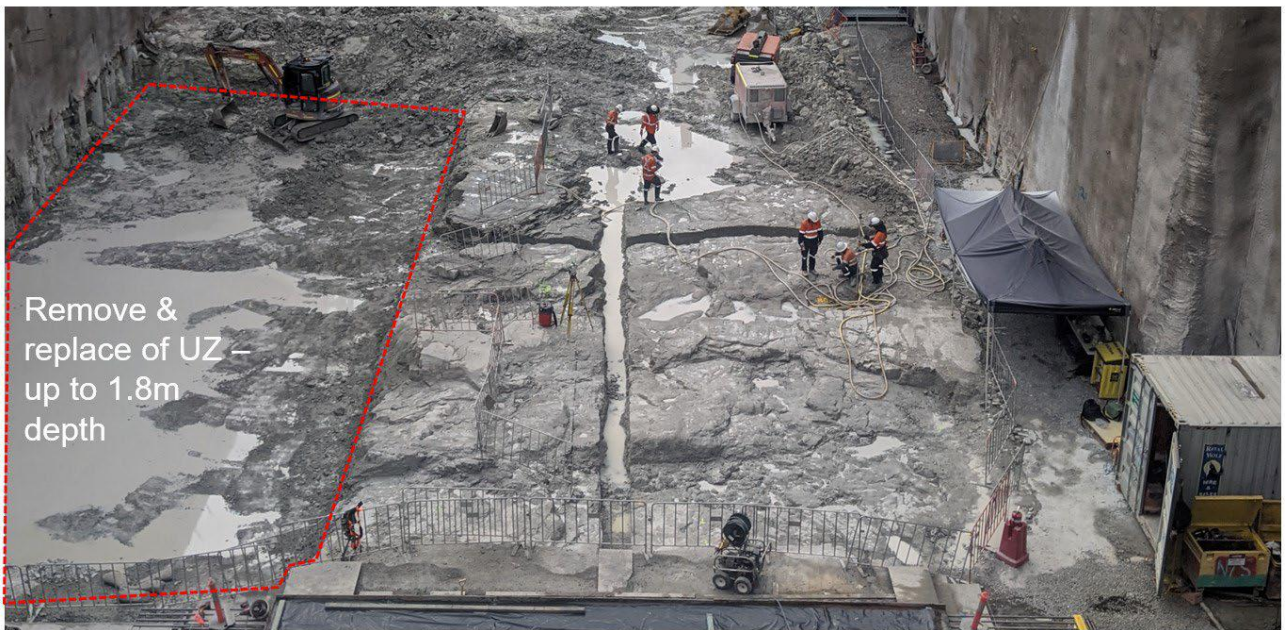
Figure 23: Excavation of Unconformity Zone materials for the Boggo Road Station invert floor treatment.
