UNCOVERING GEOHAZARDS AFFECTING INFRASTRUCTURE IN THE HIMALAYAS

Ranjan Kumar Dahal

Central Department of Geology, Tribhuvan University, Kirtipur, Kathmandu, Nepal

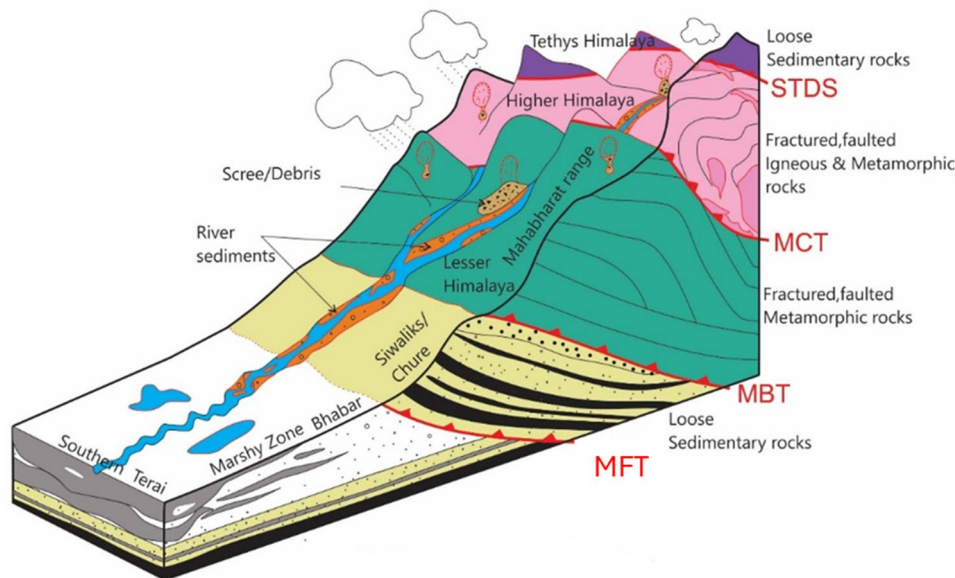
Figure 1: Geological and geomorphological settings of the Himalaya (source: DMG, 2025)

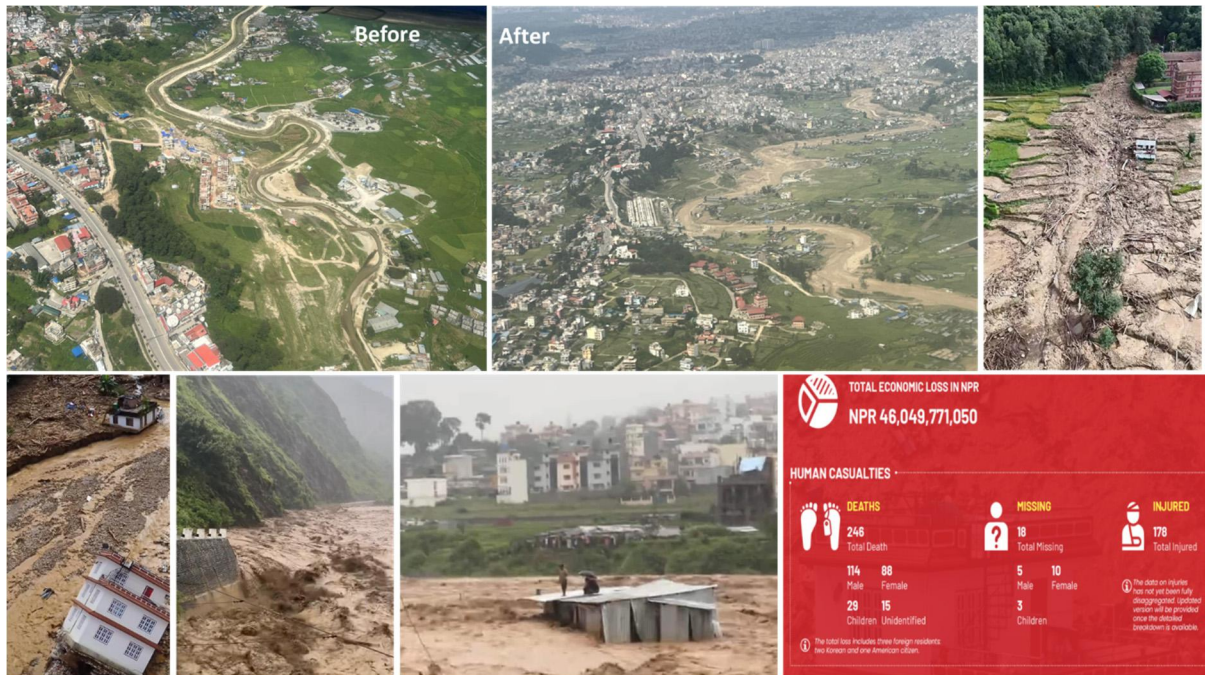
Figure 3: Damage and loss scenario during extreme rainfall of September 26 and 30, 2024. Red box is official data of National Disaster Risk Reduction and Management (NDRRMA), Government of Nepal.

Between September 26 and 30, the Kathmandu Valley received over 700 mm of rain, nearly half its annual average—over just three days. This deluge caused the Bagmati River to overflow, inundating large parts of Kathmandu and Patan. The resulting floods and landslides led to at least 246 confirmed deaths nationwide, with over 4,000 people rescued and more than 1,200 homes destroyed or severely damaged. Infrastructure damage was extensive: 25 bridges, 37 highways, and 11 hydropower stations were impacted, while seven major highways leading out of Kathmandu were blocked by debris. The disaster also disrupted power, water, and telecommunications services across multiple districts. In the Kathmandu Valley alone, at least 73 fatalities were reported. Rescue operations were hampered by blocked roads and ongoing landslides, with entire vehicles, including buses, buried under debris.

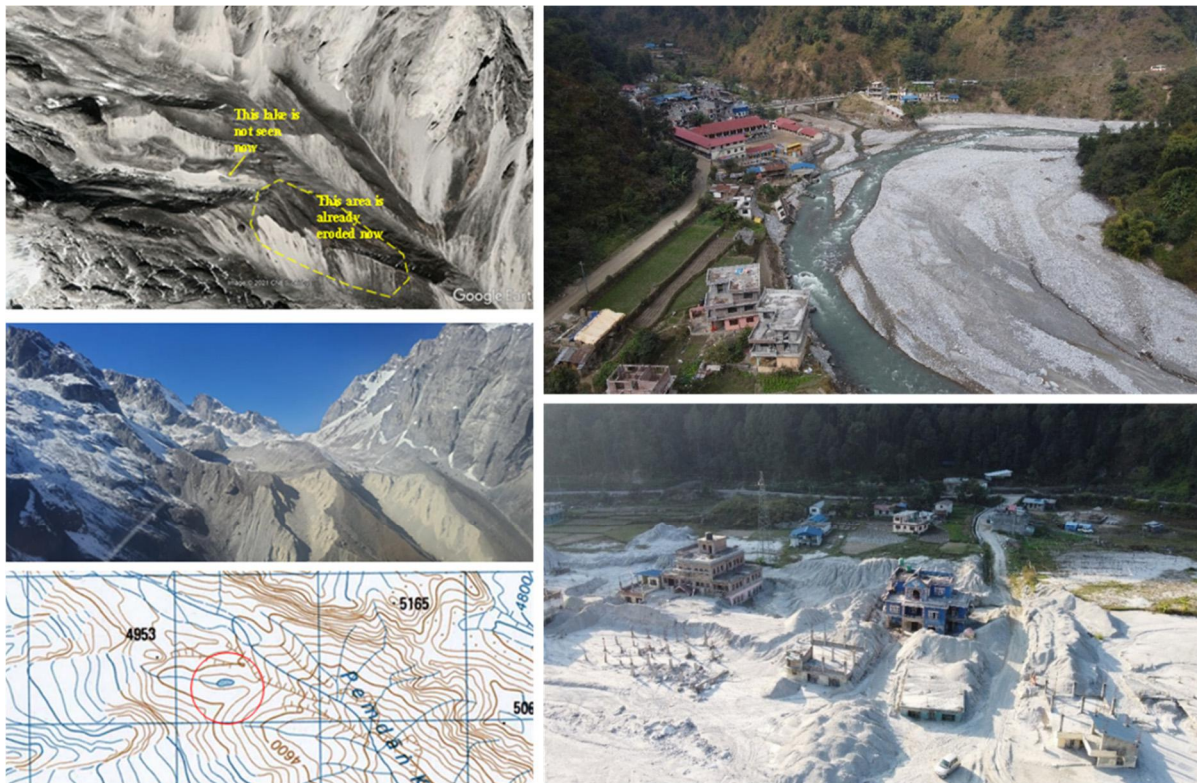
Figure 5, Pemdan Glacial Lake in 4750 m and status of erosion in Pemdan creek and burst of the lake.

On 15 June 2021, Melamchi Municipality in Sindhupalchok District experienced a devastating flood, followed by a second major event on 31 July 2021. These floods caused extensive damage to 255 households, destroyed two concrete and two suspension bridges, and inundated thousands of hectares of agricultural land, isolating the municipality and its surrounding areas for several weeks. Although the scale of destruction was immense, early warning from upstream communities played a critical role in preventing human casualties. Scientific investigations suggest that the main trigger

of the flood was the outburst of Pemdan Glacial Lake (Figure 5), which led to the breaching of an old natural dam near Bhemathan. This initiated rapid riverbed erosion, sediment mobilization, and a cascading series of landslides along the Melamchi River (Figure 5). The downstream impacts extended up to the Sipaghat area of the Indrawati River, with severe debris deposition particularly around low-clearance bridges. Based on flood hazard modelling, settlements from Talarang to Sipaghat are vulnerable to high-magnitude floods with 100-year return periods and should be avoided for permanent habitation. The 2021 event revealed the inadequacy of the earlier 20-meter river setback, prompting the development of new setback standards, risk-sensitive land use plans, and structural as well as bioengineering mitigation measures. The total estimated cost for implementing a comprehensive rehabilitation and disaster mitigation plan in the Melamchi area is over NPR 3.38 billion.
