# STRAIN SOFTENING AND NAVIGATING KARSTIC RISKS IN THE DESIGN AND CONSTRUCTION OF LARGE RETAINING WALLS

Ken Chen<sup>1</sup>, Michael Wiechecki<sup>1</sup>, Jessica Dalton<sup>1</sup> and Philip Davies<sup>2</sup>

<sup>1</sup> WSP, <sup>2</sup> GeoReports, Sydney

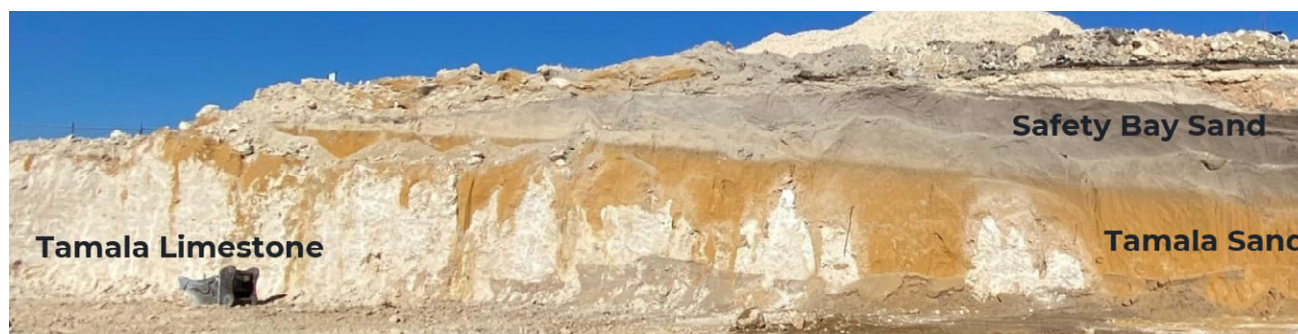
**Figure 2: Inherently variable top of limestone rock profile along the YRE alignment**

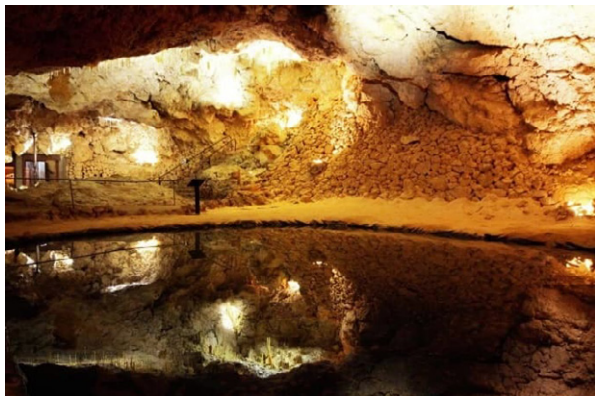
**Figure 8: Example of a karstic features: (a) left: interior of Crystal Cave (Morey, 2025), a solution cave located 4 km from Pipidinny Road Bridge and (b) right: karstic features encountered during earthworks along YRE**

Figure 8 below, shows an example of a large solution feature at Crystal Cave, located in the Yanchep National Park, about 4.2 km NNE of Pipidinny Road Bridge. Other karstic features were also encountered during bulk earthworks and foundation preparation for gravity retaining walls and structures along the YRE alignment, which is also shown below.

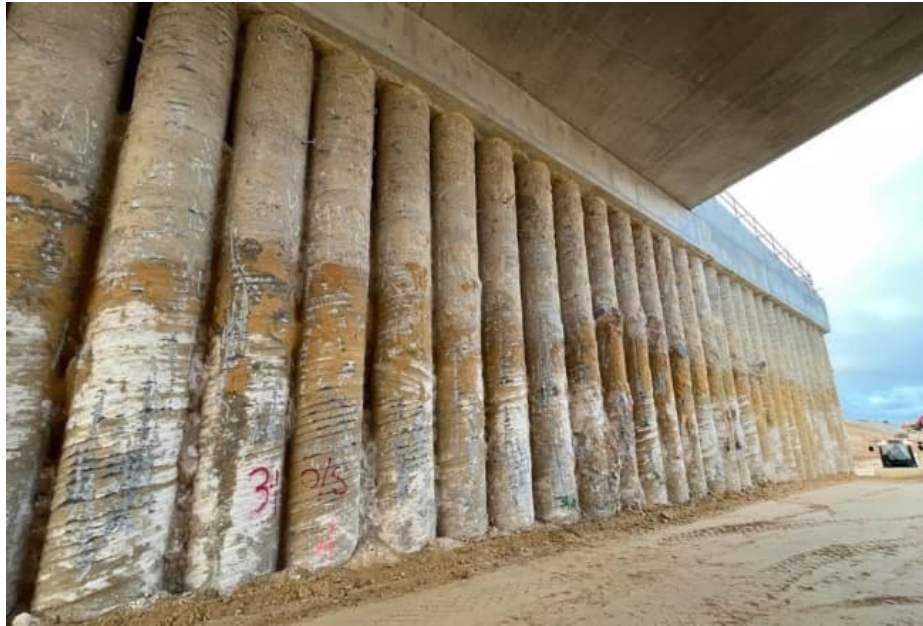
Figure 12: Contiguous Piles exposed after bulk excavation during construction of Pipidinny Road Bridge

A photograph of Pipidinnny Road Bridge during construction is shown in Figure 12, below.
