Design and construction of a multi-anchored retention system within Ashfield Shale

Keith Roberts
Douglas Partners Pty Ltd, Sydney

Excavation for a four-storey basement alongside a busy commuter railway line required both temporary and permanent support within the Ashfield Shale formation. Rail authority requirements were such that the new building had to remain independent from the retaining wall supporting the railway line. A multi-anchored wall was therefore adopted to permanently support the excavation.

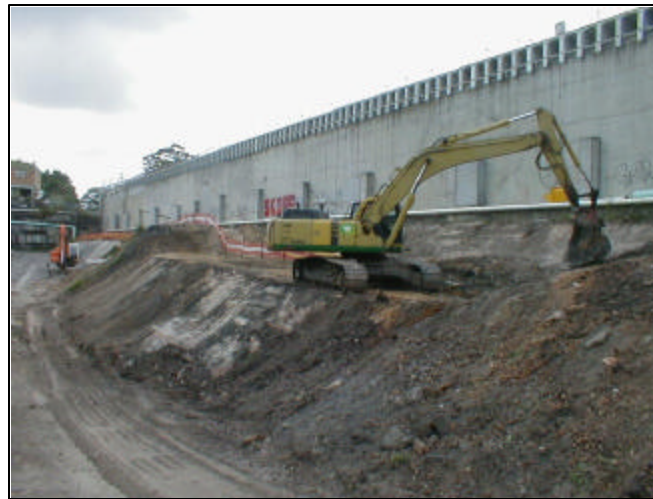
Figure 2 – RES and rail embankment prior to excavation

The railway line originally ran along an open section of track on top of an earthfill embankment of 2 to 3 m height. Prior to initial excavation at the site, a Railway Enclosure Structure (RES) was built around the rail line for the length of track included in the development. The RES formed an above-ground tunnel structure of approximately 20 m width and about 10 m high over the rail corridor. The RES was constructed on beams supported by large diameter concrete filled steel piles founding at typical depths of 20 m to a level below the base of the proposed excavation. A photograph of the RES on the earthfill embankment prior to excavation is shown in Figure 2.

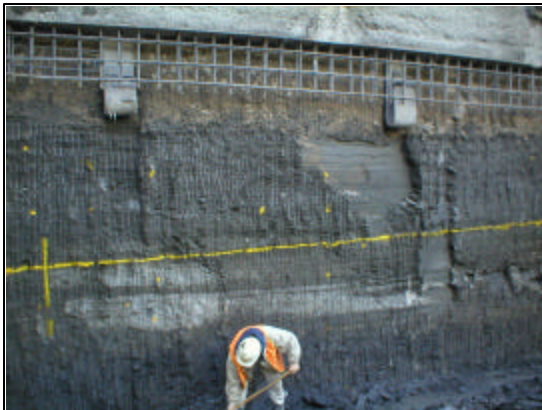
Figure 5 – Typical exposed joint

The faulting and jointing was mapped and measured for every panel exposed within the shale, allowing larger features to be identified and tracked to lower panels on the wall. A typical joint exposed within the shale is shown in Figure 5.

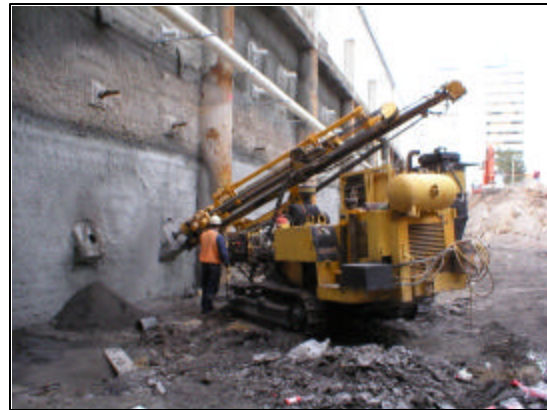
Figure 6 – Drilling of the anchor holes

The shotcrete was applied using a hand held nozzle fed by a concrete pump truck located at surface level. Drilling of the anchor holes commenced 1 day after shotcreting of the panels (Figure 6). Typically 3 anchor holes were drilled into each panel between the large diameter piles. The holes were inclined at 30° to the horizontal and extended to between 12 m and 16 m depending on the free length of the anchor to be installed. 150 mm diameter holes were used to allow for placement of the 125 mm diameter anchor assembly. Drilling resistance and cuttings returned by the compressed air from the drill bit were used to confirm the strength of the anchor bond material.

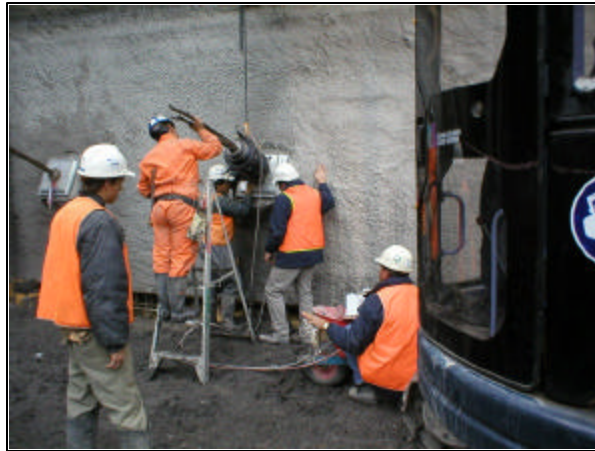
Figure 7 – Stressing of Anchor

The anchors were stressed using the jack shown in Figure 7, which was lifted using a 7 tonne excavator. The anchors were proof loaded to 125 % of the design working load in 5 equal increments with the load held at each increment for 30 seconds and the final proof load held for 10 minutes to allow time for anchor-wall movements and some movement of the wall within the extremely low strength shale. Once the anchors had demonstrated that they could successfully hold the proof load they were locked-off at 5% above the design working loads. Lift-Off testing was carried out on each anchor to provide a reference force in each anchor to compare to future lift-off test results.

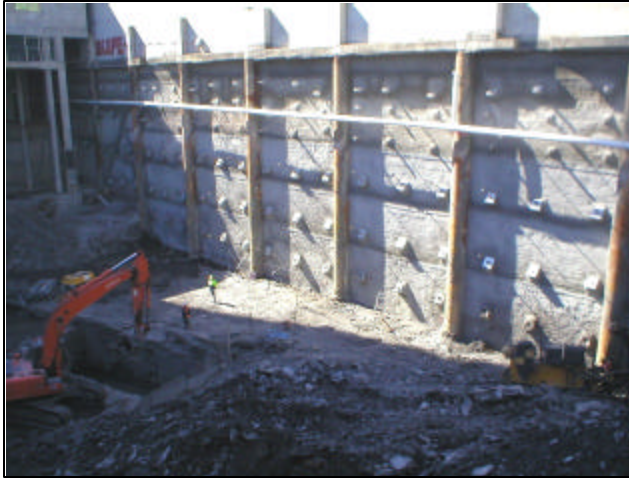
Figure 8 – Completed Permanent Multi-Anchored Retaining Wall

Following the immediate lift-off test the next panel below was excavated with the above procedure repeated until the full depth of excavation had been reached. A photograph of the completed wall is shown in Figure 8.

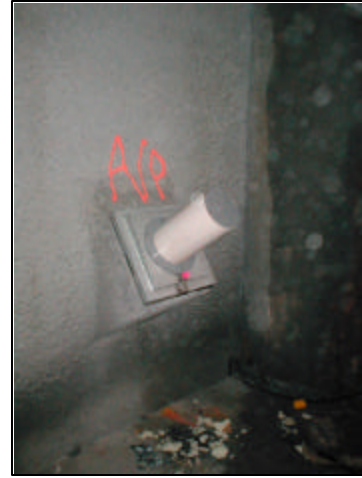
Figure 9 – Grease capped RES anchor

During the construction of the building the final corrosion protection was applied to the anchors. This included secondary grouting and a grease filled cap. The secondary grouting was used to fill the void which is left behind the anchor plate during initial grouting of the anchors. The placement of a protective cap filled with grease protects the strands extending from the anchor head and allows for removal of the cap in the future for long-term lift-off testing over the life of the structure. A photograph of a capped anchor is shown in Figure 9.
