# Rockfall Protection Structures on a Critical Lifeline in Christchurch

## ABSTRACT

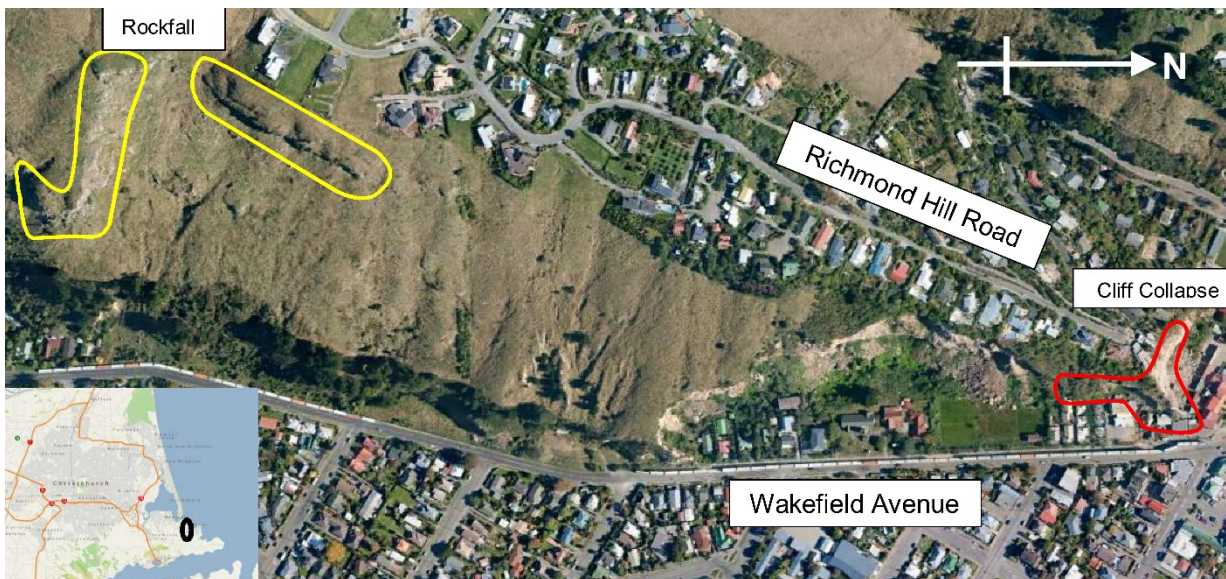
Figure 1. The rockfall and cliff collapse hazards affecting Wakefield Avenue are indicated in yellow and red respectively. (Image courtesy of Google Earth Pro, 30 June 2016).

Wakefield Avenue runs approximately north-south along the western side of Sumner at the base of Richmond Hill as shown in Figure 1. The slope above Wakefield Avenue rises from approximately 3 m above sea level (masl) at Wakefield Avenue to 170 masl at the crest of the slope. The site geology is typical of the Port Hills and predominantly consists of loess (wind-blown silt), underlain by the Lyttelton Volcanic Group basaltic to trachytic lava flows interbedded with breccia and tuff (Forsyth, P.J. et al, 2008). The joints and defects within the basalt and pyroclastic deposits generally form tabular or

The three main geo-hazards affecting Wakefield Avenue are rockfall or boulder roll, cliff collapse and debris flow. During the 2011 CES, notably the 22 February and 13 June aftershocks, over 15,000 m<sup>3</sup> of debris (Massey et al. 2014) fell from the cliff collapse at the northern end of Wakefield Avenue (Figure 1). Significant ground cracking was mapped through the properties above the cliffs extending up to 50 m back towards Richmond Hill Road (Massey et al. 2014). The results of GNS mapping, modelling and investigations of the area identified 10 debris avalanche (cliff collapse) sources and thus the area was designated a Class 1 Mass Movement Area (Massey et al. 2014). The modelling of the 10 debris sources by GNS identified that only two of the sources have the potential to impact Wakefield Avenue.

At the southern end of Wakefield is a 170 m long continuous bluff below Richmond Hill Road and a smaller mid-slope bluff that were sources of a significant amount of rockfall during the CES (Figure 1). The majority of boulders that fell from these sources during the CES accumulated on the slope and park area at the base of the slope, however approximately 20-25 discrete boulders and some fly rock came to rest on the road with at least 7 boulders rolling across Wakefield Avenue into properties on the eastern side of the street.

A risk assessment of future rockfall to the Wakefield Avenue portion of the Sumner-Lyttelton Corridor was undertaken (Swatton 2014) and identified four sections where the risk was classed as high to very high. GNS undertook research (Massey et al. 2012) and provided advice to CCC on acceptable levels of risk for different activities to allow CCC to identify what an acceptable level of risk for normal use of Wakefield Avenue would be. The sections of the Sumner-Lyttelton Corridor where the risk was assessed to be higher than medium, some form of remediation or rockfall protection structure was required. This paper focuses on two of the high risk sections on Wakefield Avenue (below the highlighted areas in yellow and red in Figure 1).

GNS carried out slope stability modelling of the cliff collapse hazard at the northern end of the site for the 10 individual cliff collapse sources (red and black areas in Figure 1) and identified the potential run out distance of slip material and debris. To determine the energy level and bounce height of boulders that could impact a protection structure during a cliff collapse event, rockfall modelling was undertaken. The 95<sup>th</sup> percentile boulder for modelling the cliff collapse scenarios was assumed to be the largest mapped boulder that was generated from the cliff collapse, which was 8 m<sup>3</sup>.

percentile boulder size for the rockfall hazard in Sumner (yellow areas in Figure 1) was 3 m<sup>3</sup> (Massey et al. 2012a).

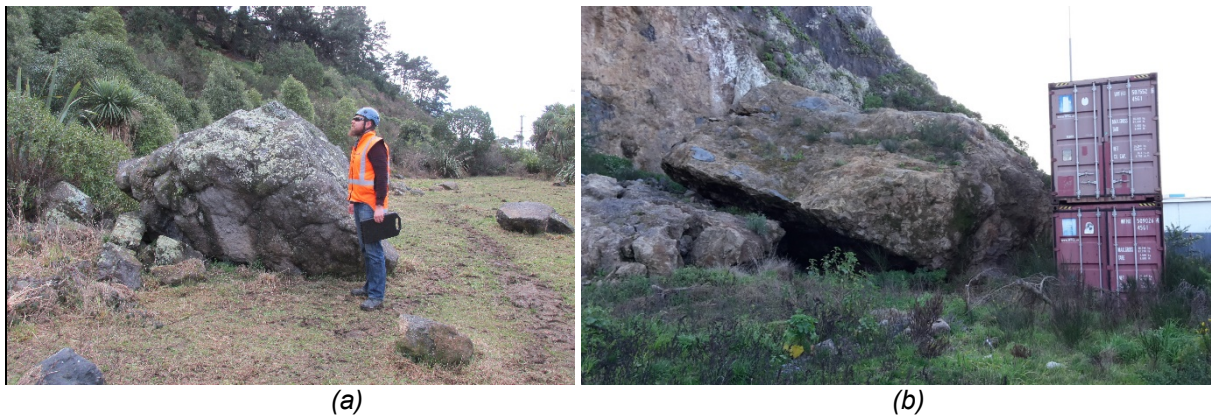
Figure 2. (a) This boulder is approximately 3 m<sup>3</sup> and is the result of rockfall from the continuous bluffs at the southern end of Wakefield Avenue; (b) This boulder fell as a result of the cliff collapse at the northern end of Wakefield Avenue. The boulder has landed at the base of the cliff immediately below where it was located; it has not rolled out towards Wakefield Avenue.

The majority of the work undertaken on site prior to Jacobs's involvement centred around GPS mapping of rockfall boulders and some at source remediation of rockfall hazards. After the 22 February 2011 event, contractors undertook at source remediation of the continuous bluffs at the southern end of the site, including blasting and rolling loose boulders to the bottom of the slope. The highly fractured nature of the bluffs made this kind of at source remediation difficult, as removing unstable material at the surface often uncovered more unstable material behind. Jacobs mapped fallen boulders – refer Figure 2(a) and (b) – to identify run out distances and sizes of the boulders which were compared to the information used in the GNS pilot study (Massey et al 2012a) to determine what size boulders the remediation solution would be required to stop. It was difficult to determine which boulders fell as a result of the earthquakes and which had fallen from the source treatment works. Regardless, they all provided information on the size of boulders and run out distances that could be expected at road level.
