Design and construction of a commercial building on a closed municipal solid waste landfill in Takapuna, Auckland

ABSTRACT

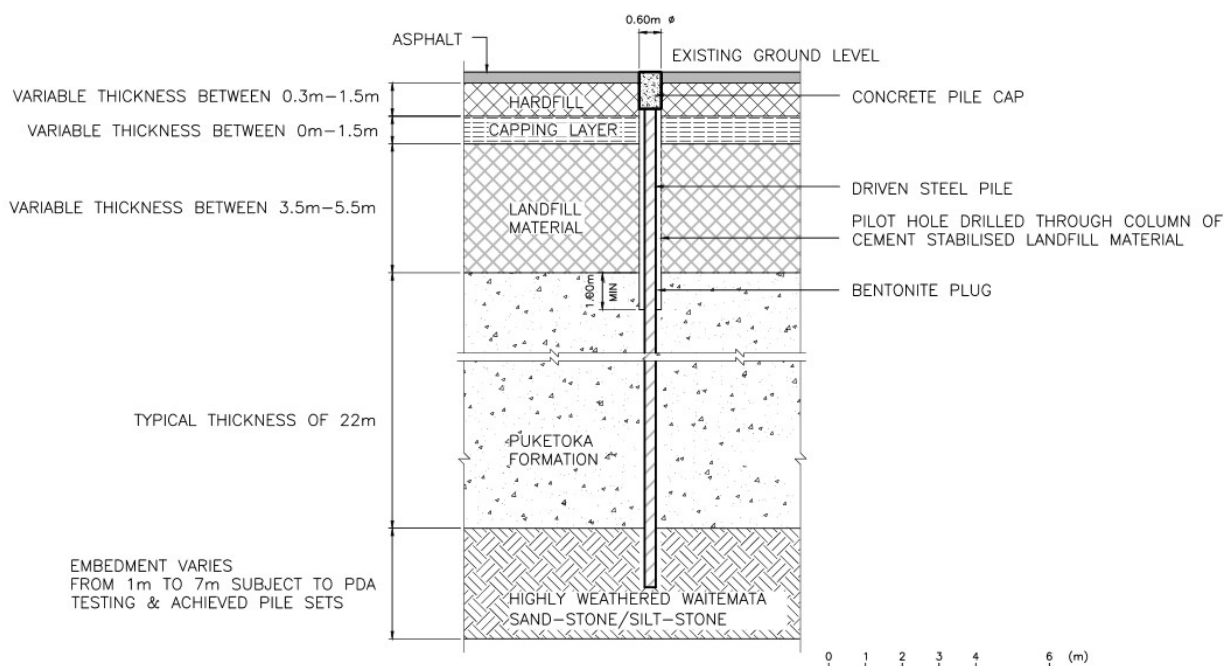
Figure 2. Typical pile cross section

In consultation with the piling contractor, an installation methodology combined of pre-drilling and driving was developed. All pile holes were pre-drilled to approximately 1m depth into the natural ground beneath the refuse (i.e. approximately 7.5m depth below the existing ground surface), and backfilled with low-strength concrete. This methodology not only provided a solution to the challenges, but also prevented both leachate entering the natural soils, and landfill gas escaping into the construction site. A smaller diameter pilot hole was then augered through the low-strength concrete to the bottom of the backfill. The steel H-pile was lowered vertically into the pilot hole, and driving commenced at 7.5m depth below ground surface. Figure 2 presents a typical pile cross section.

The foundation design involved 39 driven steel H-piles of varying size and length. The pile size ranged from 310 UC158 to 200 UC46, and extended to an average of 30m depth below the existing ground surface. All piles were connected by a network of ground beams to resist lateral loads. Pile corrosion was addressed by allowances in steel thickness for uncoated steel and coating protection systems.

The upper portion of each pile, approximately 10m in length was then painted with a high performance epoxy coating to provide protection against severe corrosion within the landfill layer. A minimum of 100mm cover of the low-strength concrete backfill was allowed around the steel piles over the pre-drilled depth to further minimise corrosion. In addition, pile driving analyser testing with CAPWAP analysis was undertaken on approximately 15% of the piles.

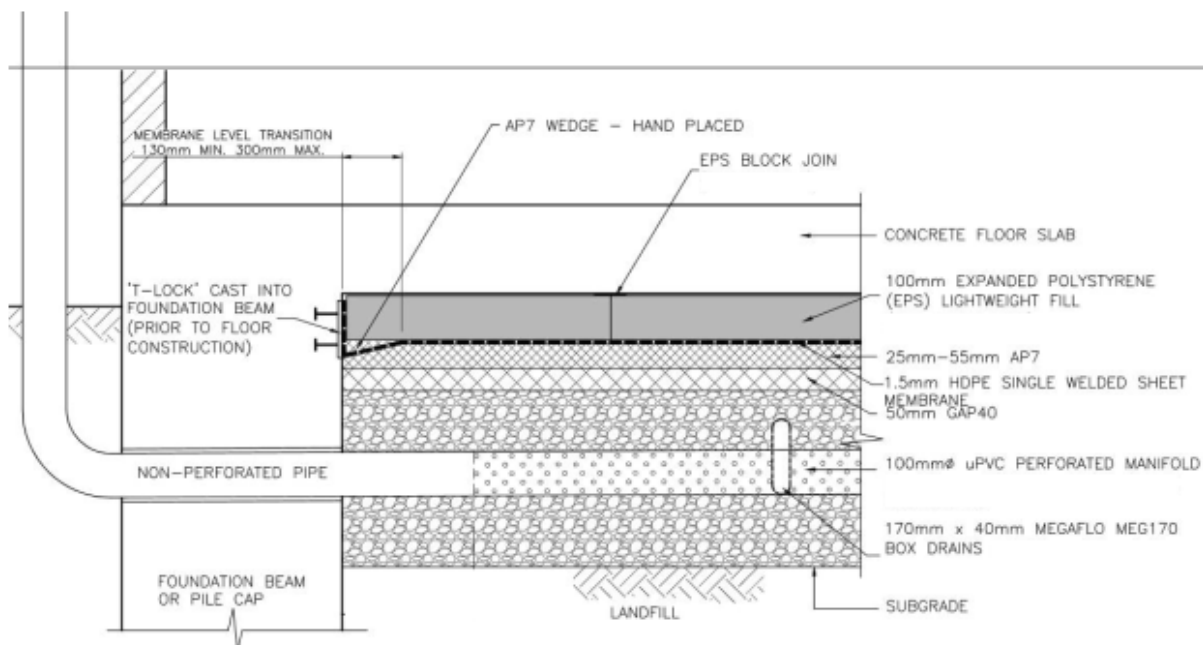
Figure 3. Typical details of Area 1 passive ventilation

Design of the Area 1 gas protection system includes a continuous subfloor passive gas collection network and an intact gas resistant HDPE membrane beneath the ground floor slab. The gas collection network consists of perforated manifold pipes, falling at a gradient of 0.5% towards vent stacks located between Areas 1 and 2. Box drains, connected perpendicularly to the manifold pipes at regular intervals, are incorporated into the design in order to maximise the area of influence. The manifold system is buried within a layer of granular materials, which provides a pathway for the landfill gas to migrate into the system. The landfill gas is directed and discharged via rotary ventilators on the building's roof. The HDPE membrane was placed above the granular layer. The membrane was designed to be welded to polyethylene brackets ('T-locks') that were pre-casted into the foundation ground beams. Figure 3 shows typical details for the gas membrane and subfloor passive ventilation within Area 1.

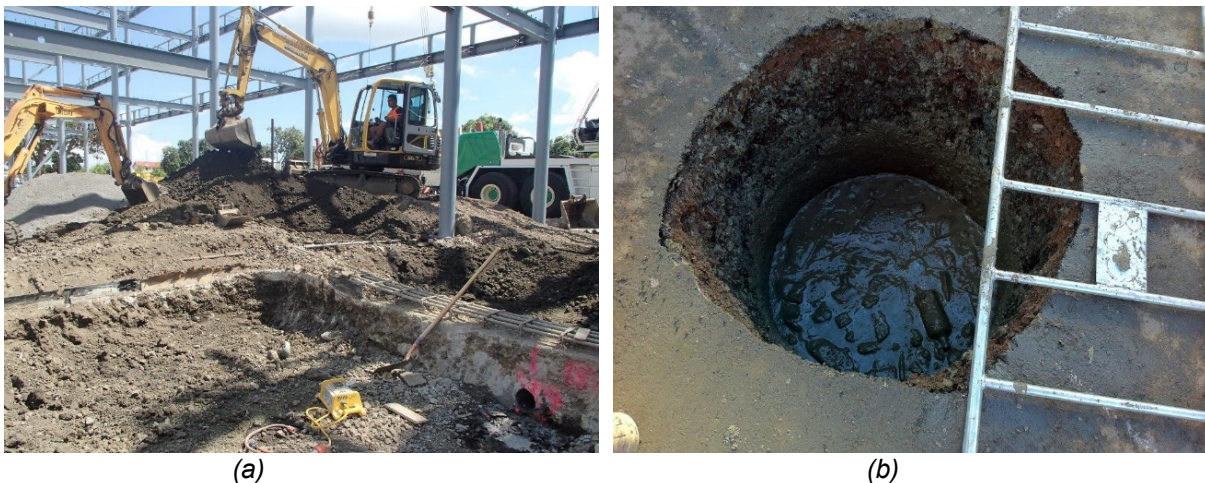
Floor levels were positioned to minimise excavation into the refuse. However, due to the highly variable thickness of the landfill cap (which is not consistently in place across the site), it was difficult to predict the volume of excavation into the refuse during ground works. Large amounts of refuse, consisting of bottles, glass, metal pieces, plastic, etc., along with a strong odour were encountered during site excavations – refer Figure 4(a) and (b).

Figure 4. (a) Excavation within landfill; and (b) Landfill refuse observed

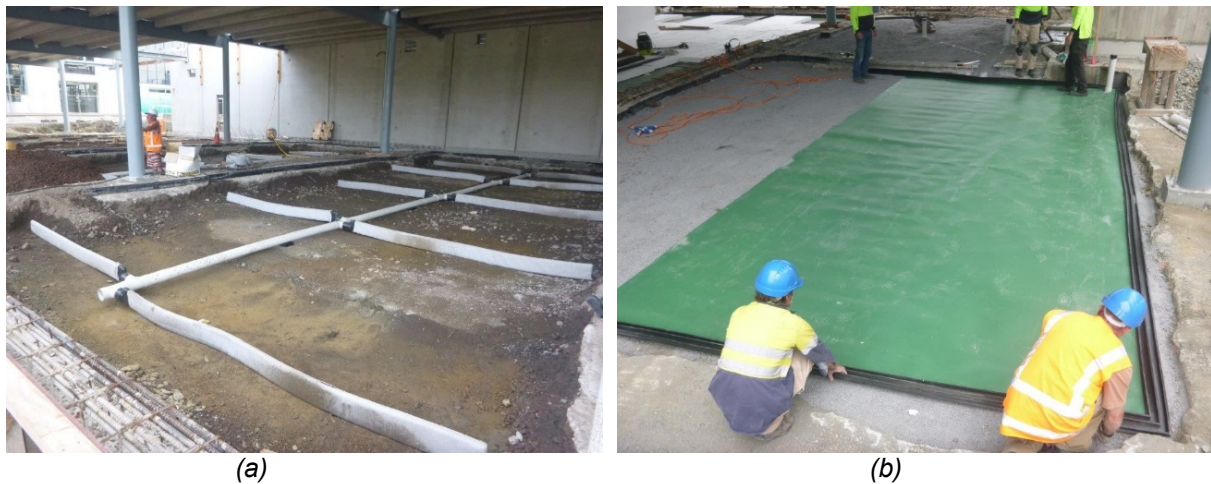
The subgrade for the gas manifold system was prepared by removing all sharp objects on the surface and proof-rolling. On completion of the subgrade preparation the manifold pipes were assembled within individual foundation compartments (divided by ground beams). To accommodate the slight difference in size and shape of each compartment, the length and space of the drains and pipes were adjusted on-site, under the instruction of the Engineer. Figure 5(a) shows a typical alignment of an assembled manifold system, prior to placement of the granular venting layer. The top blinding layer was hand placed to ensure a smooth finishing surface for the HDPE membrane.

The HDPE membrane was installed by a specialist contractor under full time observation of the Engineer to ensure the manufacturers' requirements for the gas membrane were correctly adopted and the membrane was undamaged. Extrusion welding, a technique that 'glues' HDPE materials together by using hot polyethylene, was utilised to weld the HDPE membrane to the T-locks. Quality control, via spark testing (electrical current passed through copper wire to generate spark), was undertaken on completion of membrane placement within each compartment, to detect if there were any unsealed/damaged spots.

Figure 5. (a) Gas collection network; and (b) Placement of HDPE membrane

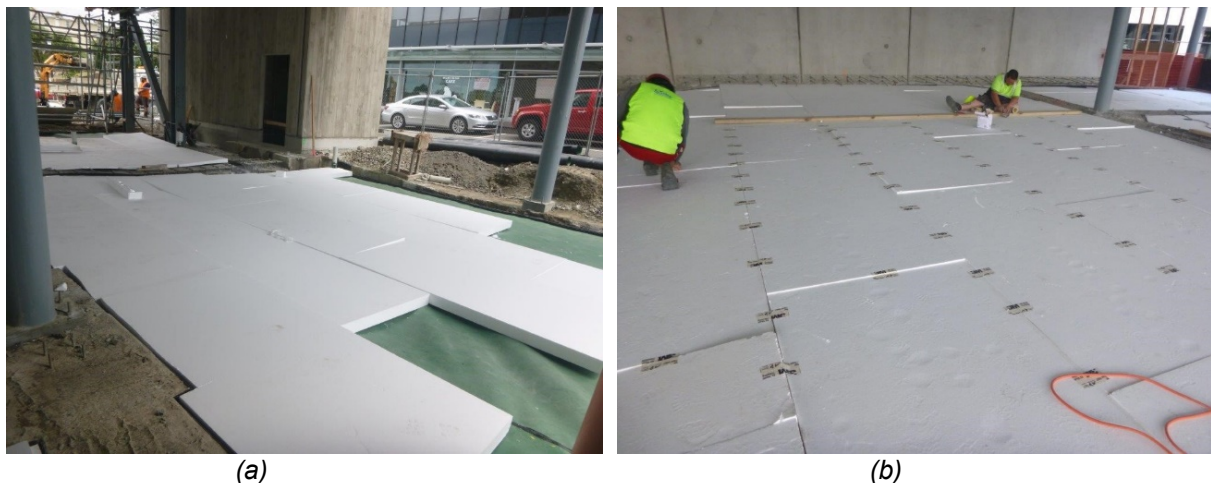
It was noted by the Engineer that the membrane (which had been installed and tested) was regularly damaged by site personnel. Frequent repair (in conjunction with re-testing) of the membrane was time consuming and could reduce the performance of the gas membrane. Following numerous discussions with the site contractor, placement of blocks of expanded polystyrene (EPS) lightweight fill on top of the membrane was considered the most practical solution to prevent further damage – refer Figure 6(a). The lightweight fill blocks were closely butted and taped to further minimise physical contact with the HDPE membrane, as shown in Figure 6(b). Subsequently the HDPE membrane remained undamaged.

Figure 6. (a) EPS fill on HDPE membrane; and (b) Closely taped EPS fill
