# 3D terrain and geological modelling for the design of a cut slope in Wellington

A 3D terrain and geological model has been used to assist in the design of a cut slope for a proposed house in Wadestown, Wellington. The natural slope of the site is  $\sim 30^\circ$  and consists of colluvium overlying fractured greywacke. A 3D geological model was built from site investigation data, a topographical survey, and from point cloud data generated via photogrammetry (utilising photographs obtained by a UAV). The 3D model was analysed using TSLOPE; a 3D limit equilibrium slope stability package. This enabled calculation of the appropriate parameters for design of slope reinforcement.

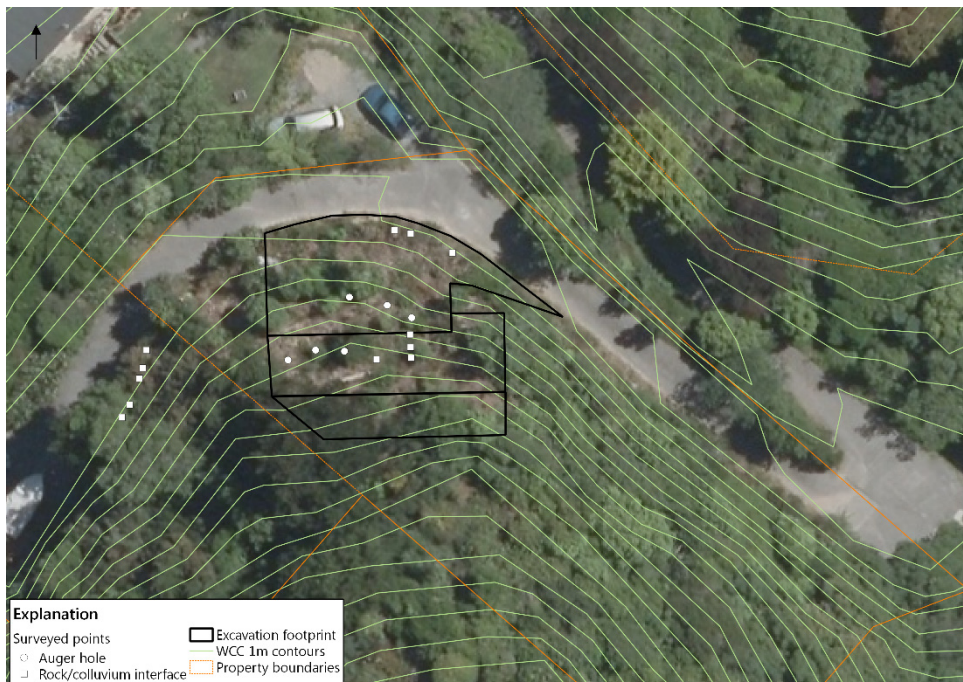
Figure 1. Topography, auger holes and surveyed rock/colluvium contacts

This paper outlines a methodology for deriving the design parameters for an appropriate slope retention system for a largely unmodified, north facing ridge in Upper Wadestown, Wellington. The site was originally covered by sparse bush/scrub that was cleared before investigations commenced. The site slopes much more steeply to the north-east than to the north. It is the north facing part of the site which will be excavated to accommodate a house over three levels (Figure 1).

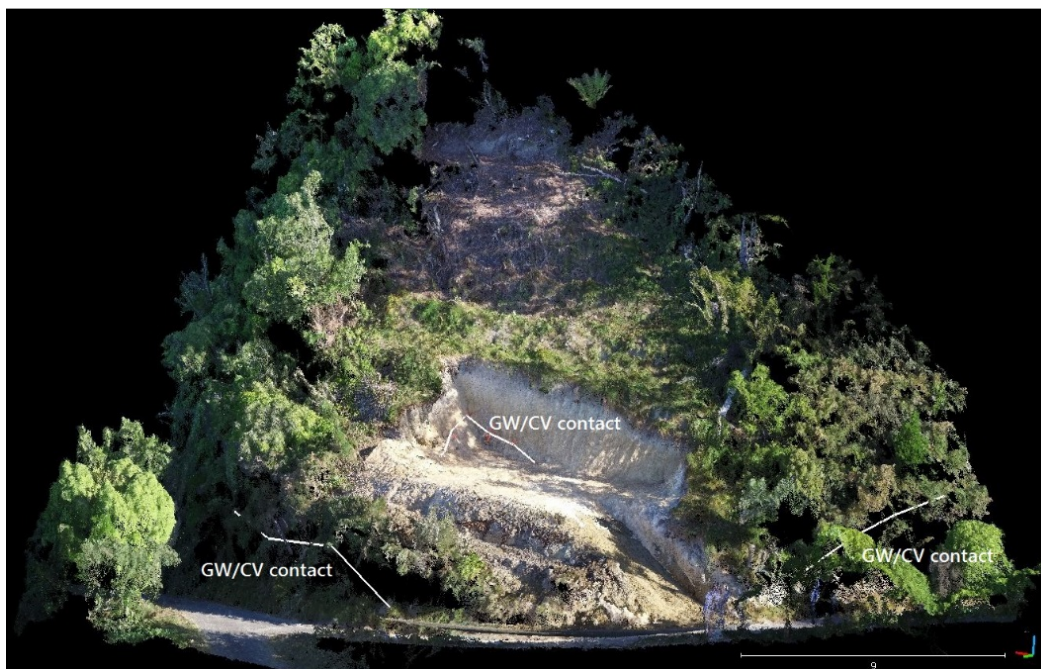
Figure 2. The resultant 22,609,500 point, 3D point cloud showing the excavated bench.

The photos taken by the UAV were processed using Pix4D (Pix4D, 2016). This program uses geolocation data and photo stitching algorithms to generate a highly accurate 3D point cloud (Figure 2) and an orthomosaic image of the site.

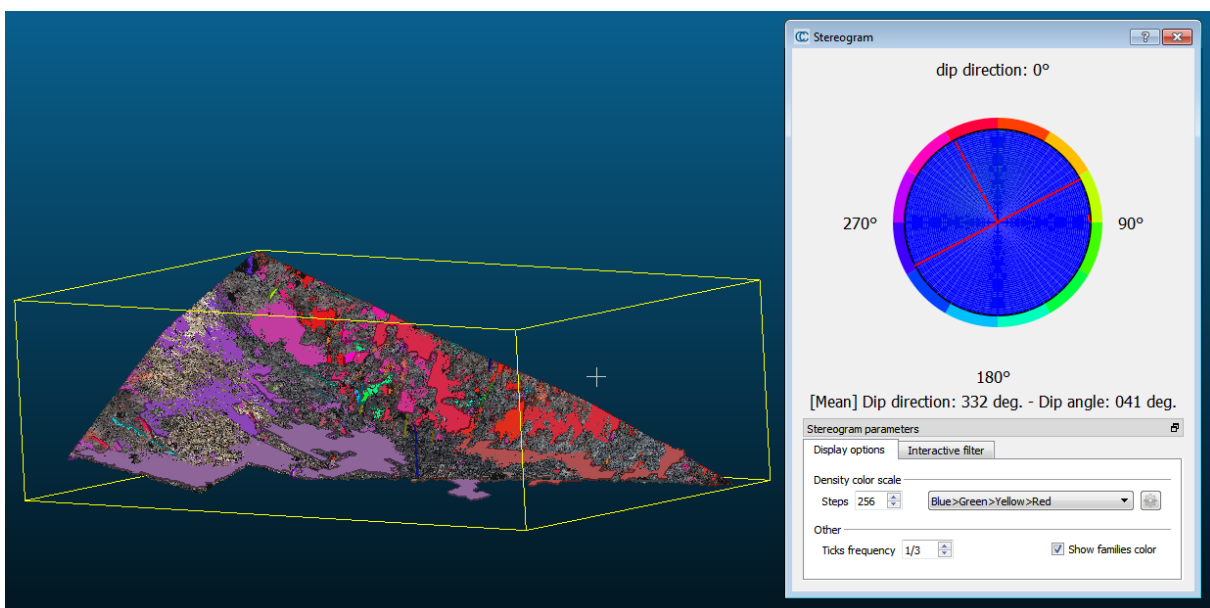
Figure 3. CloudCompare fracture orientation and stereonet

The area of exposed rock was segmented out of the point cloud using CloudCompare for fracture analysis. CloudCompare generated a stereonet from the point cloud giving us mean joint direction and mean joint angle (Figure 3).

The stereonet results compared well with those compiled from field measurements ([Mean] Dip direction: 316 deg. – Dip angle: 041.5 deg.) Although these measurements correlated well, due to the highly fractured nature of the rock it was decided that there were no clear trends to the fracturing and this will not be used in the stability analysis.

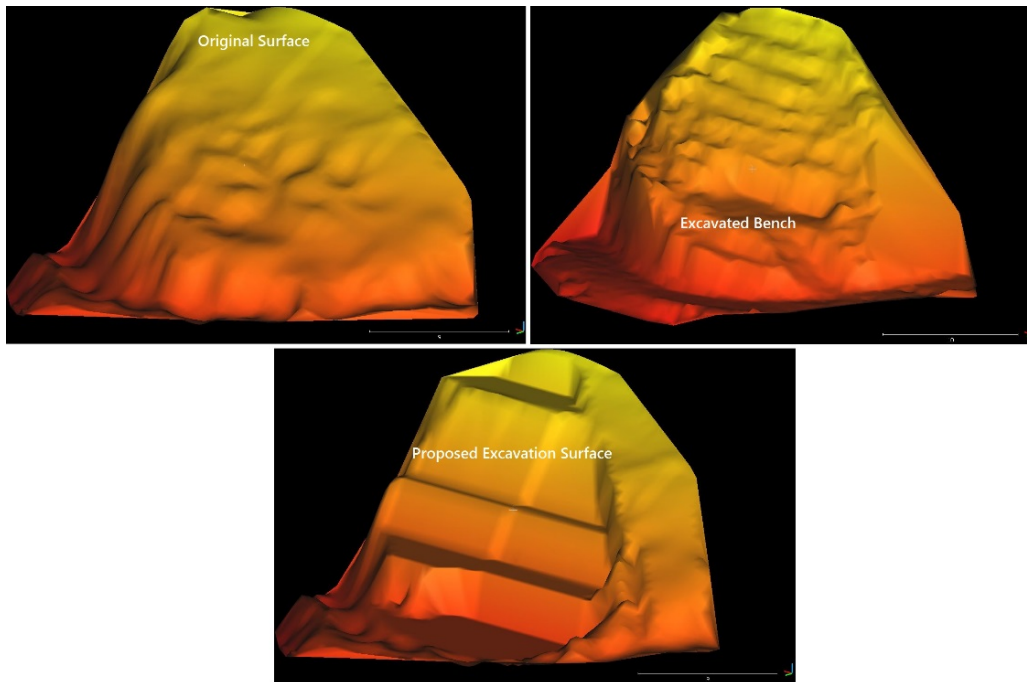
Figure 4. 'Original', 'current' (showing the bench excavated for investigation) and 'proposed' ground surfaces

On the completion of investigations and modelling we had; an accurate 'original' topographical surface, an accurate 'modified' topographical surface, an accurate 'proposed' excavation surface and an inferred greywacke/colluvium interface (Figures 4, 5). We also had highly detailed aerial imagery, a segmented point cloud representing freshly cut greywacke and some guidelines for material strengths. We now had the information required to model the slope.

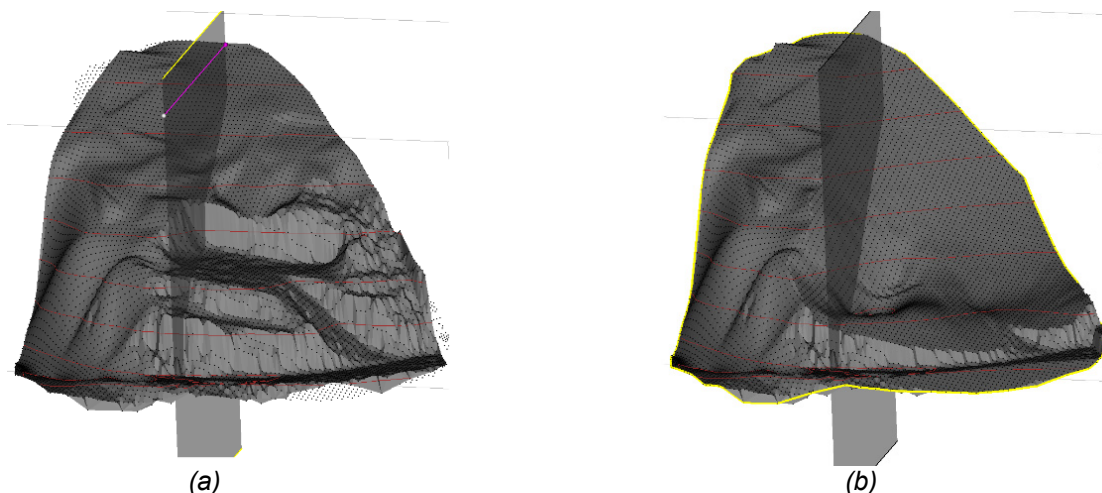
Figure 5. (a) Current slope; and (b) GW / CV interface, showing cross-section line

A stability analysis was performed using the colluvium strengths recommended by Davidge (2007). Figure 5 shows the current slope and the colluvium/greywacke interface located beneath the current surface. Figure 6 shows the slope in cross-section.

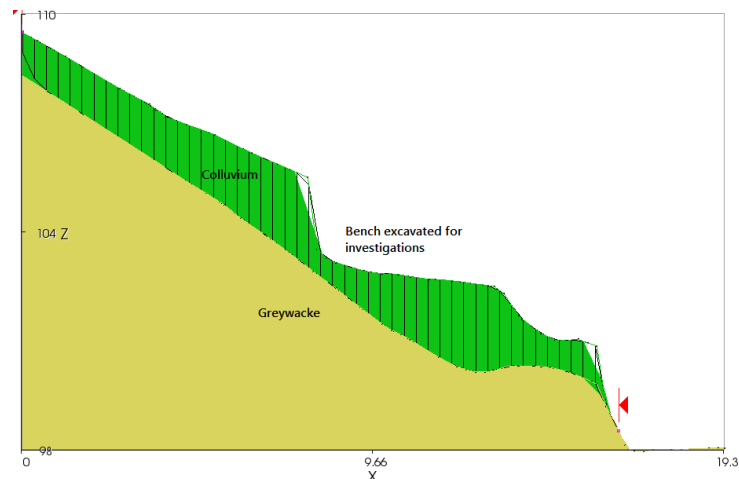
Figure 6. Cross-section showing slope failure controlled by greywacke/colluvium contact

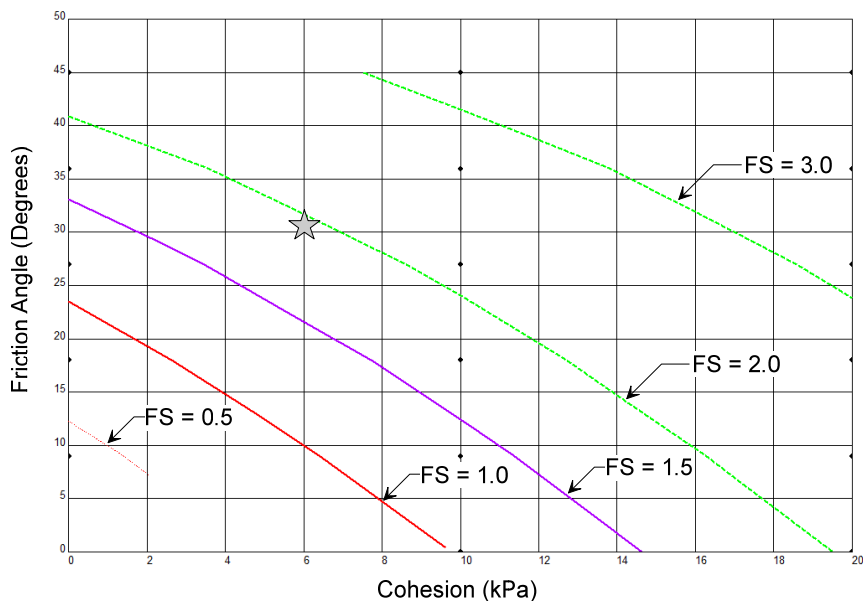
Figure 7. Cross plot of friction angle versus cohesion for a range of factors of safety. The star indicates Davidge (2007) parameters.

A back calculation was performed using the 'current' slope geometry. The strengths from the back calculation (Figure 7) show that Davidge's (2007) parameters may be non-conservative and therefore inappropriate to use for a forward analysis of the excavated slope. A more appropriate strength to use in forward analyses may be picked from the red line on Figure 7 indicating a factor of safety of 1.0.
