IMPACT OF ZERO BOND TO ROCK ON SHOTCRETE LINING DESIGN

Erik Stefan Bernard¹ and John C. Braybrooke²

ABSTRACT

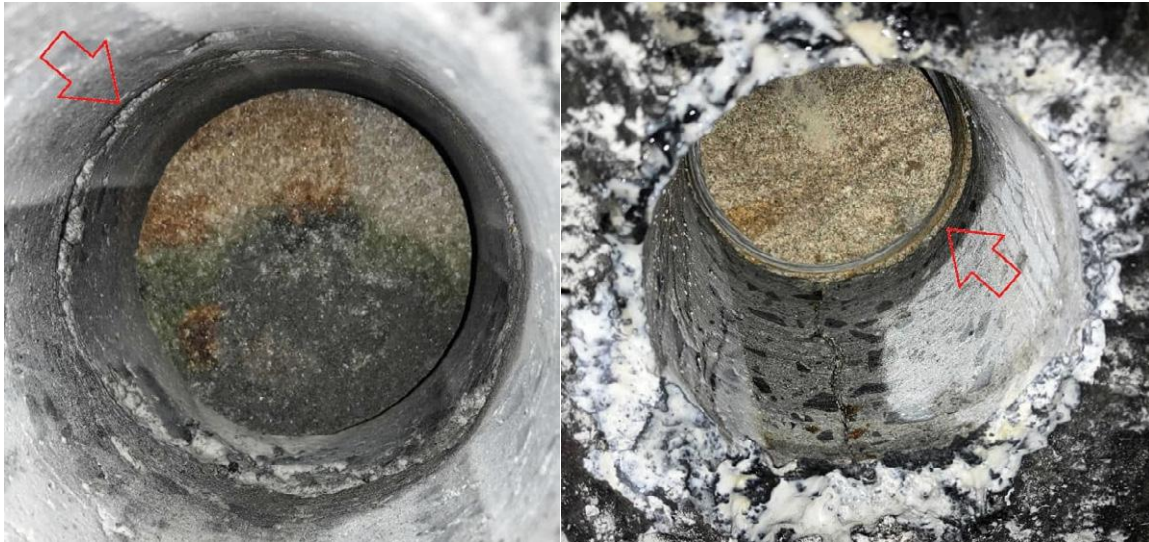
Figure 1: Examples of delamination zones evident in core holes a) inside shotcrete, and b) at the shotcrete/substrate boundary, leading to zero bond strength results.

Zero bond results may indicate an actual absence of bond (e.g., Figure 1) or may be due to the coring and testing process. Simply dismissing zero bond results as an artefact of the testing process is an unconservative approach that would never be tolerated for other structural parameters such as compressive strength. One therefore needs to consider the causes of zero bond more thoroughly and investigate the effect that an actual absence of bond has on the structural resistance of a shotcrete lining.

then the ‘zero’ result must be counted as valid (Figure 1). An endoscope may be useful for this purpose. Even if a gap is not visible at the substrate boundary, profuse dripping of water after coring may indicate that a narrow delamination plane exists.

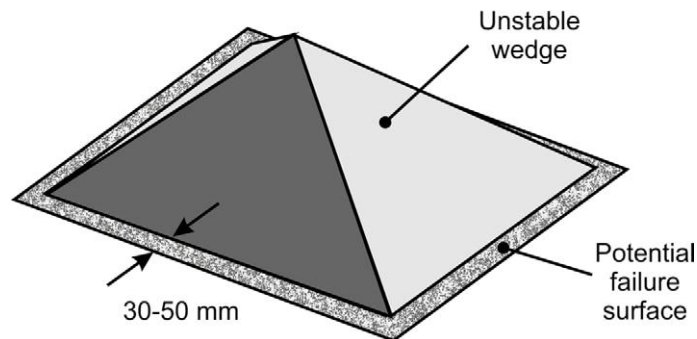
Figure 2: Bond failure zone around falling wedge, according to Barrett and McCreath (1995) based on work by Fernandez-Delgado et al (1975) and Holmgren (1987).

The significance of adhesion is illustrated by the following example in which lining capacity is assessed according to the method by Barrett and McCreath (1995). For a lining of thickness t and orthogonal bolt spacing s , with shotcrete shear strength τ , the direct shear resistance V around a square failure zone (Figure 2) is found as

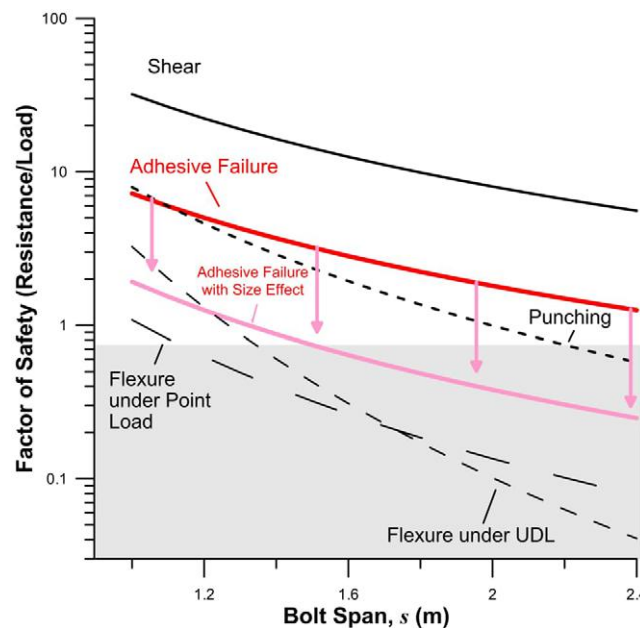
Figure 3: Factor of Safety on failure by various modes for a 75 mm thick shotcrete lining of between 1.0 and 2.4 m bolt span, calculated using method by Barrett and McCreath (1995).

If we take $\tau = 2.0$ MPa, $f_t = 3.0$ MPa, $f_b = 0.5$ MPa, cover plate side length to be 200 mm, and assume the adhesive width w_a around the unstable wedge to be equal to the thickness of the lining, we obtain the series of plots of Factor of Safety (FOS, based on unadjusted resistance/load) against bolt spacing s for the failure modes represented by Equations 1 to 6 shown in Figure 3. The direct shear resistance (solid black line) is clearly greater than the load to cause adhesive failure (red line) around the periphery of the unstable wedge. Punching around the cover plates offers a lower FOS but does not have an adhesive failure limit when the plates are on the outside of the shotcrete lining or are physically attached to the shotcrete. In contrast, the flexural modes of failure offer a lower degree of load resistance. For the case shown, adhesion to the substrate is maintained across the entire range of bolt spans so the lining can be taken to support the wedge in shear. However, there may be some problem with punching around the bolts for spacings greater than 2.2 m. Similarly, if the peripheral bond strength is diminished in some way then the likelihood of flexural failure is increased. A similar set of curves can be generated for other wedge shapes and failure zones.

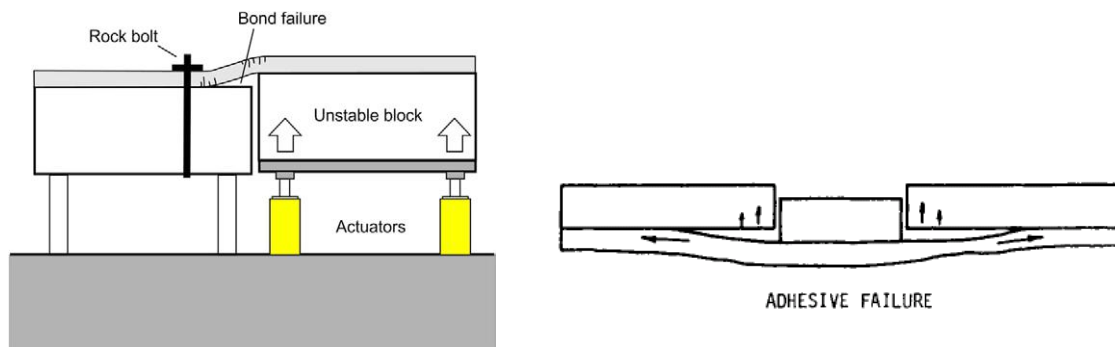
Figure 4: a) Adhesive failure in falling block test used by Holmgren (1987) to assess shotcrete lining capacity, and b) Fernandez-Delgado et al (1975) tests to assess shotcrete lining capacity.

Adhesive failure primarily involves separation of the lining and substrate by peeling action (Figure 4b). Peeling is the process by which tensile failure occurs at an adhesive surface that is eccentrically loaded. Eccentric loading is known to have a deleterious effect on the apparent tensile strength of concrete; that is why bond tests such as EN1542 and SS137243 have been developed to eliminate eccentric loading and achieve an ‘optimal’ bond strength estimate (see the Appendix for a more detailed discussion of available bond test methods and their limitations). However, ground loads are usually applied to shotcrete in an eccentric manner with the result that a peeling mode of failure is more likely than direct tension. Moreover, peeling is more likely to occur at an interface of regular geometry (typical of excavations made using a road header or TBM) than irregular geometry (such as blasted rock surfaces) because geometrically regular surfaces exhibit fewer physical obstacles to the propagation of a long splitting crack.

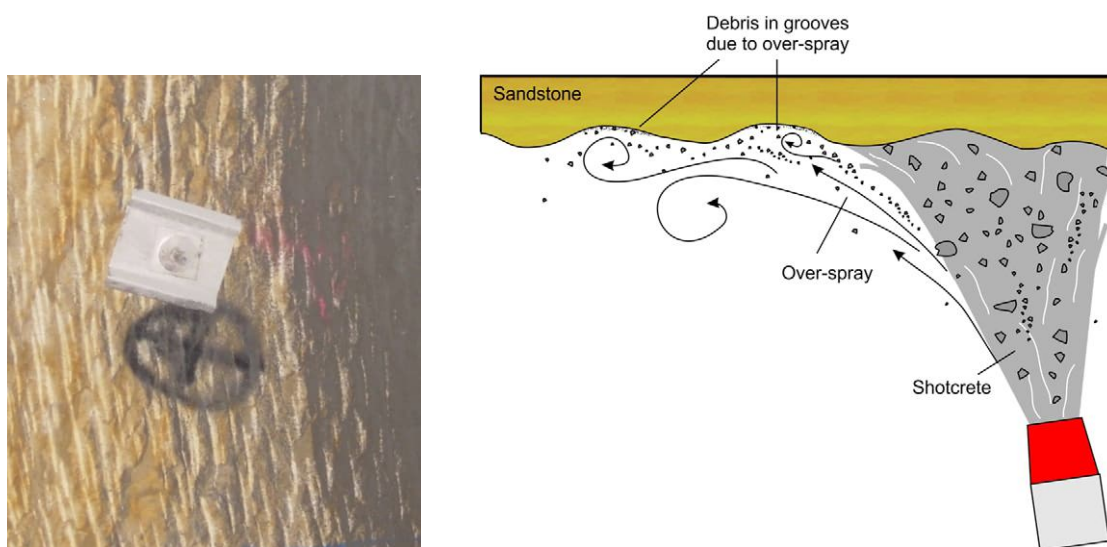
Figure 5: a) Accumulation of loose over-spray in pick grooves, and b) adjacent to an active spraying area.

Each of these phenomena are associated with the characteristic grooves that are left in the surface of the rock following excavation by road header (Figure 5).

Accumulation of Over-spray in Grooves. Even if the surface of the excavated rock is carefully cleaned prior to spraying, the spraying process itself can lead to over-spray associated with the shotcrete jet accumulating as loose debris in adjacent grooves (Figure 5). This over-spray consists of small loose particles that rapidly dry out and form an unconsolidated layer at the base of each groove that later acts as an initiation point for cracks.

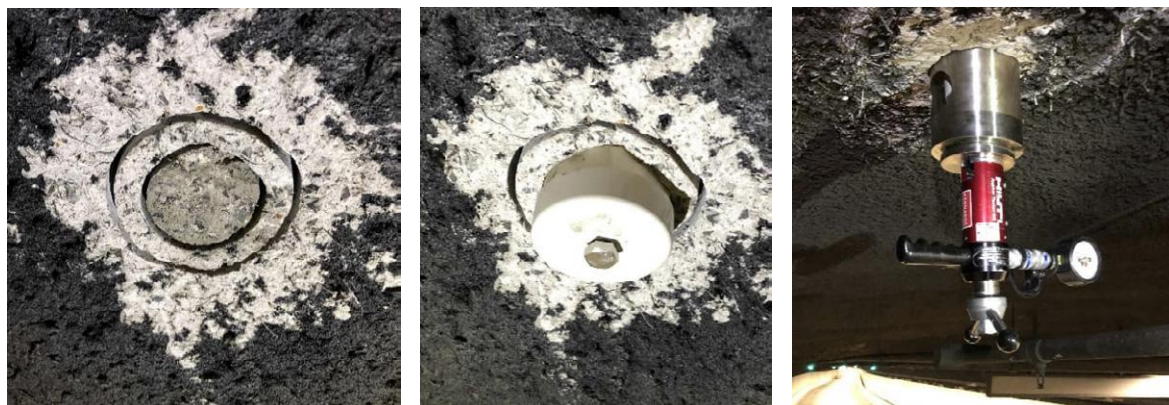
Figure A1: In situ testing of bond strength using a) drilled concentric core holes, b) mounting of a glued dolly to the end of a partially drilled core, and c) pull-testing, similar to the SS137243 test method.

Swedish Standard SS137342 is the only actual standard in existence specifically for testing the bond between a layer of shotcrete and its substrate. It differs significantly from earlier guidelines and specifications in that it requires a double-core bit to drill an over-sized round groove around the primary core so that a chuck can be mounted concentrically over the sample to be pulled (Figure A1). This method is more detailed and better thought-out than the EFNARC specification for ensuring that eccentric loading is eliminated from the load train.

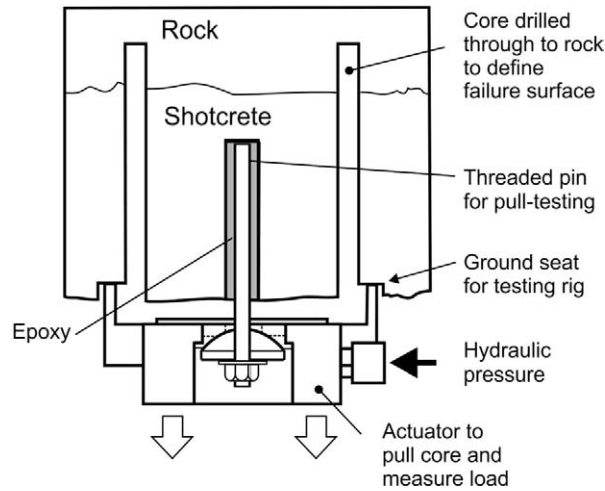
Figure A2: Test configuration similar to that described by Holter (2015) for pull-testing with drilling and surface grinding completed prior to installation of pull-pin in central hole.
