GEOTECHNICAL CHALLENGES OF A DEEP BASEMENT EXCAVATION: A CASE STUDY

Michael Egan, Andrew Jackaman & Ali Parsa-Pajouh
JK Geotechnics, Sydney, Australia

ABSTRACT

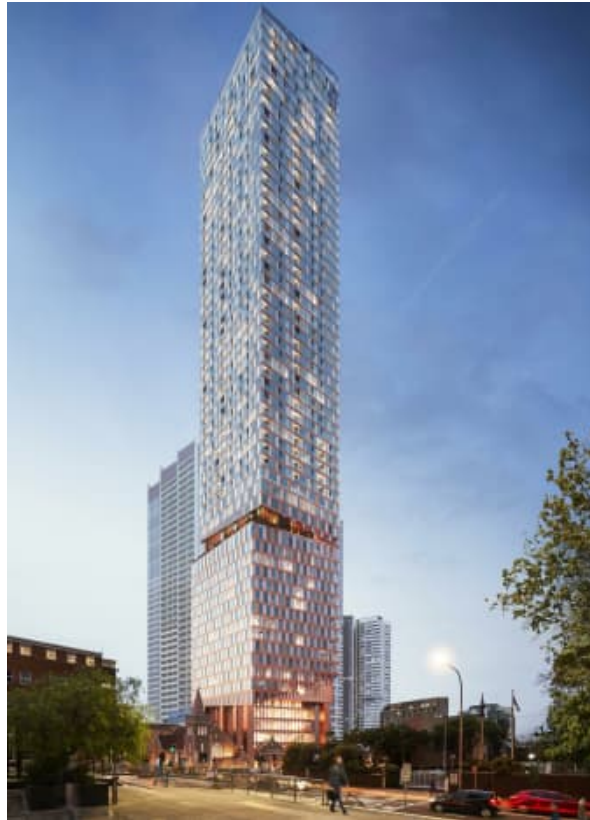
Figure 1: Rendered image of the proposed 59 storey tower (image courtesy of Woods Bagot)

Construction of a 198m high, 59 storey tower overlying nine basement levels is currently underway in Parramatta, NSW. Figure 1 presents a rendered image of the proposed tower. The site is roughly rectangular in plan area being approximately 48m long by 30m wide. The almost 100 year old 'St Andrew's Church' abuts the western site boundary. The original church hall and a five storey office building were located within the site. Due to heritage constraints, the front facade of the church hall needed to be retained as part of the development.

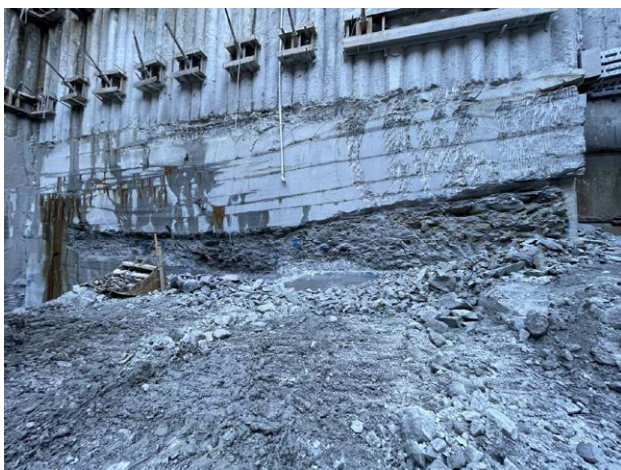
Figure 7: Upper shear zone exposed along the northern elevation

During these inspections, the upper shear zone observed within the neighbouring basement excavation and confirmed during the detailed geotechnical investigation was encountered in the cut faces at the northern end of the basement excavation. The fractured, gouged and extremely weathered material within the shear zone was expected to soften and potentially spall/topple from the cut faces if left unsupported, both in the short and long-term. As a result, the upper shear zone was stabilised with reinforced shotcrete and rock bolts. Other potentially unstable blocks or wedges of rock that had been isolated by inclined joints and/or sub-horizontal partings, seams etc. were identified and removed from the cut faces, as necessary.

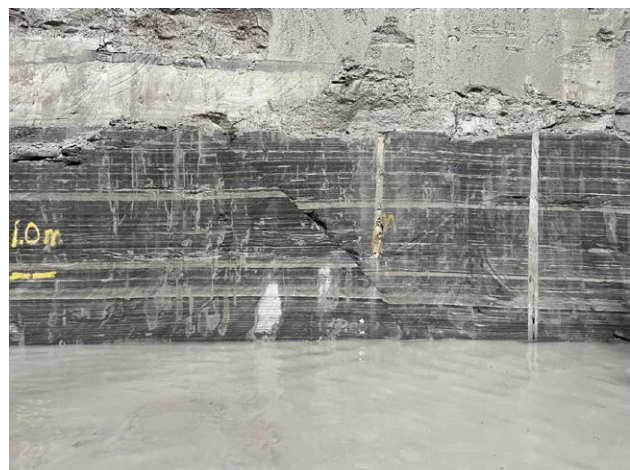
Figure 8: Localised fault within the laminite bed along the southern elevation

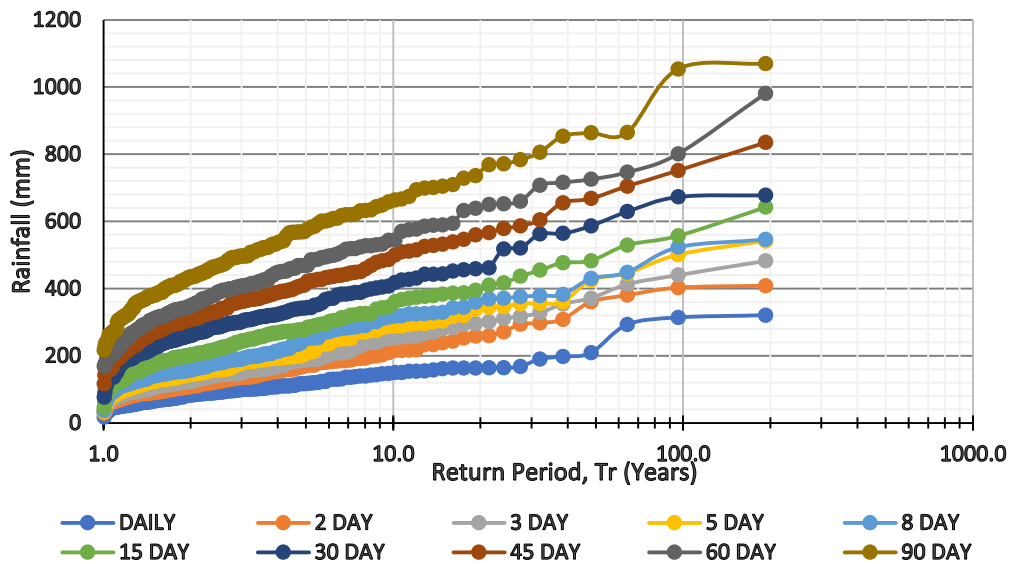
Prior to the commencement of the micro-pile and rock anchor design (completed by others), and in an effort to reduce the design head of water which was considered overly conservative, a detailed rainfall analysis of daily and antecedent rainfall (2 day to 90 day) events was prepared from available rainfall records for the period between 1 January 1832 and 28 March 2022. The rainfall data was obtained from the Bureau of Meteorology’s (BOM) rainfall records for their nearby monitoring stations. A Gumbel probability plot showing the predicted return period for daily and antecedent rainfall events in Parramatta was prepared and is shown in Figure 12 below.

Figure 12: Probability plot of actual rainfall and antecedent rainfall between 1 January 1832 and 28 March 2022

From Table 5, the highest recorded groundwater level at the site was RL5.99m (i.e. JK107). This level was recorded during a 1 in 38.4 year, 1 in 48 year & 1 in 64 year rainfall event for 45, 60 & 90 day rolling totals, respectively. As outlined above, the highest recorded groundwater level in JK107 was considered to be partially elevated due to a leaking sewer pipe and ponded water, which may have infiltrated into the standpipe piezometer. Notwithstanding this, for the historical daily rainfall events and recorded groundwater levels presented in Table 5, it was postulated that a 1 in 100 year rainfall event at the subject site could temporarily raise groundwater levels up to a maximum of approximately RL7.0m.
