REDEVELOPMENT OF HERITAGE BUILDINGS IN SYDNEY: CASE HISTORY OF COMPLEX UNDERPINNING AND SUPPORT WORKS

Juno Liang and Jeremy Toh
PSM, Sydney

ABSTRACT

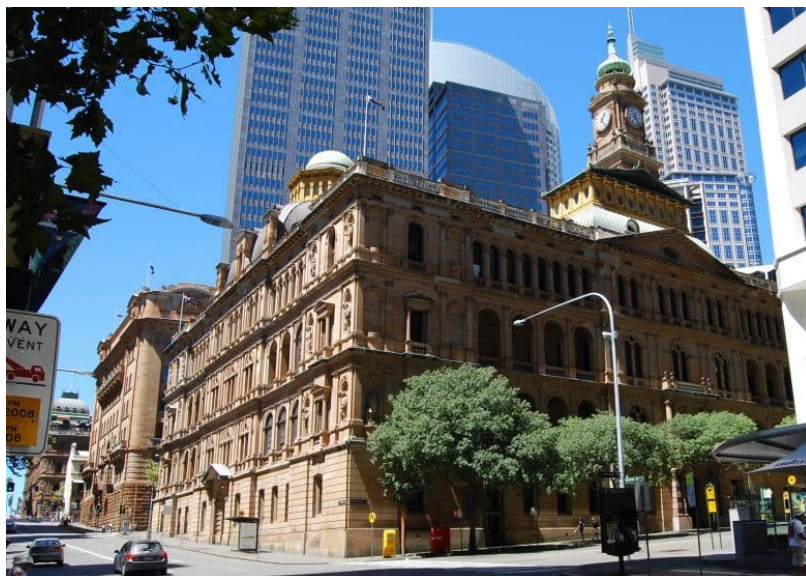
Figure 1: Photograph of existing heritage sandstone buildings being redeveloped

- The Victorian-style building façades, crafted from sandstone blocks and adorned with classical sculptures and arched windows
- A significant feature on the Bridge Street façade is the Lands Department Datum Benchmark Plug, which served as the origin for all survey levels in New South Wales
- The central clocktower rising to a height of 5 storeys
- Moat walls surrounding the perimeter of the building basement on Gresham, Bridge and Loftus Street to provide essential light and ventilation to the basement

- Adjacent to the western side of the shaft, a clocktower that extends above the top of the building (Figure 1:) and imparts a bearing pressure of over 1000 kPa.

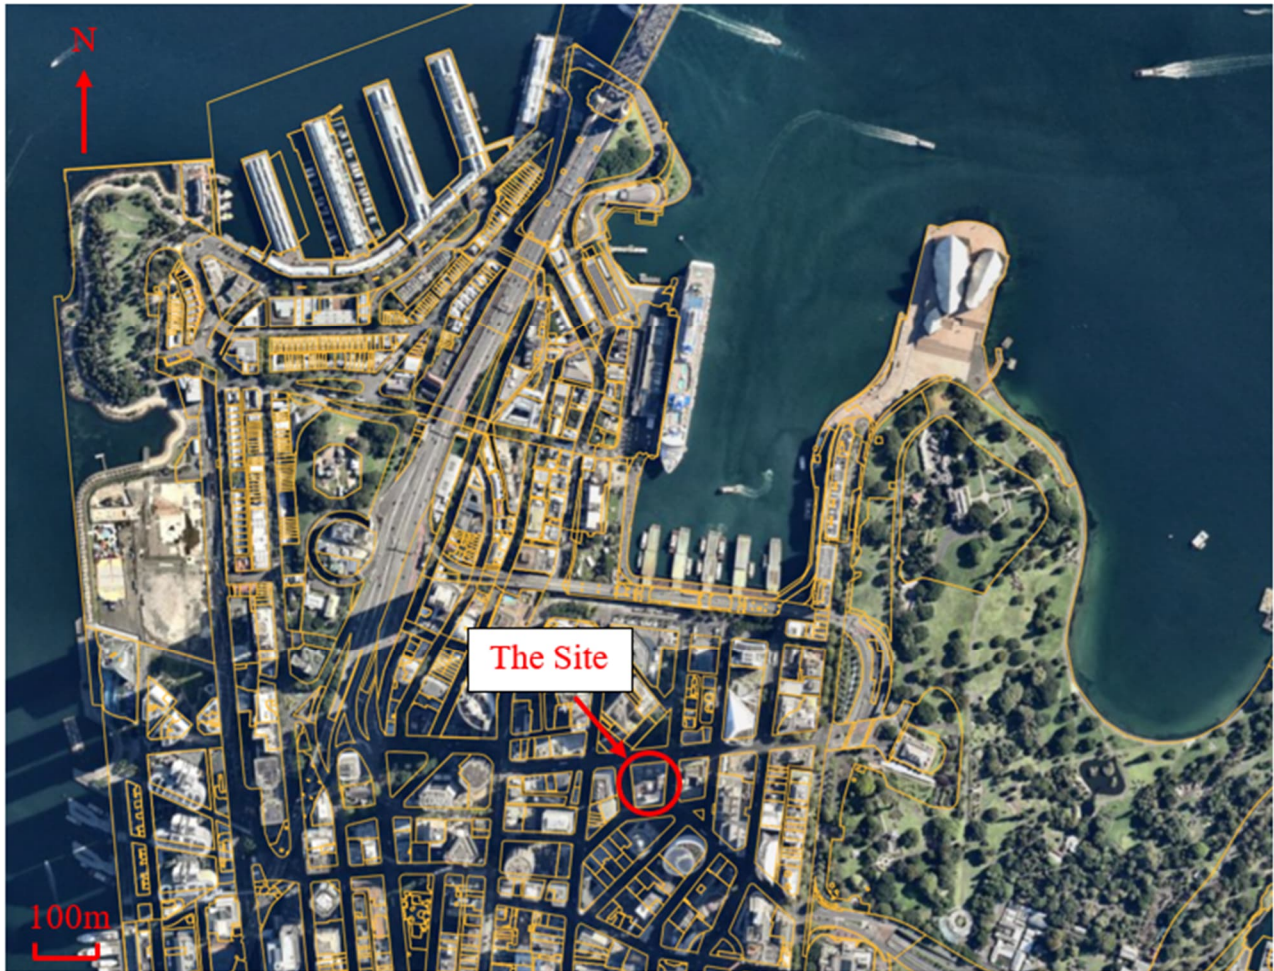
Figure 2: Site locality

The site is located in the northern part of Sydney's CBD close to Circular Quay (Figure 2:), on a block bounded by Bridge, Loftus, Bent, and Gresham Streets. The four-storey sandstone building was built around 1880 and historically was occupied by the NSW Department of Lands. Until as recently as 2016 it was occupied by the NSW Department of Planning.

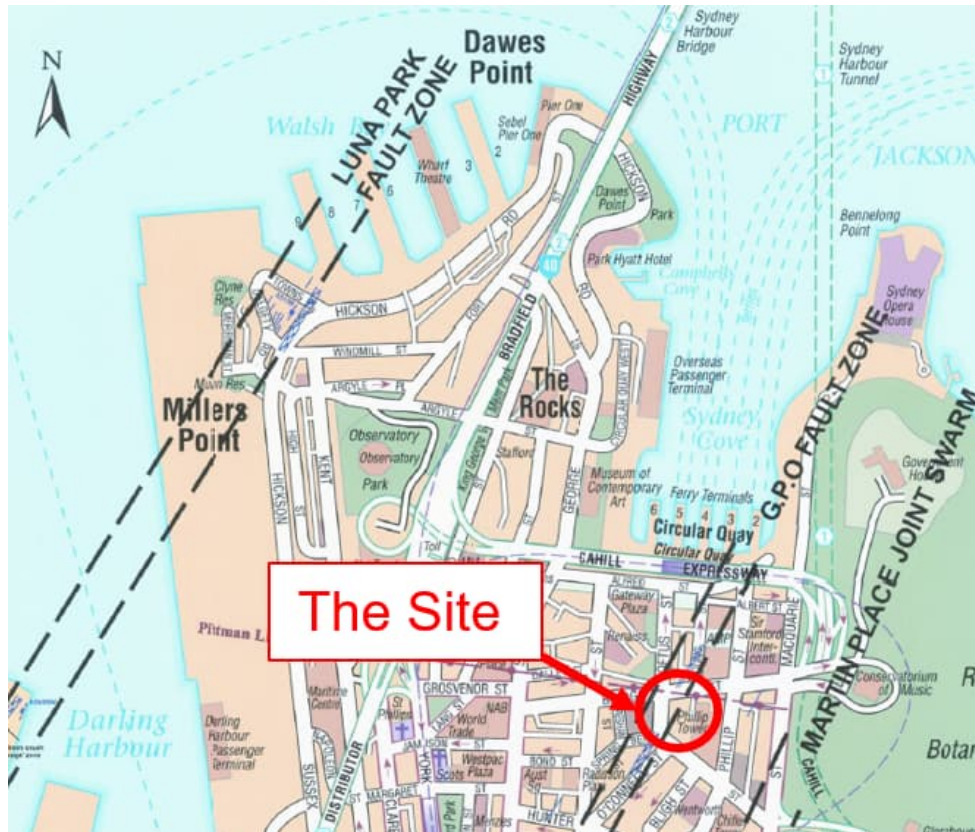
Figure 4: Geological setting (from Och et al 2004 and Pells et al 2004)

Sydney CBD is underlain by Hawkesbury Sandstone (Pells et al, 2019), which is typically a medium to high strength horizontally bedded sedimentary rock unit with either massive or cross-bedded fabric. At this site, the main geological feature of relevance is the “G.P.O. Fault Zone” which is a zone where sub-vertical joints striking NE-SW are expected to be encountered more frequently (Figure 4:). It is important to note that this does not mean that the entire width of the G.P.O. Fault Zone as mapped (Och et al (2004), Pells et al (2004)) contains closely spaced joints. Likewise, it also does not mean that conditions return to “normal” immediately beyond the extent of the G.P.O. Fault Zone as mapped, simply that the prevalence of sub-vertical joints will gradually decrease.

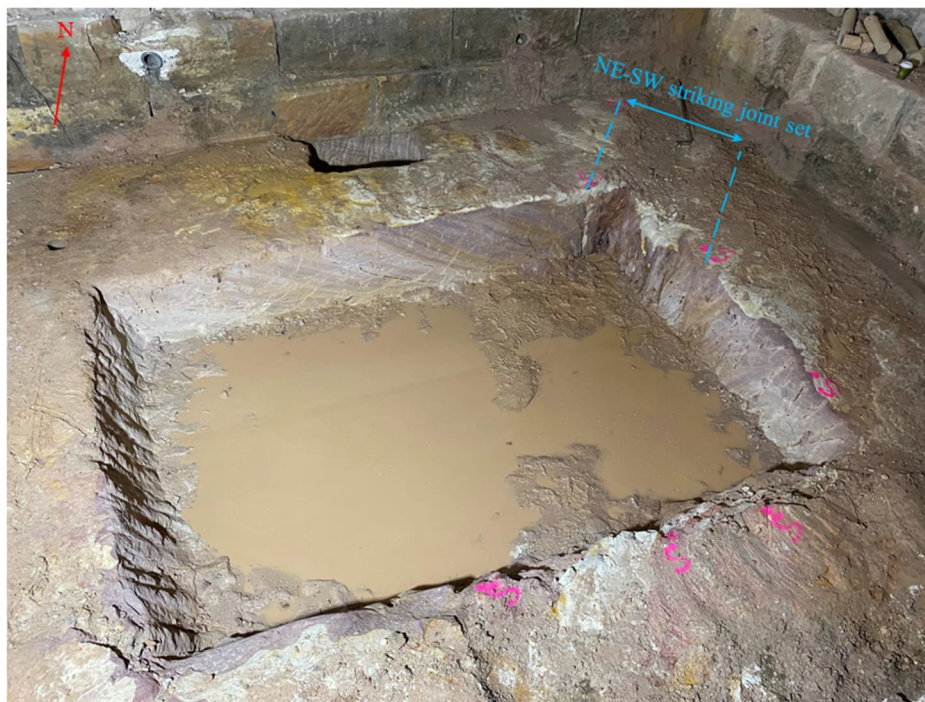
Figure 6: Typical jointing observed in trial trenches, refer to the blue hatched zone in Figure 7

During the detailed design, it was collectively decided between the geotechnical engineer and contractor to undertake trial trenches within the shaft near its perimeter. The main purpose of the trial trenches was to further increase the certainty of the precise location of defects prior to construction, such that the design could be almost completely prescriptive and not have to respond to changes in conditions encountered during construction. The trial trenches, excavated approximately 1 m deep into sandstone bedrock (Figure 6:), confirmed the persistence and orientation of the NNE-NE striking joint set on both sides of the sandstone block wall to be underpinned. The projection of this joint set indicated a potential intersection with the eastern rock pillar designated to support the new transfer beam footing and extending behind the tunnel portal face. Every defect intersecting the top part of the shaft wall was encountered and precisely mapped, to inform the design.

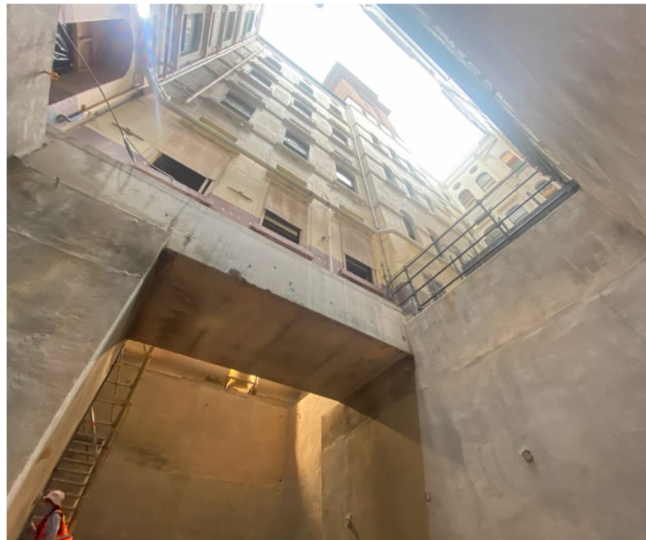
Figure 17: Photograph of the completed transfer structure, taken from the bottom of the shaft

The implementation of these controlled construction and monitoring strategies proved highly effective. The measured movements of the existing walls and footings were negligible and remained well within the strict design tolerances throughout the construction. As a result, the impact of the access shaft excavation on the integrity of the existing heritage building was minimal. Figure 17: and Figure 18: show some photographs taken during the construction works.

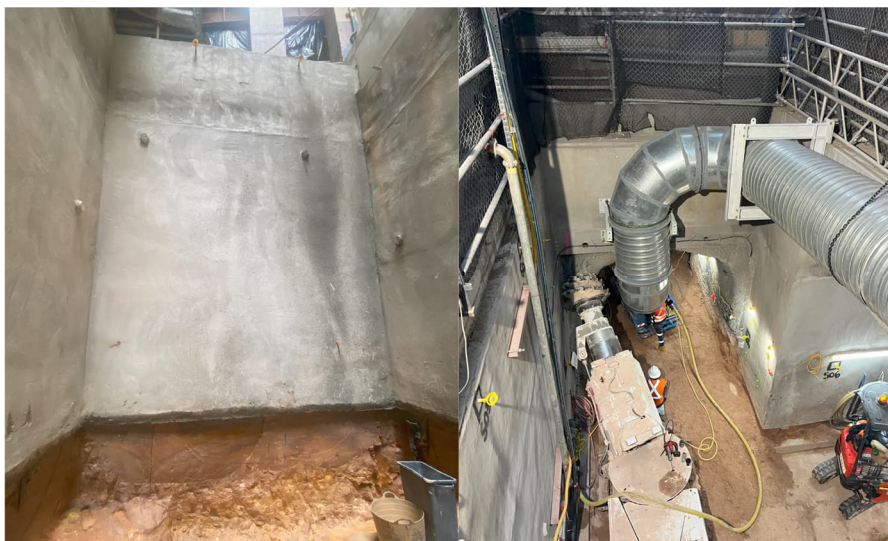
Figure 18: Photograph of the completed tunnel portal before tunnel breakthrough (left) and after tunnel breakthrough (right)
