# PILES CREEK EMBANKMENT COLLAPSE – THE INVESTIGATIONS, THE EXPERT’S FINDINGS AND SUBSEQUENT IMPROVEMENTS IN ASSET MANAGEMENT OF CULVERT STRUCTURES ON MAJOR ROADS IN NSW

C. Shackell<sup>1</sup> and P. Retsof<sup>2</sup>

<sup>1</sup>Technical Director, <sup>2</sup>Geotechnical Engineer, Aurecon Australia Pty Ltd

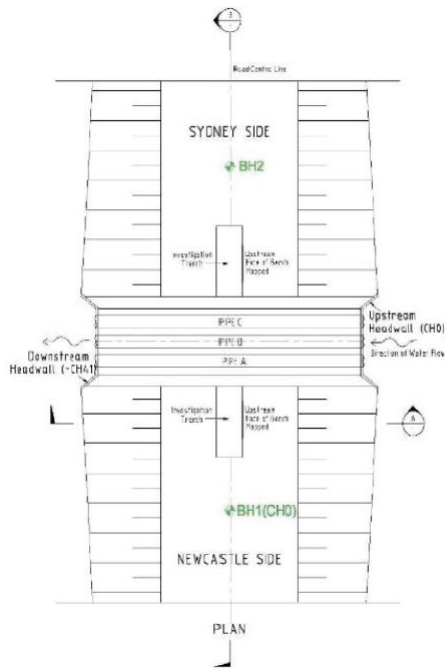
**Figure 3: Schematic plan of the Piles Creek investigation area**

Prior to the commencement of fieldwork the technical experts agreed to the methods and approaches that would be used for the investigation. A progressive, controlled excavation of both sides of the collapsed zone was then undertaken to gather geotechnical information by inspection, mapping and testing of the embankment materials. Figures 3, 4 and 5 illustrate the investigation layout and notation used to distinguish between the different areas of the Piles Creek site.

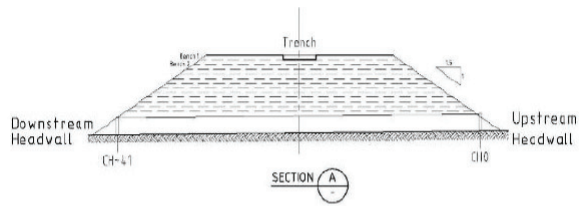
**Figure 4: Schematic section A-A of the Piles Creek investigation area**

It was agreed that the embankment on both sides of the collapsed zone should be progressively excavated in 0.5m deep lifts (benches) to pipe obvert level as shown on Figures 4 and 5. The 0.5 m deep benching would allow a significant amount of ground exposure for inspection and logging, it would minimize the amount of information being lost by the excavation process. The benching also provided an easy means of dealing with and comparing field measurements and relating them back to surveyed measurements. Figures 6 and 7 below show excavated trenches which were used to capture and log the remaining embankment profile.

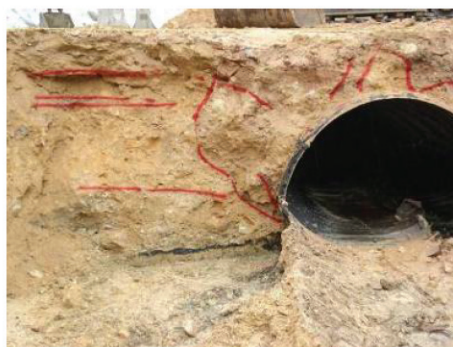
Figure 8: Typical section through the pipes

Below pipe obvert level, it was agreed by the technical experts that sections would be logged at 4.0 m intervals along the length of the pipes (see Figure 4). Figures 8, 9 and 10 illustrate one such section and Figure 11 shows the removal of the pipes in sections as the investigations progressed. As the entire investigation process was destructive, each stage of the work required complete agreement by the technical experts. A sufficient and relevant level of detail and accuracy had to be captured before progressing to the next phase of work

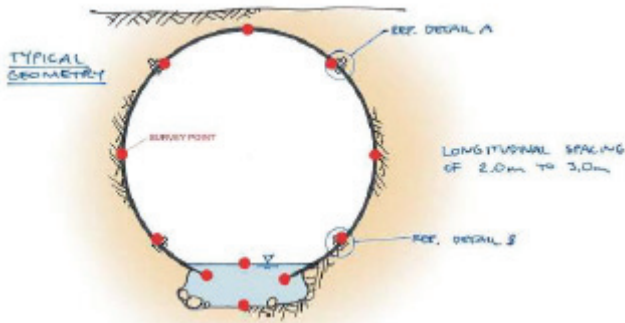
Figure 12: Survey points for typical pipe geometry

The technical experts agreed that a detailed survey of the inside of the pipe culverts was needed in order to capture the final state of the pipes, the degree of deformation undergone by the pipes and the amount of perforation evident in the pipe inverts. Figures 12 and 13 outline the approach used to survey the pipe culverts. Figures 14 and 15 illustrate the degree of perforation and deformation of the pipe culverts.

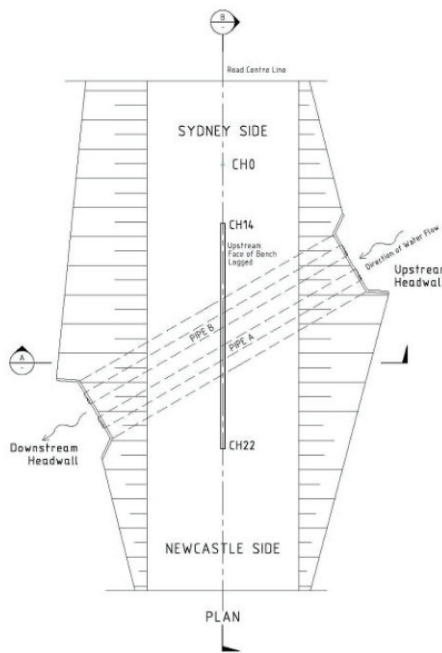
**Figure 16: Schematic plan of the Leask Creek investigation area**

The technical experts agreed that due to the similarity in construction between the Leask and Piles Creek embankments, and the fact that the embankment at Leask Creek appeared to be exhibiting similar mechanisms of failure, that investigating the Leask Creek road embankment would provide more evidence to support our thoughts in regards to the mechanism of failure at Piles Creek. The investigative procedure undertaken was similar to that at Piles Creek with the exception of omitting sampling and laboratory testing of embankment materials. Figures 16, 17 and 18 illustrate the investigation layout and notation used to distinguish between the different areas of the Leask Creek site.

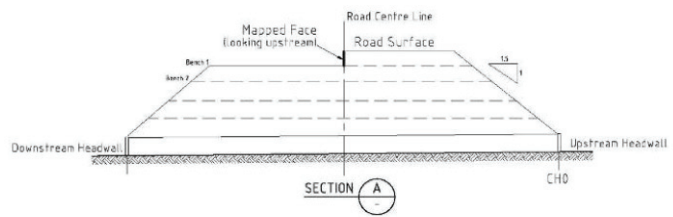
**Figure 17: Schematic section A-A of the Leask Creek investigation area**

It was agreed that 1.5m deep benches would be excavated, located at the centre of the road directly above the pipes. The fieldwork at Leask Creek comprised of the following:
