# REAL TIME MONITORING OF A ROAD EMBANKMENT SUBJECT TO COASTAL EROSION AND SLOPE INSTABILITY

Ground Engineering and Tunneling Team, AECOM Australia Pty Ltd (Sydney), Australia

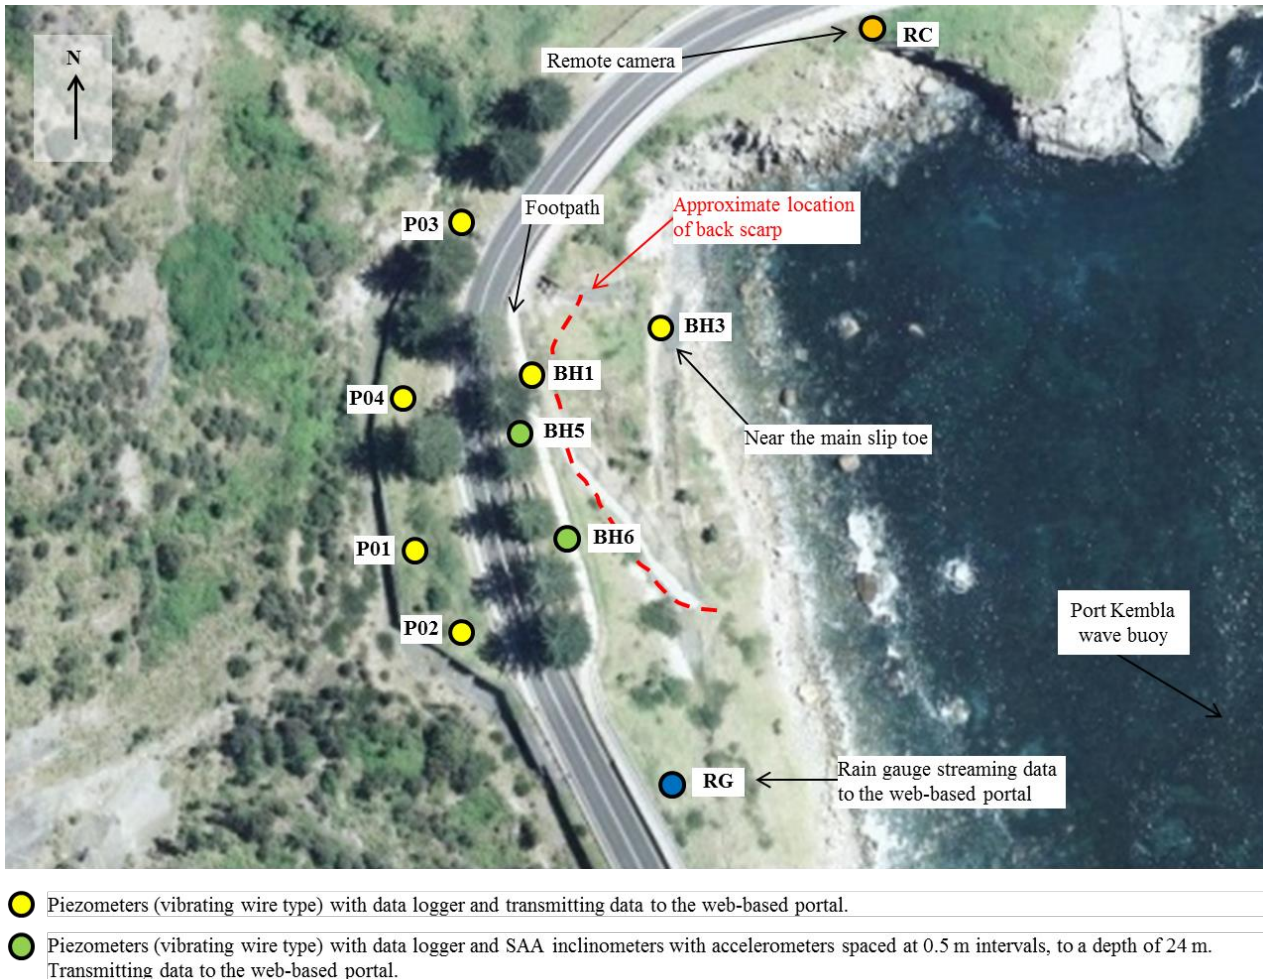
**Figure 4: Borehole locations and Instrumentation plan.**

Boreholes BH5 and BH6, which contained the main geotechnical instrumentation (vibrating wire piezometers and SAA inclinometers), were located behind the slip failure. This was done for three reasons:

Using the data obtained from the instrumentation in the monitoring plan, it was possible to develop relationships between the various monitored parameters. Data from various sets of instruments were plotted to the same time scale as in the example in Figure 4. The figure was plotted to assess the interaction between rainfall, piezometric pressure and wave height with inclinometer movement. The data set presented in the figure is from borehole BH5, located immediately behind the main slip. The following data are plotted from this borehole in Figure 4:

In the sections that follow, the relationship between piezometric pressure and inclinometer movement is discussed in some detail and in more general terms for other data. The storm event in March 2012 presented in Figure 4 provides much of the data for establishing relationships between the various monitored parameters and referred to from here on as ‘the storm event’.

Following rainfall, pore pressures rise rapidly at the piezometer at P5/-15.5 with very little lag, suggesting the recharge is close to the slope. The effect of surface water ingress can be clearly seen with sharp spikes in piezometric pressure associated with rainfall. It would not be practical to accommodate these spikes in a response plan. However, after relatively simple upgrades and repairs to surface drainage, it can be seen from the figure that these sharp spikes were

At the rock interface (-20.5 m) there is distinct inclinometer movement of approximately 1 mm at the time of the storm event. From review of the full height time displacement curves for this inclinometer, this movement was interpreted as shear movement within the crushed zone at the base of the colluvium as a result of elevated piezometric pressures. It can be inferred from the data that once piezometric pressures at P5/-15.5 exceed approximately 14 m, there was a possibility of deep seated failure occurring. There was no further significant movement in this zone during the monitoring period.
