Landslide Damage to Road Networks in the 2021 Marlborough Storm

ABSTRACT

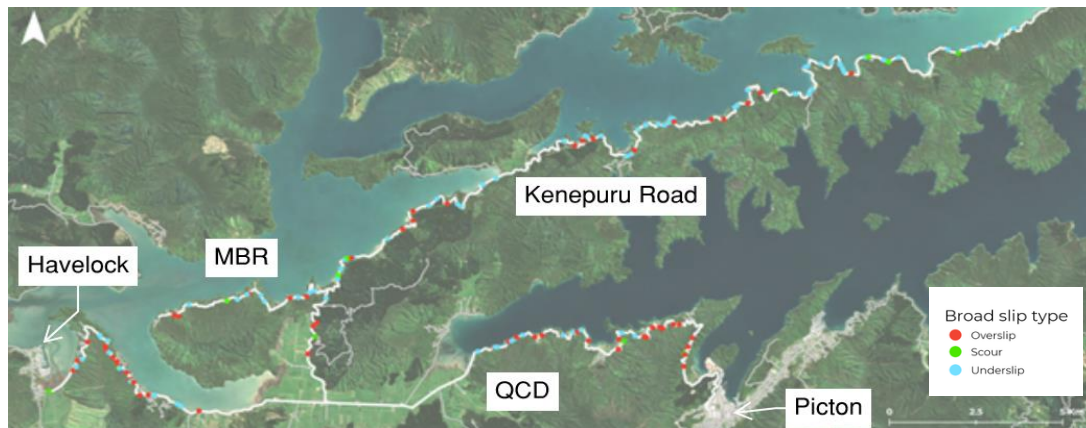
The storm event caused over 1,500 faults on the road network, including landslides, rock falls, debris flows, flooding, scour, underslips, tree falls and damage to retaining walls and bridges. Kenepuru Road, Queen Charlotte Drive (QCD) and Moetapu Bay Road (MBR) were all closed to traffic immediately following the storm due to overslip debris. Work to reopen the roads proceeded straight away, with different levels of prioritisation for each road based on their One Network Road Classification (ONRC)(Waka Kotahi NZ Transport Agency, 2022). At the time of writing (July 2022) ongoing recovery works mean that Kenepuru Road and MBR are still subject to frequent day-time closures. Works on QCD are typically within one-lane closures. The locations of failures on this part of the Sounds network are shown in *Figure 1*.

Figure 1. Locations of slope failures on the road network
