# CHALLENGES IN CONSTRUCTION MONITORING – ADAPTING TO UNFORSEEN CONDITIONS: A CASE STUDY IN RICcartON, CHRISTCHURCH, NEW ZEALAND

**Lauren Foote and Ana Pereira**

*NZGS and Engineering New Zealand*

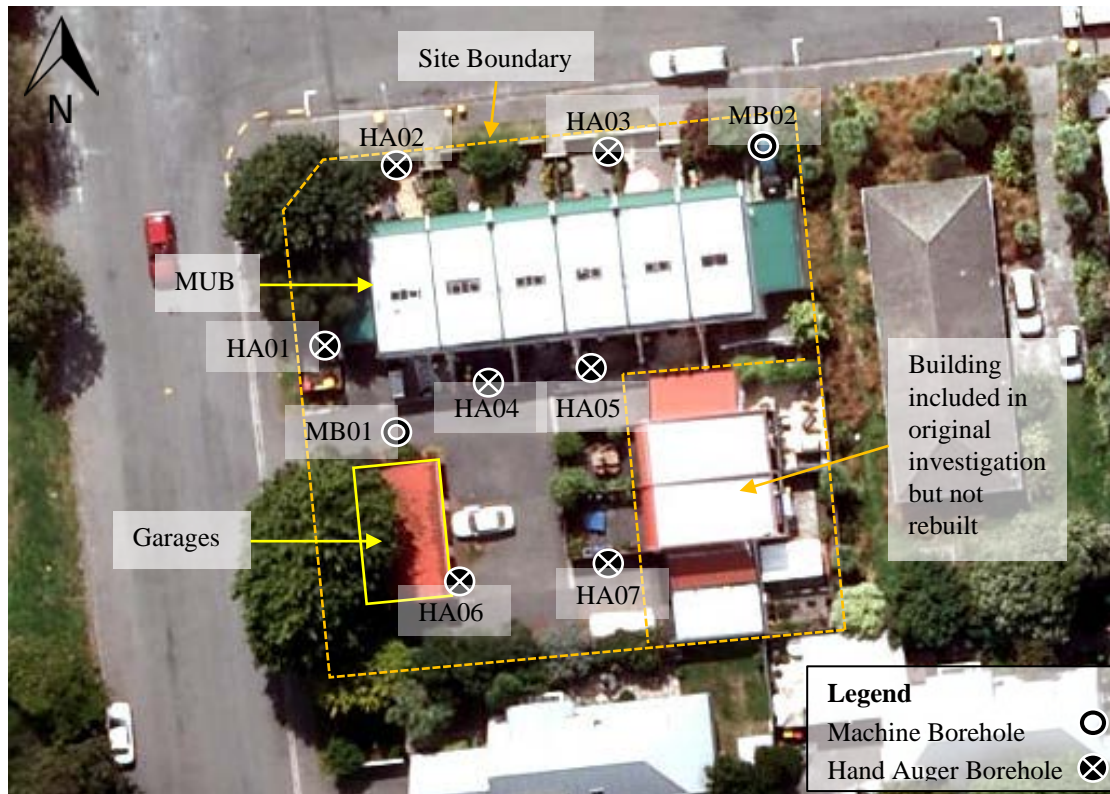
**Figure 1: Site layout at the time of the 2014 investigation including the hand auger boreholes and machine borehole locations (aerial imagery sourced from Canterbury Maps, not to scale).**
