COMPARISON OF PREDICTED AND OBSERVED SEISMIC PERFORMANCE OF KEKERENGU AND TIROHANGA BRIDGES DURING KAIKOURA 2016 EARTHQUAKE

Jawad Arefi, Richard Young, Nik Stewart

Beca Ltd, Christchurch New Zealand

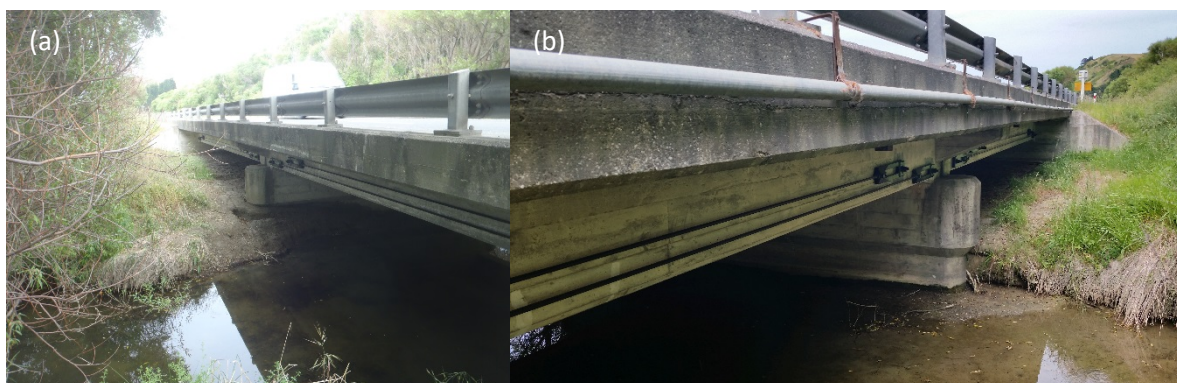
Figure 1. a) Tirohanga Bridge deck and pier, looking south, b) pier and abutment pre earthquake, looking north

The seismic assessment identified that damage to the piles and abutment walls under the DCLS earthquake would likely comprise cracking and spalling at the top of the piles, with some deformation and settlement at the abutments. Shear failure of the piles under transverse loading under a seismic event with a return period of 1,300 years was predicted. It was surmised that this shear failure could result in loss of support, leading to local collapse or settlement of the bridge. However, as the bridge was shown to have acceptable levels of damage, and the structural components of the bridge to have adequate capacity under DCLS loading, further seismic strengthening was not recommended.

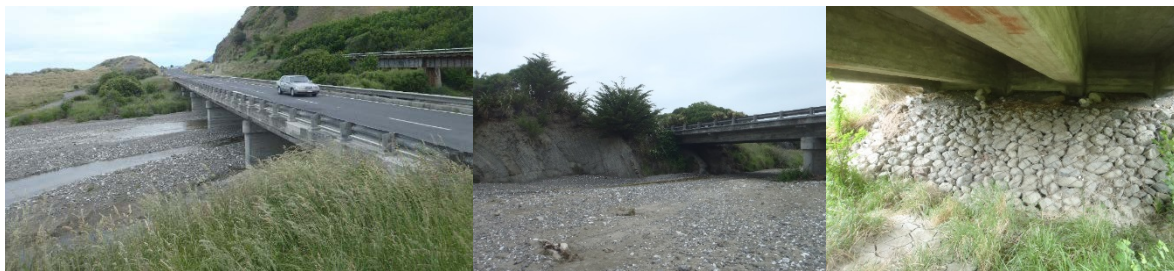
Figure 2: Kekerengu River Bridge, bridge overview looking south (left); north abutment on rock (middle); south abutment on soil (right) prior to earthquake
