ANALYSIS OF THE MECHANISM OF LANDSLIDING, GARIE ROAD, ROYAL NATIONAL PARK, NSW

Tim Donovan¹ and Luke Johnstone²

¹Associate Engineering Geologist, Aurecon ²Engineering Geologist, AtkinsRéalis

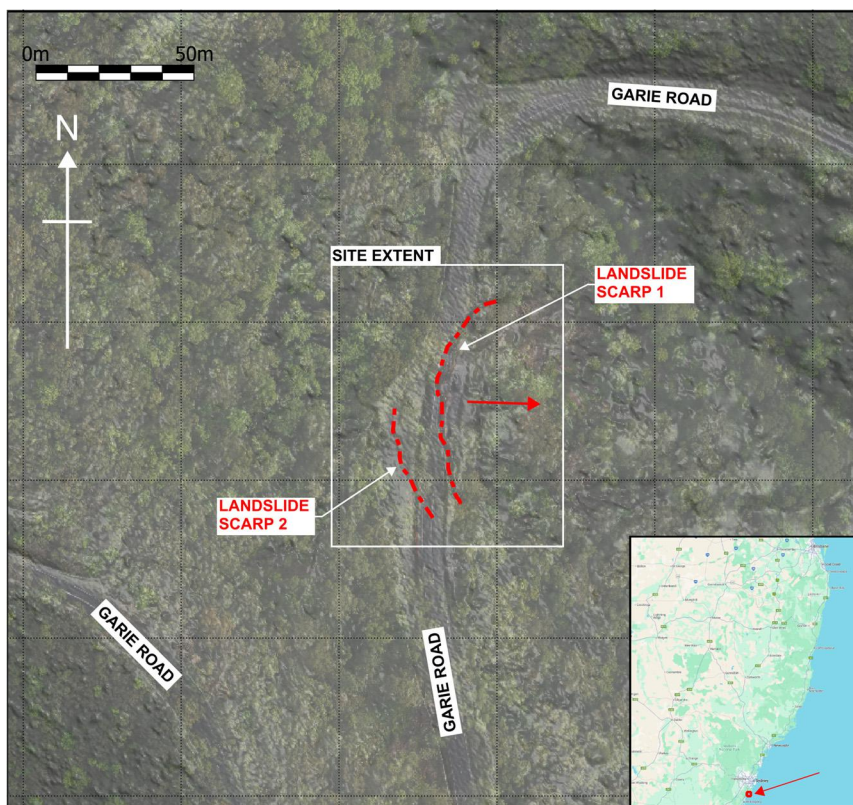
Figure 1: Location and scarp extents of the Garie Road landslide

- **Early to mid-October 2022:** 287 mm of rainfall was recorded in 13 days, resulting in additional instability and a retrogression of Scarp 1. A secondary Scarp 2 (Figure 1) opened to the west of Scarp 1 with vertical displacement ranging from 300 mm to 400 mm with creep of surrounding areas. Survey data recorded 3.3 m of maximum vertical displacement at Scarp 1 in October 2022.

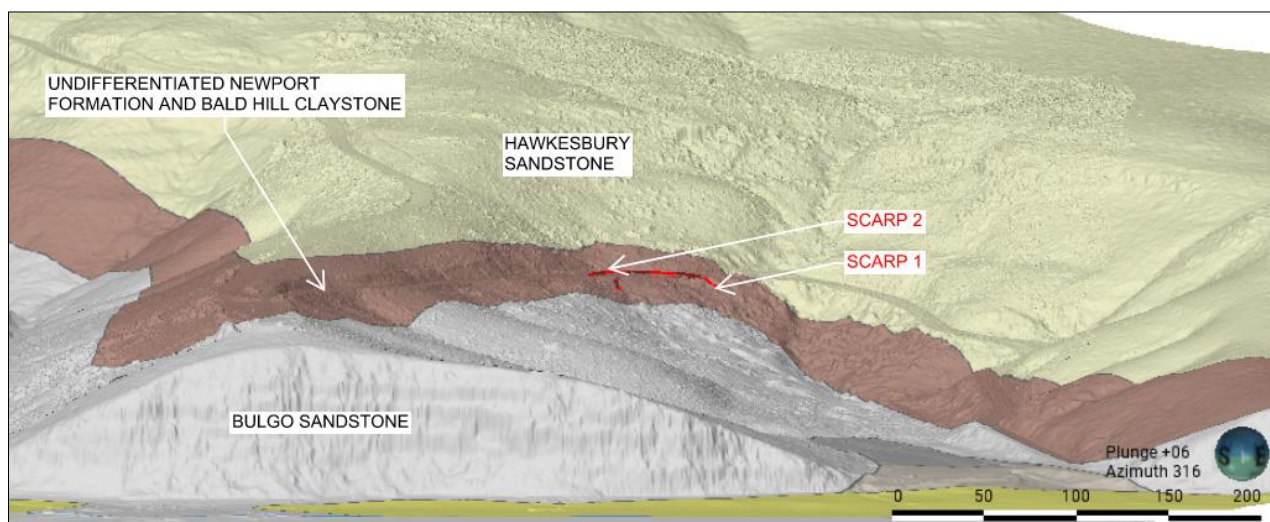
Reference to the Seamless NSW Geological Maps (Colquhoun, et al., 2021) indicates that the site geology comprises (from an upslope to downslope direction) the Hawkesbury Sandstone, Newport Formation, Bald Hill Claystone and Bulgo Sandstone (Figure 2). The landslide site is directly underlain by the Bald Hill Claystone and the top of the underlying Bulgo Sandstone is between ~12 m to 17 m below road level.

Figure 2: View of the Seamless NSW Geological Maps (Colquhoun, et al., 2021) overlain on the DTM (MES, 2022) of the Garie Road landslide and coastal cliffs. Note: no differentiation is provided on the Seamless NSW Geological Maps between the Newport Formation and the Bald Hill Claystone however the Bald Hill Claystone was mapped as an individual unit on site.

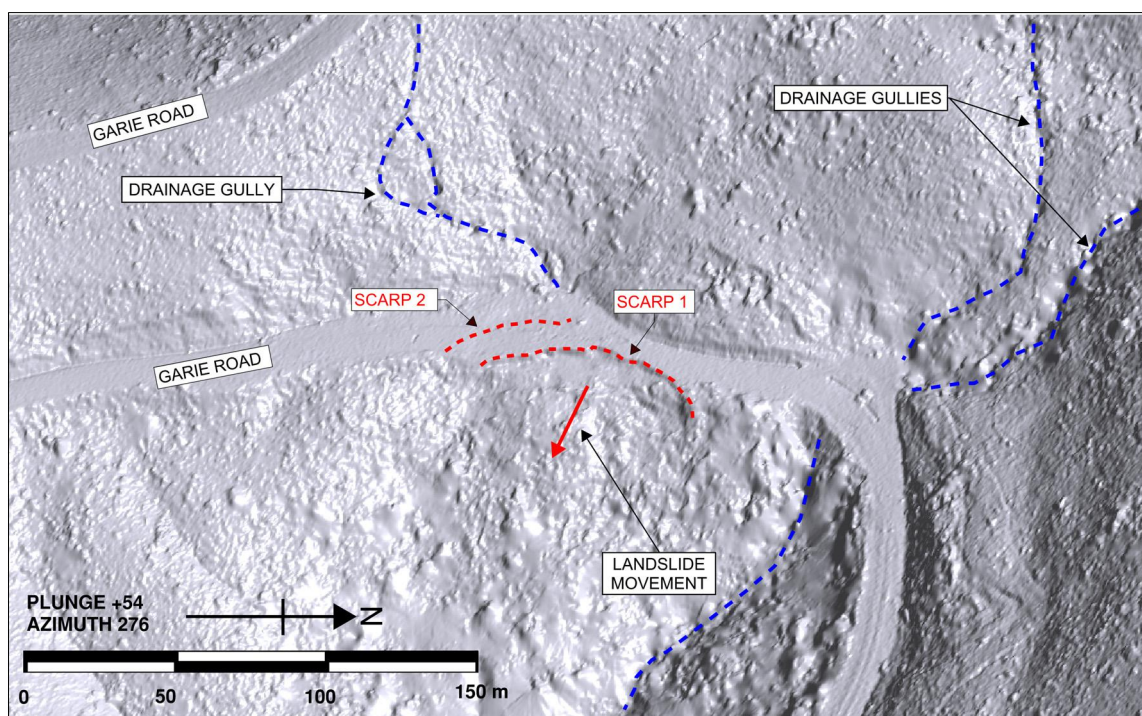
Site topographical and drainage features are illustrated in Figure 3, which presents an oblique view of the Garie Road landslide site illustrating the topography and incised drainage channels and immediate surrounding area.

Figure 3: View of the DTM (viewing west) of the Garie Road Landslide site and surrounding area. Source of DTM is MES (2022).

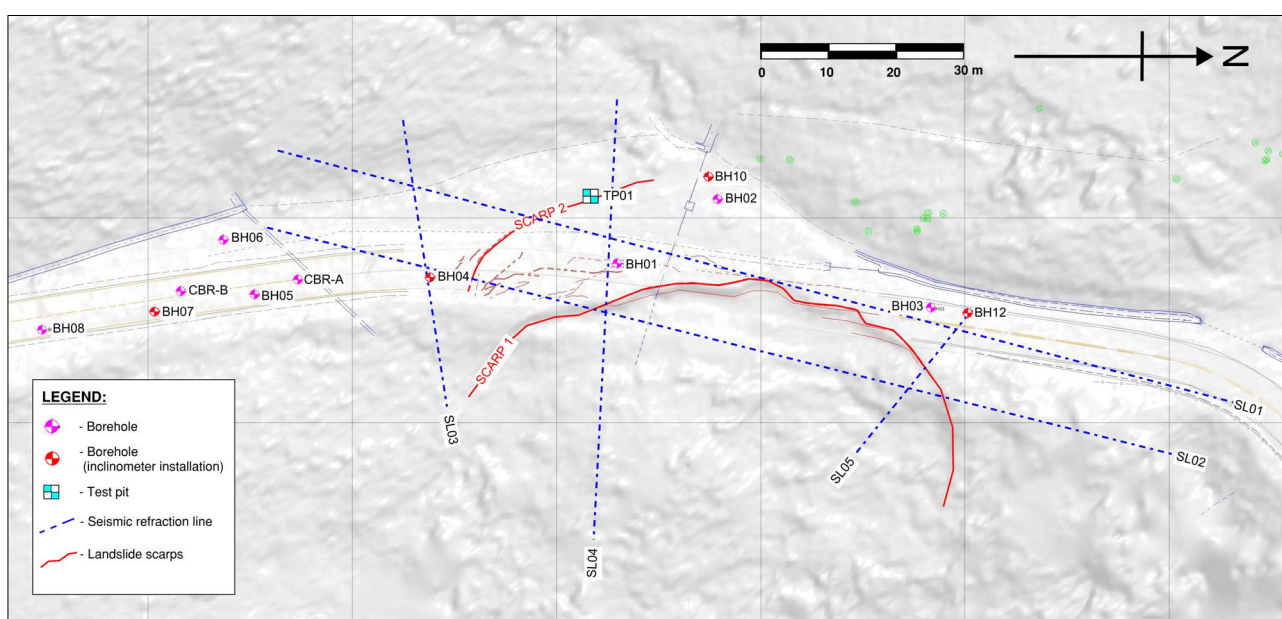
A site plan indicating the locations of the exploratory holes, inclinometer locations and seismic refraction lines is presented in Figure 8.

Figure 8: Geotechnical investigation site plan at the Garie Road landslide site. Source of DTM (MES, 2022).
