THE BOGONG LANDSLIDE, A CASE STUDY INTO AN AUSTRALIAN LANDSLIDE IN UNSATURATED SOILS

Darren Paul, Simon Harbig, Emma O'Brien, Alana Dubowik
WSP, Melbourne, Victoria

ABSTRACT

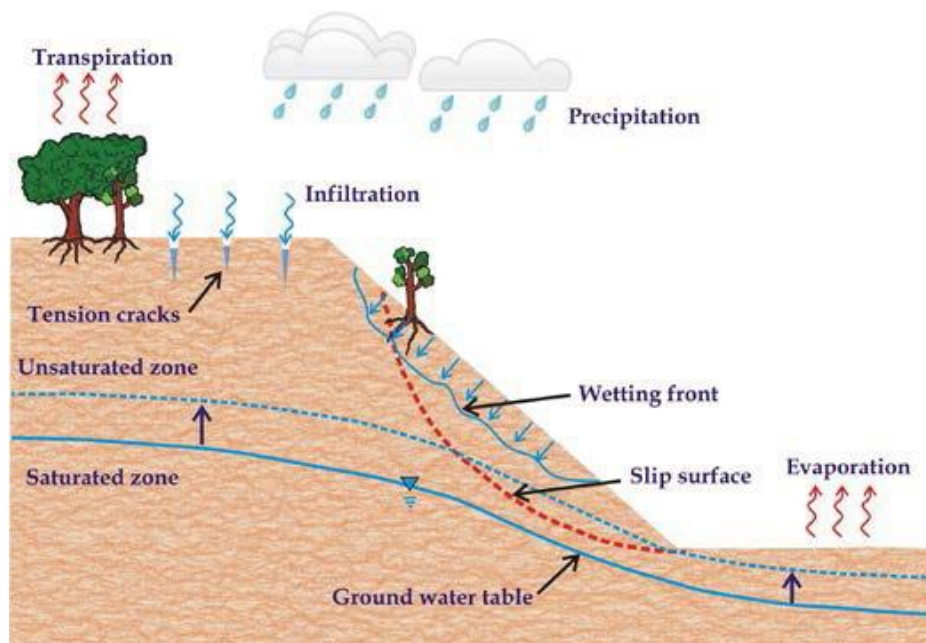
Figure 7: Concept for rainfall induced landslide in unsaturated soils, after Rahardjo et. al. (2011)

Similar landslide mechanisms in granitic soils been studied in locations such as Hong Kong, for example, Henschler and Lee, (2010). Figure 7 illustrates the concept of rainfall induced landslides caused by a loss of soil suction. As in this example, the 2022 Bogong landslide occurred in soils well above the water table that were not significantly influenced by positive pore water pressure. Note that no significant seepage or evidence of positive pore pressure development was observed to be associated with the Bogong landslide.

Strain in the form of tension cracks was first noticed upslope of the landslide, before there was any evidence of rupture in the face of the cutting at the toe of the landslide. It is postulated that the wetting front advanced into the slope commencing at the crest near what would become the headscarp of the landslide with the less saturated soils downslope. The tension cracks and some of the more permeable rocky strata within the slope may have been a conduit for water infiltration with the slope, effectively pushing displacement from upslope due to loss of strength in that area.

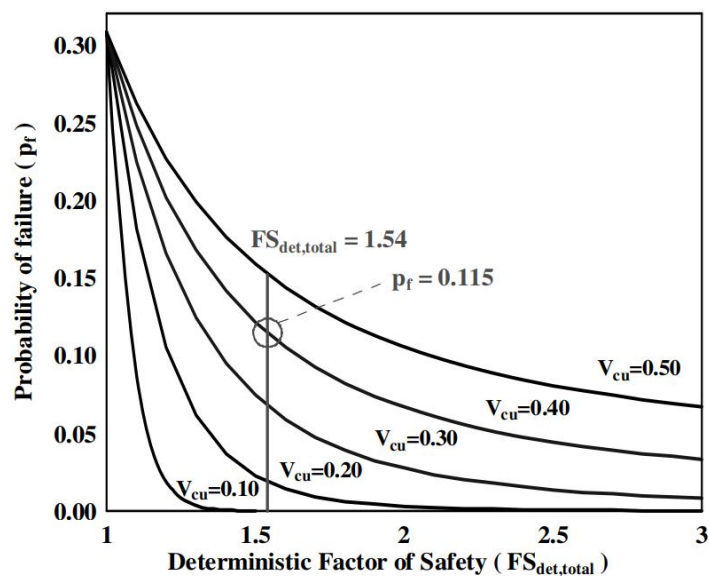
Figure 12: Extract from Kavvas et al. (2009) showing relationship between factor and safety and probability of failure for cohesive soil

A risk assessment was undertaken to assess the risk to road users noting that achieving a risk level that could be tolerated by the road regulator was a requirement of the design. The key input to the risk assessment was the probability of a landslide, related in this case to the degree of saturation within the soils. Guidance was taken from literature to estimate the probability of failure for the slope within which the global factor of safety is expected to reduce to 1.4 every 50 years or so in response to wetting. Kavvas et. al. (2009) presents a relationship between factor of safety and probability of failure for cohesive soils as indicated in Figure 12. On this diagram, V_{cu} is the coefficient of variation of c_u , (the undrained shear strength) and is a function of the certainty in that parameter calculated as the standard deviation divided by the mean for that parameter. The higher the coefficient of variation, the less certainty in the parameter and the higher the probability of failure. There was limited strength data on which to base an estimate of the coefficient of variation for the soils of the Bogong landslide. However, the observations that were undertaken, which included triaxial tests plus observations of the landslide, suggest a coefficient of variation of between 0.05 and 0.3 based on the measured friction angle and cohesion respectively. Whilst a highly uncertain estimate due to limited data, this is a low coefficient of variation, which is consistent with observations. Assuming a coefficient of variation of 0.25, a Factor of Safety of 1.4 correlates to a probability of failure of about 0.05.

This estimate is consistent with Read and Stacey (2009), who provide Table 1 indicating a general relationship between factor of safety and probability of failure and suggesting via interpolation a probability of failure of 5% (0.05) for a factor of safety of 1.4.

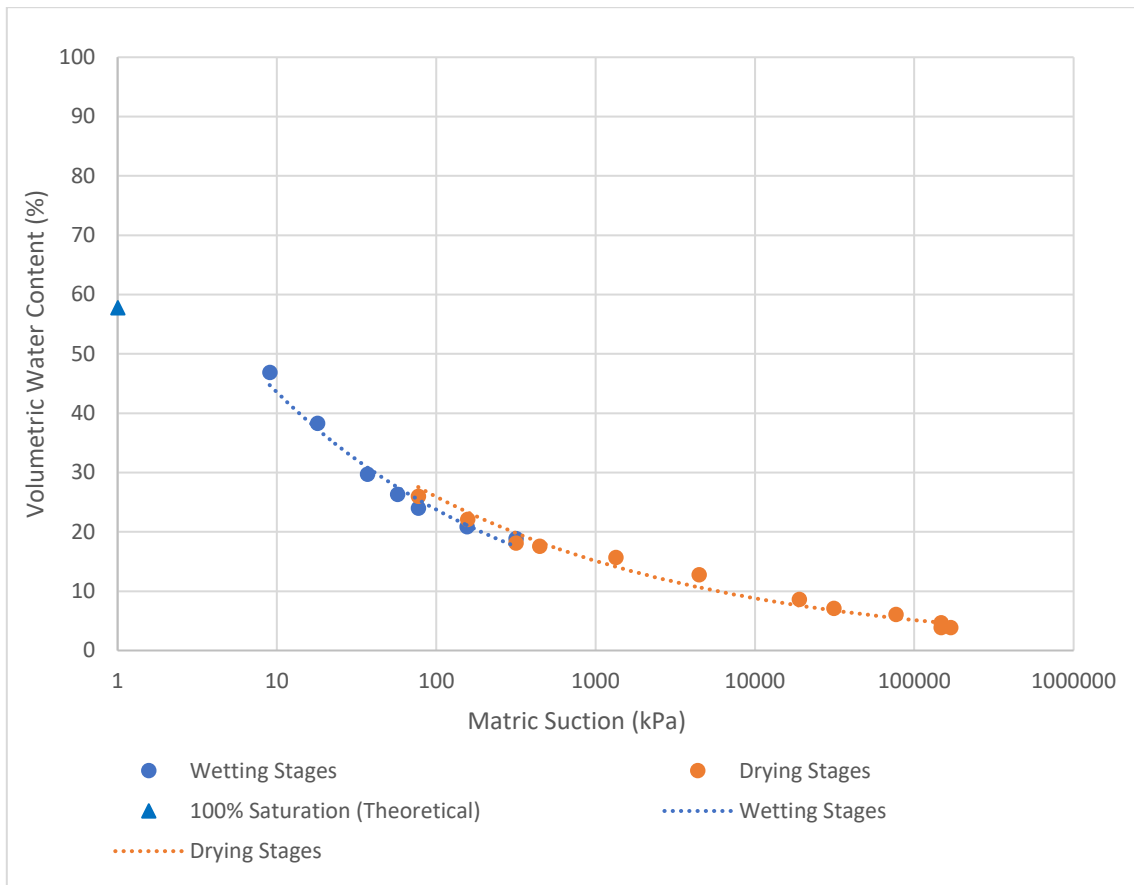
Figure 14: Soil water characteristic curve

A SWC-150 pressure plate device was used to measure volumetric water contents for matrix suction values on the drying and wetting curve of less than 1000 kPa. A WP4C water potential meter was used to measure water contents for matrix suction values on the drying curve above 1000 kPa. Figure 14 shows the SWCC developed. Testing covered suction stages ranging from 9 kPa to 316 kPa on the wetting curve and between 77 kPa and 147 MPa on the drying curve. These corresponded to a variation in volumetric water content of between 18.9% and 46.9% on the wetting curve and 3.9% and 26% on the drying curve.

The SWCC developed in Figure 14 was used to convert the in-situ volumetric soil moisture measurements into a matric soil suction. Site-measured soil moisture was between 25% and 40%, which fell between laboratory measured moisture conditions, i.e. not outside the range of available data points used to generate the SWCC. Rainfall together with the measured soil suction and corresponding soil suction developed from the measured soil moisture and SWCC is plotted in Figure 16.

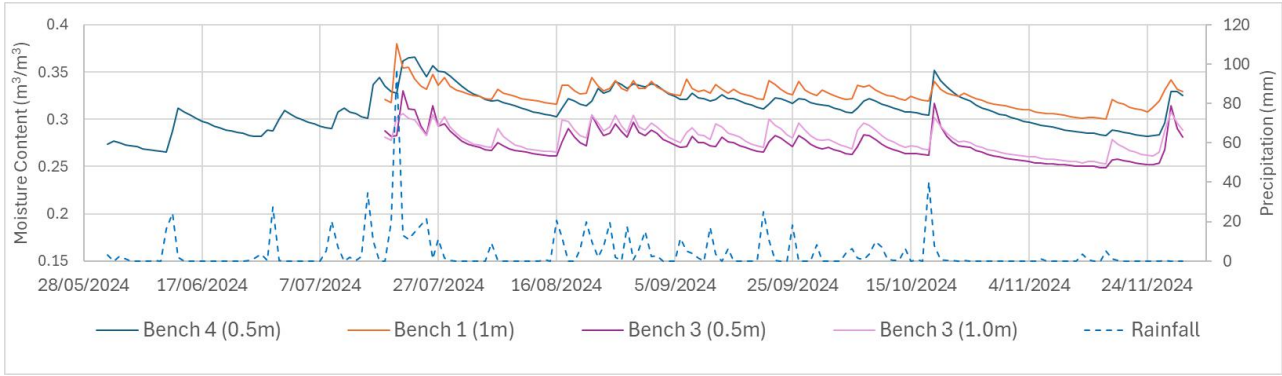
Figure 15: Measured relationship between rainfall and soil suction

The relationship measured between volumetric soil moisture and rainfall over a six-month period is presented in Figure 15. More than six-months of in-situ soil moisture data indicated a strong relationship between rain events and soil moisture, generally a sharp increase in soil moisture in all four sensors in response to a rain event followed by a gradual decrease in soil moisture. Smaller, but more frequent, rainfall events during September appear to correspond to a higher average soil moisture.

The soil moisture and suction data presented in Figure 15 and Figure 16 indicate two important behaviours of the residual granitic soil consistent with the postulated landslide mechanism:

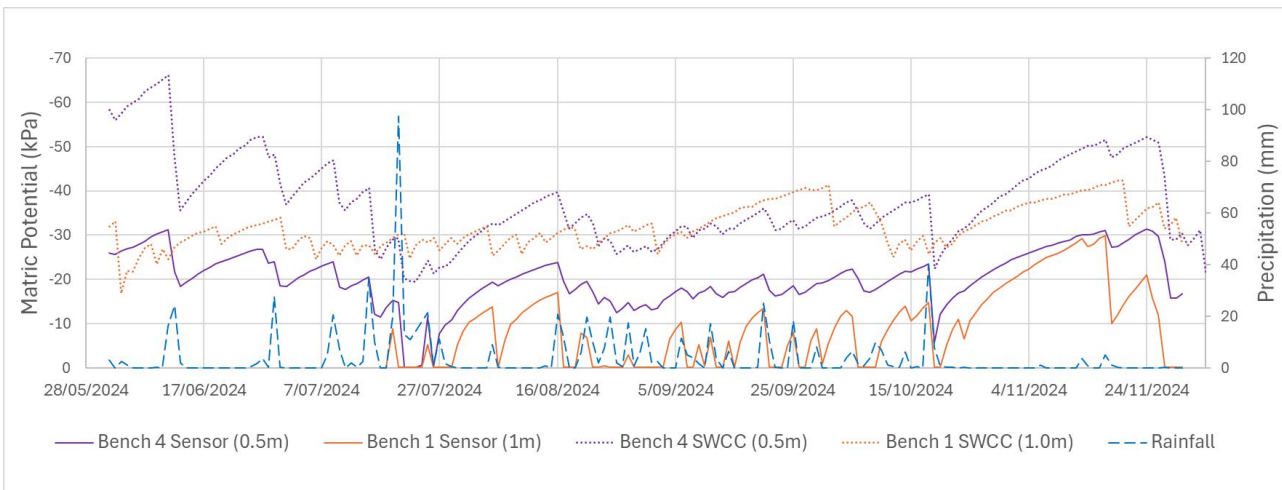
Figure 16: Relationship between rainfall, and estimated matric suction and estimated matrix suction from SWCC

The measured soil suction generally followed a similar, but inverse, pattern as the soil moisture with sharp decreases in soil suction measured following rain events followed by a gradual increase in periods of no rainfall. During winter and spring months (July to October) several instances of zero suction occurred, likely due to frequent rainfall events during this period. Compared to the measured soil suctions, the soil suctions estimated by SWCC were significantly higher, showed more variation and did not show instances of zero suction.

These differences could be due to the SWCC better estimating soil matric suction for in-situ soil compared to the disturbed soil at the base of the borehole in which the sensor was installed. Another potential cause for differences could be the differences in soil composition tested in the laboratory compared to the soil the sensors were installed in.

Measured soil suctions ranged between 0 kPa and -31 kPa, whereas estimated soil suctions ranged between -16 kPa and -66 kPa. This significant change in effective cohesion support the model that that the Bogong landslide could have occurred due to a general increase in soil moisture during a period of increased rainfall leading to a reduced overall matric soil suction in the slope. Furthermore, if disturbance of the in-situ soil occurred due to failure of the soil matrix, it is likely a significant amount of suction (and therefore effective cohesion) would have been lost near the zone of failure.
