WEST CUT TAILINGS DAM

G J HUNTER

D J DOUGLAS & PARTNERS PTY LTD, NEWCASTLE

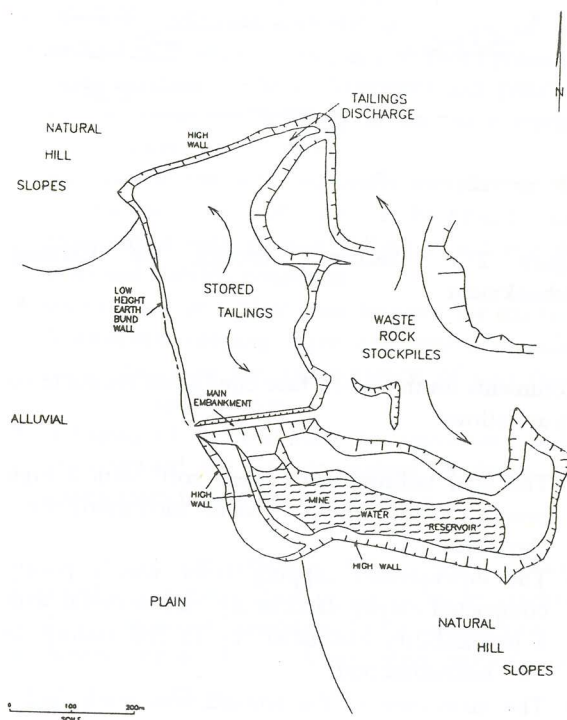
Figure 1: Site Layout

The main embankment to the tailings dam divided the disused open cut into a tailings disposal area to the north and water supply reservoir to the south as shown in Figure 1 below. At the time of initial consultation the embankment was about 150 metres in crest length and 12 metres in height at its deepest point, underlain by a further 8 metres of dumped waste to the open pit floor. The western abutment comprised the former high wall to the open pit and the eastern abutment stockpiled overburden/interburden granular waste rock.

Tailings from the washery plant was discharged via pipeline into the north-eastern point of the West Cut Tailings Dam as shown on Figure 1. The tailings had formed a very flat lying beach with only a relatively shallow change in height over the length of deposition. No segregation of size fractions was visually apparent between the discharge point and main embankment.
