Slope Stabilisation-Site investigation, Design and Application of Deep Soil Mixing

Cristien Gani
BE , MEngSt.

Geotechnical Engineer, Sinclair Knight Merz Ltd, New Zealand

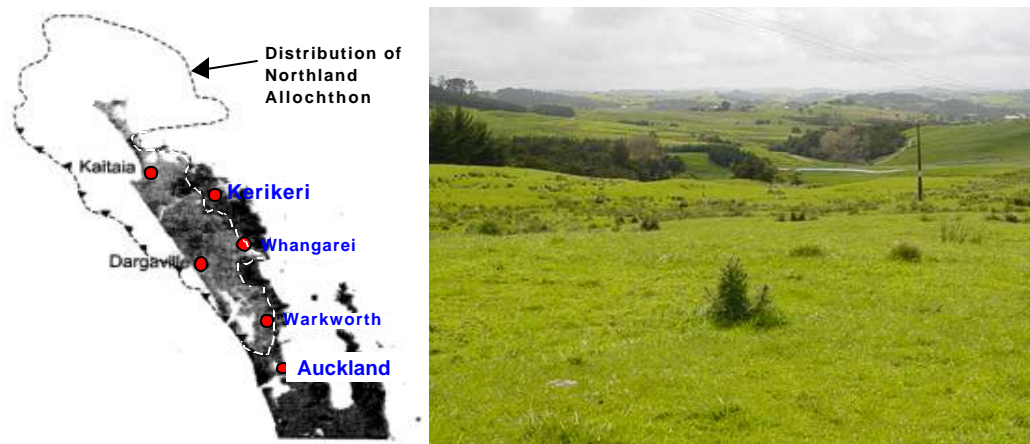
The geomorphology of Northland Allochthon is typically long, gentle to moderately grading broad hummocky slopes with hummocks generally extending all the way from the toe of the slope to the crest of the ridge, and side spurs. The hummocks are generally between 5m to 20m wide, tend to be oval and aligned parallel to the surface contours. Swamp reeds are found growing on the surface due to the very low permeability of the underlying soil (Figure 1). Another characteristic is the presence of numerous shallow-seated slope failures. Shallow failures have been observed on relatively gentle slopes of 5° to 15°, due to the low residual strength and ongoing creep movement of the in situ material (Winkler [1]).

Figure 1. Location of Northland Allochthon (Winkler [1]) and typical geomorphology of the Northland Allochthon

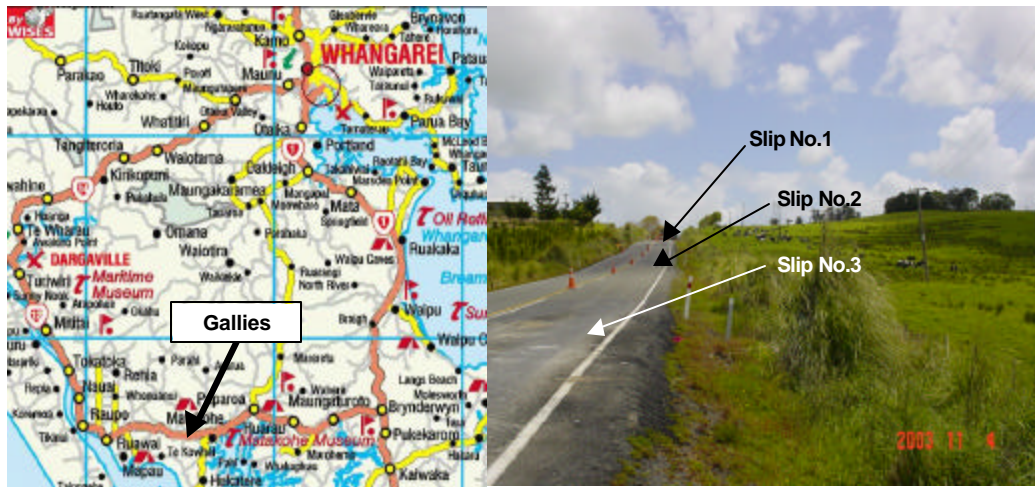
Figure 2. Location of Gallies Slip.

The Gallies Slips are located on State Highway 12, approximately 90 km south east of Whangarei as shown on Figure 2. The slips have occurred in an existing road embankment. This stretch of the highway has previously been subjected to slope failures and unsuccessful slip repair work. The selected case study includes three slips with a total length of 50m over 190m of highway. The site is bounded on the north by water logged hummocky farmland and on the south by a farmhouse and some sheds (Figure 2). Figure 3 illustrates the extent and shape of each slip.
