## Embankment Failures – Local Experiences

E. G. Maynard<sup>1</sup>, BE (Hons) Nat Res, MEM, GIPENZ

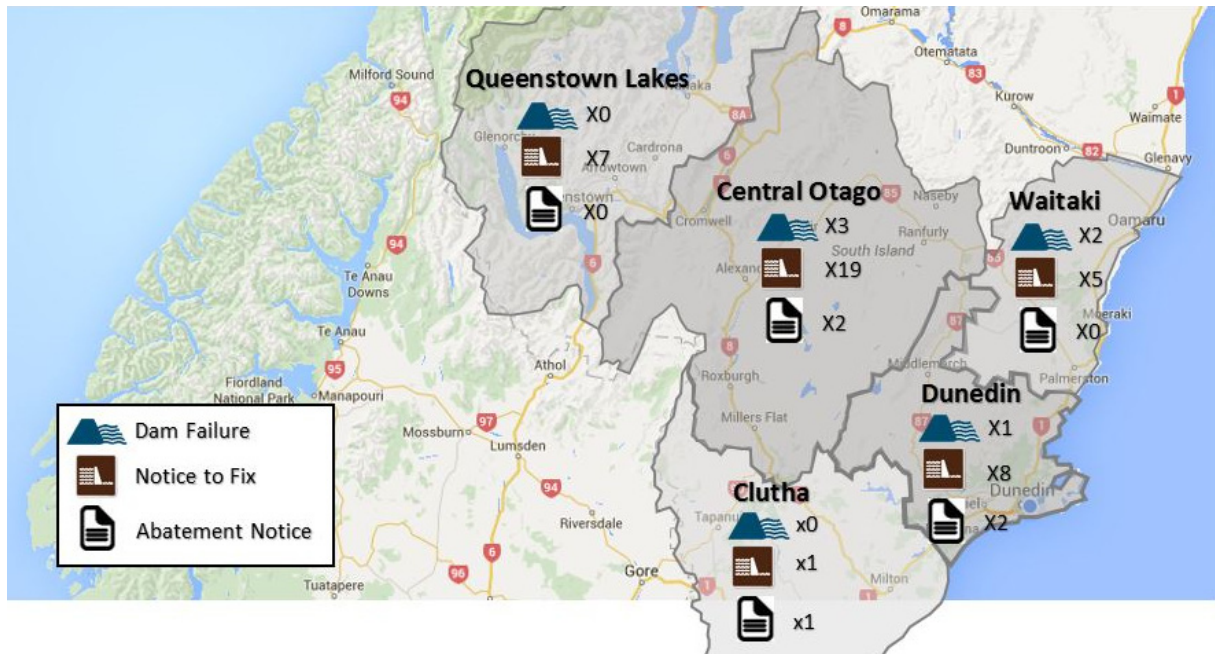
The Otago Regional Council (ORC) is responsible for issuing building consents for large dams and compliance matters for all dams in Otago. Since 2011, the ORC has documented six dam failures, issued 40 notices to fix for non-compliance with the building code, and five abatement notices for

dams in breach of the RMA (refer Figure 1). These equate to approximately one incident per month. The most precarious dams in the database are summarised in Table 1.

Figure 1. Failure rates and dam enforcement for dams in Otago since 2011.
