Case History of an Unusual Embankment Failure

Andrew Campbell, Maunsell Pty Ltd

Summary: The partial failure of a 7.5m high surcharged embankment constructed over soft clay and peat is described. Extensive instrumentation within the embankment and its foundation gave only partial warning of the impending failure. Failure occurred during the final lift of surcharge and resulted in a 0.6m wide tension crack approximately 100m long down the centre line of the embankment. Unusual features included the fill material, lack of pore pressure dissipation during construction despite installation of wick drains, limited lateral deflection prior to failure, near perfect symmetry of the failure and the remedial measures implemented.

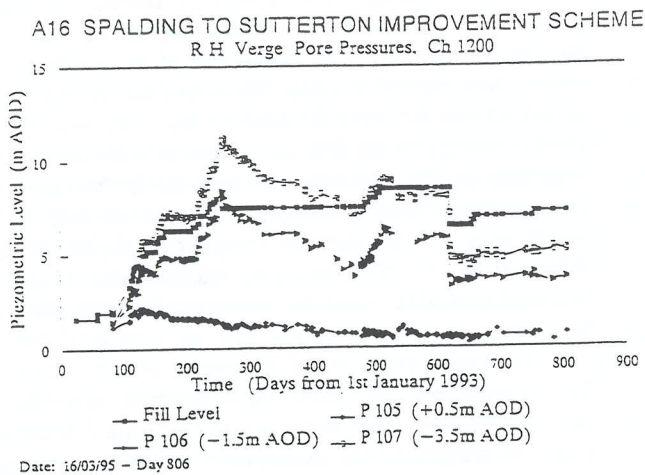
Figure 5: Right hand verge piezometer readings

Installation and commissioning of instruments was completed at the end of March 1993. The instruments were monitored on a regular basis throughout the construction and surcharge periods. Records for the centreline, right hand verge, shoulder and toe, and fence line piezometers are attached as Figures 4 - 8 respectively. Selected toe inclinometer data is shown on Figures 9 & 10. Centre line and right hand toe extensometer data is shown on Figures 11 & 12. Selected readings from the hydrostatic settlement gauge are shown on Figure 13.

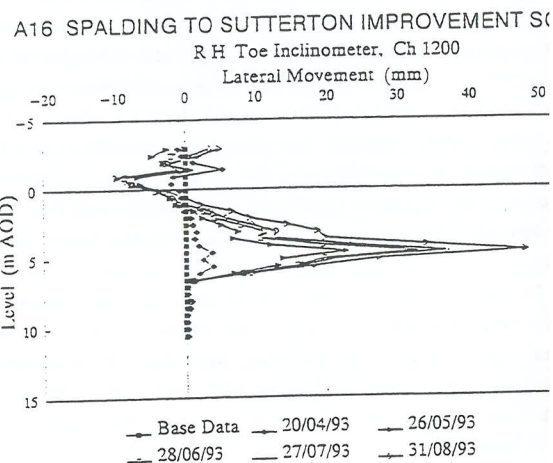
Figure 9: Right hand toe inclinometer reading

Surcharge was placed throughout August. Prior to placing the final lift, inclinometer readings indicated only 50mm lateral movement, concentrated in the peat. Although B-bar was approaching 1.0, it was felt that this was misleading. Continued settlement and limited lateral deflection suggested that the embankment foundation was capable of taking the final lift of material. Placing of the final lift was substantially complete on Friday 10 September. Dramatic pore pressure changes were observed on the following Monday during final trimming: there was a drop of approximately 1m head at the centreline and comparable rises throughout the rest of the foundation, indicating failure. Heave of 200mm was observed in the toe extensometers. The shape of the

hydrostatic settlement gauge plot indicates that the embankment had split and rotated although the toe inclinometer readings still showed no lateral movement at ground level and only minor movement in the peat. Small swallow holes appeared in the surface of the surcharge along with a very faint step along the centreline. A trial pit was excavated into the brick fill however no crack was observed. The following day the four inclinometers were unreadable as were four of five extensometers and the hydrostatic profile gauge. A metre of surcharge was removed over a 150m length in a bid to prevent complete collapse. Over the following weeks, the centreline extensometer kinked and became unreadable. New inclinometers were installed at the toes.
