Geotechnical Aspects of the Sydney 2000 Olympic Site

Roberta Lindbeck, Douglas Partners Pty Ltd, Sydney, Australia

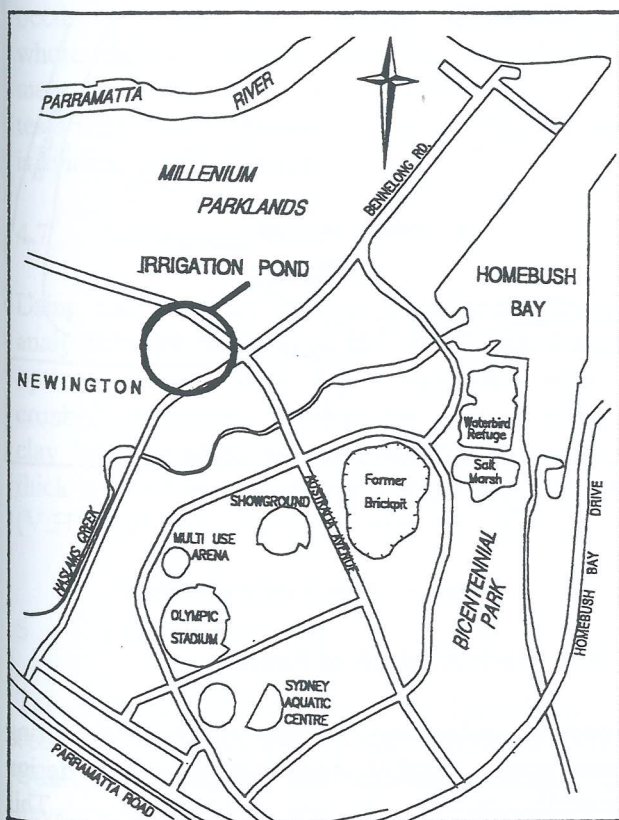
Figure 3. - The Irrigation Ponds

The redevelopment of the Homebush Bay site for the 2000 Olympic Games resulted in the removal of uncontrolled filling from low-lying areas of Newington, and replacement with imported clay filling material. The resultant refilled area was proposed for recreational use, comprising a number of water features that could be used as irrigation ponds and for flood control. A plan showing the area of the proposed ponds is included as Figure 3.

During the removal of the waste filling, it became evident that the proposed pond area was underlain by soft clay, and as a result, investigation was carried out by Douglas Partners Pty Ltd (DP) to assess the stability of the proposed ponds⁴.
