Excavations In The Brisbane CBD

David Qualischefski

This paper highlights the geological and geotechnical engineering aspects of some recently completed deep excavations in the Brisbane CBD.

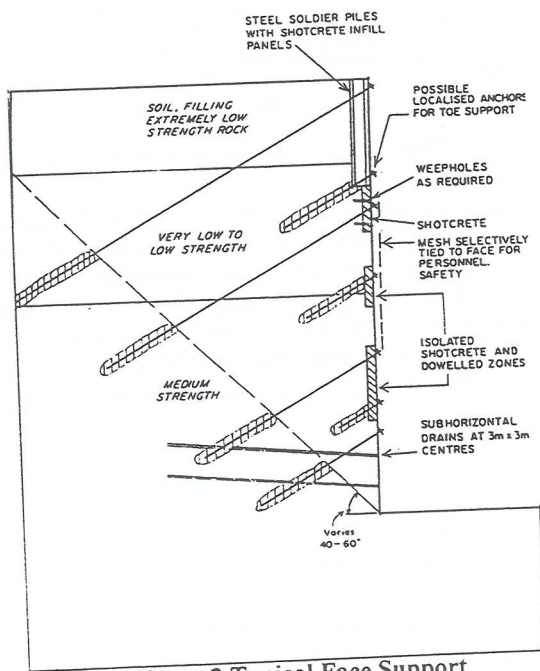
Figure 2 Typical Face Support

The ground below the soldier pile and lagging comprised competent rock (ie slightly fractured, medium strength phyllite, argillite or greywacke) and was supported by a regular grid of prestressed rock anchors. An anchor spacing of 2m to 3m horizontally was suggested for initial design.

Loose rock zones between the anchors were to be supported by shotcreted and meshed panels.

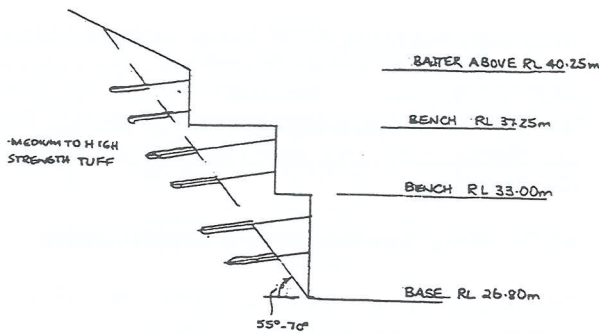
Figure 6 Typical Face Support

The excavation profile of faces B and C was to be a vertical slope, benched at 6m and 9m above the base. The bench widths were to be 3m and 5m wide respectively. Face D was to have a single bench 3m wide at 6m above the base. Face E was to be a vertical 6m high face. Faces B, C, D and E were anchored for temporary support.

Face A, was to be left in its original condition with only localised support provided to wedges. A typical excavated and anchored profile is shown on Figure 6.
