## Tairāwhiti Roads Storm Damage: Determining factors for the best remediation solution to a mass number of slope failures

### ABSTRACT

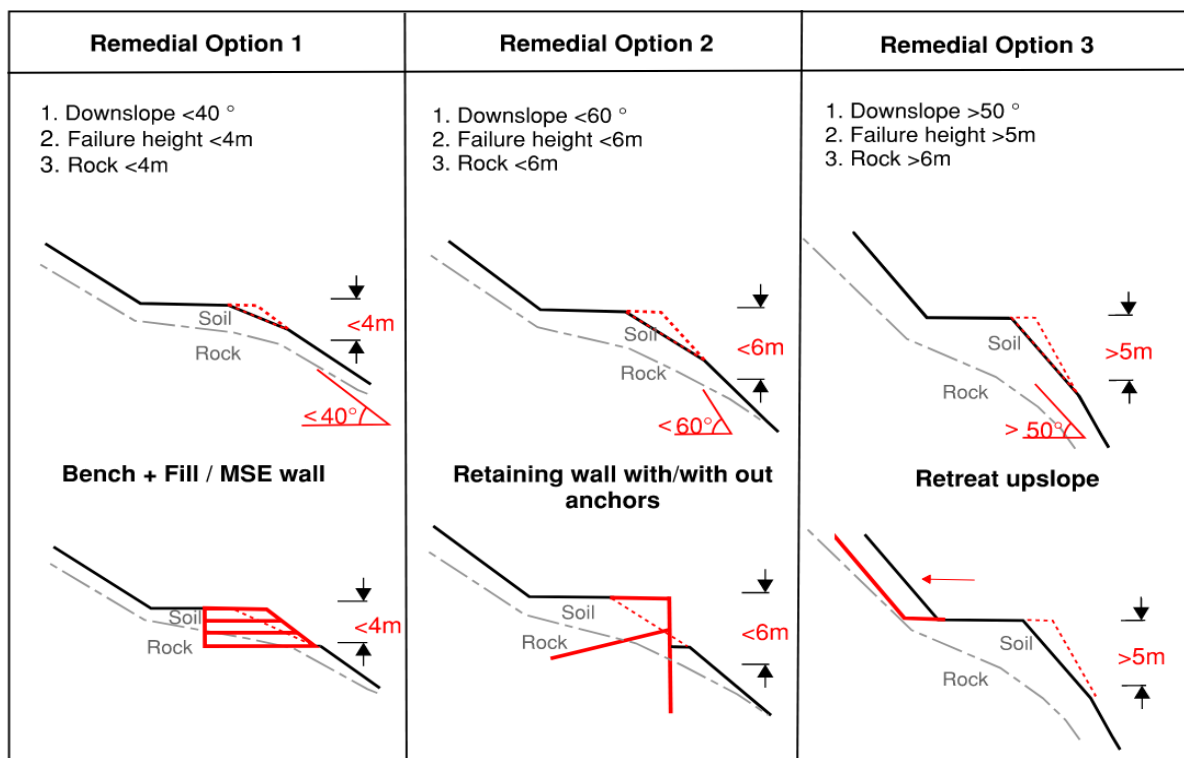
Figure 3: Generic schematic of the geometric and geological factors that helped determined the remedial option.

Although the triggers and failure mechanisms are similar for many sites, the geology and geometry were always different. Every remedial option had to be tailored to fit the site. Experience from assessing many sites enabled the field team to understand the key geologic and geometric factors which influence the remedial options. Figure 3 shows a general schematic of what geometric and geological factors helped form the best fit remedial option. Option 1 relies on the underlying material to provide a suitable bench for an MSE/bench foundation. The depth to solid founding soil or rock coupled with slope angle on the downslope side strongly influences the choices for Options 2 and 3. A steeper downslope often arises in longer poles and/or multiple anchors, resulting in Option 2 becoming uneconomical. Remedial Option 3 was often the preferred solution by the client due to the short-term economic benefit.
