# STRUCTURAL CONTROLS OF THE OTWAY RANGES AND HAZARDS FOR ROAD USERS

Dane Pope  
PSM, Geelong.

## ABSTRACT

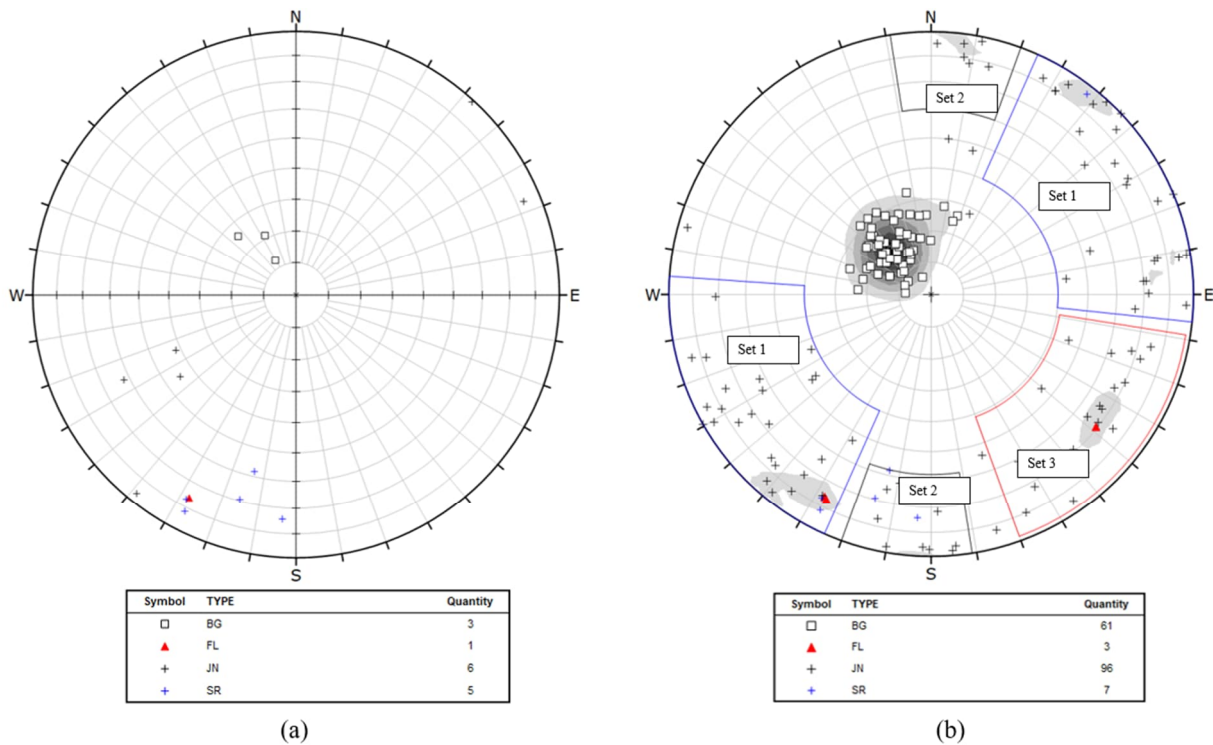
Sandstone exposures within the cut face on the southern end of the site, Figure 2 (b) presented as a blocky rock mass which is consistent with mapping completed across the township. Mapping from available exposures and across the coastal exposures of Wye River and Separation Creek, and within similar domains, are presented in Figure 7 and Table 1.

Figure 7 (a): Stereonet of features at the site mapped in 2021 (b) 2021 data supplemented with data from 2019 mapping at the site and the coastal exposures of Wye River and Separation Creek

Discontinuities are inferred to have formed during deposition (bedding) and post-depositional folding (joint sets). In folded sedimentary rocks, Fookes (2000) indicates that longitudinal, transverse joints and cross cutting joints are common. Two joint sets were mapped within the sandstone cut face on site and typically three sets are documented in the Wye River coastal exposures, Figure 7 (b) and Table 1.

A persistent fault was logged in 2019 as part of a separate investigation, Figures 7 (a) and 8. The author notes that the infill may include partially recemented boulders associated with Quaternary variations in sea level and erosion/deposition (Gill, 1979). The fault zone is inferred to have had a series of tightly spaced joints that were evacuated by erosion. This fault zone is inferred to control the abrupt change in depth to bedrock, Figures 3 to 6 and the location of the gully west of and above the road, Figure 3. Broadly the intersection of the fault with bedding (and bedding parallel shears) is inferred to control the location and axis of the gully.

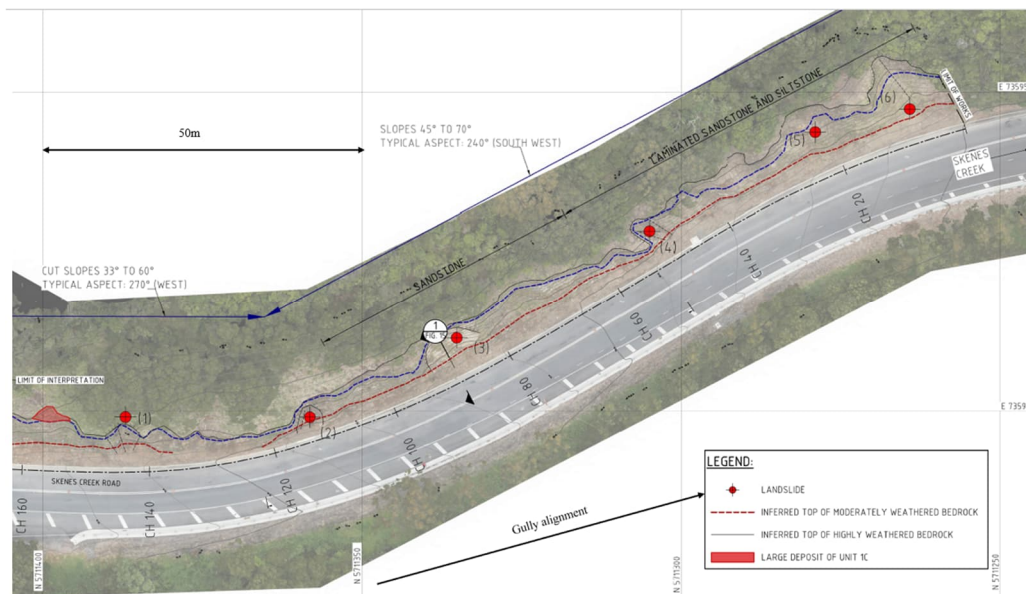
During the Author's initial visit in 2020, most of the cutting had thick vegetation, Figure 10. The slope at the 2018 wedge failure was comprised of weathered, blocky Sandstone. Two intersecting joint surfaces with relatively minor variation on southwest dip created a thin wedge, Figure 10. A limited zone was mapped between approximate project chainage Ch. 60 and Ch.150; however, it was clear that the joints controlling the failure were prevalent in all exposures. Evidence of several similar failures was observed in the cuttings, Figure 11. Due to the size of potential landslides and the limited space between the cutting and road, engineering controls would almost certainly be required to reduce the risks to target DTP levels, however vegetation clearance was required to map the exposures in detail. The extent of 2021 vegetation clearance was in the order of 180 m and the extent of works is highlighted in Figure 12.

Figure 12: Extent of Skenes Creek site with project chainages highlighted

The extent of the site post vegetation clearing is highlighted in Figure 12. The site investigation was completed entirely with field mapping techniques that included:

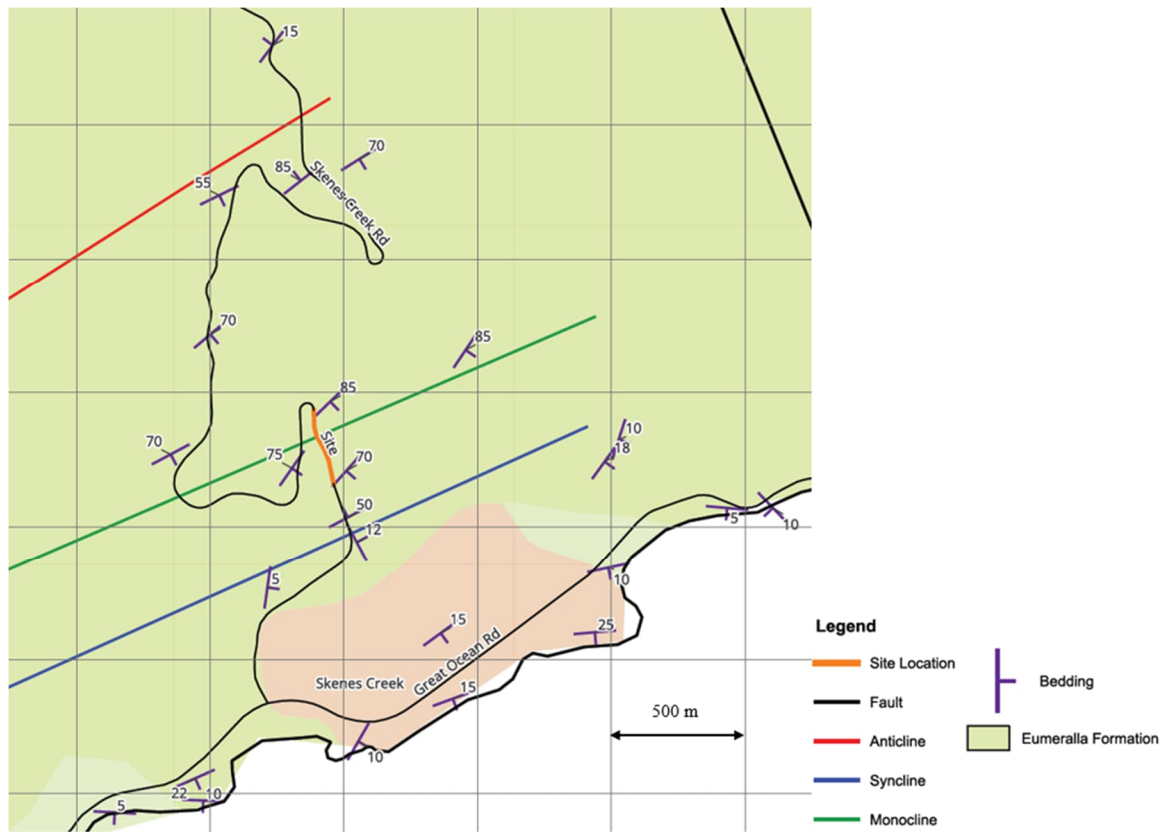
Cooney (1982) presents a readily available landslide inventory for the Skenes Creek and project area. The geology of Skenes Creek Road is well documented due to its proximity to major geological structures. For example, Cooney (1982) reported bedding typically dipping at 70 to 80° to the southeast with variation in dips inferred to occur due to proximity to the Skenes Creek Monocline, Figure 14. Furthermore, surface geology, local and regional structures in the vicinity of Skenes Creek were published by Medwell (1968), Cooney (1982), Duddy (1983), Geological Survey of Victoria (GSV), (1995) and Edwards (1996).

Various cross-sectional interpretations are available for the Skenes Creek folds (Medwell (1968) and GSV (1995) with differences in interpretation where a major regional fault is located. The varying interpretations along this section of coastline are not the purpose of this paper. The site is entirely within a region of sub-vertical to overturned beds with evidence of shearing that is universally referred to as the “Skenes Creek Monocline” by all the authors listed above. The author notes that the folding at the site could be readily interpreted as the southeast dipping limb of an asymmetrical anticline and the over-turned beds dipping at 85° towards the northwest may be aligned with major faults as suggested by GSV (1995). It is the Author’s opinion that the fold sequence from coast to hinterland aligns with Medwell (1968), Figure 14, and the reasons why Edwards (1996) has a different sequence is not clear. The published information highlights that complex structural conditions are to be expected at the site due to the close spacing of fold hinges, and steep bedding dips.

Figure 14: Regional geology with approximate published fold/fault locations based on Edwards et al, (1996), Cooney (1982), Medwell (1968) with minor variation on fold type from the Author

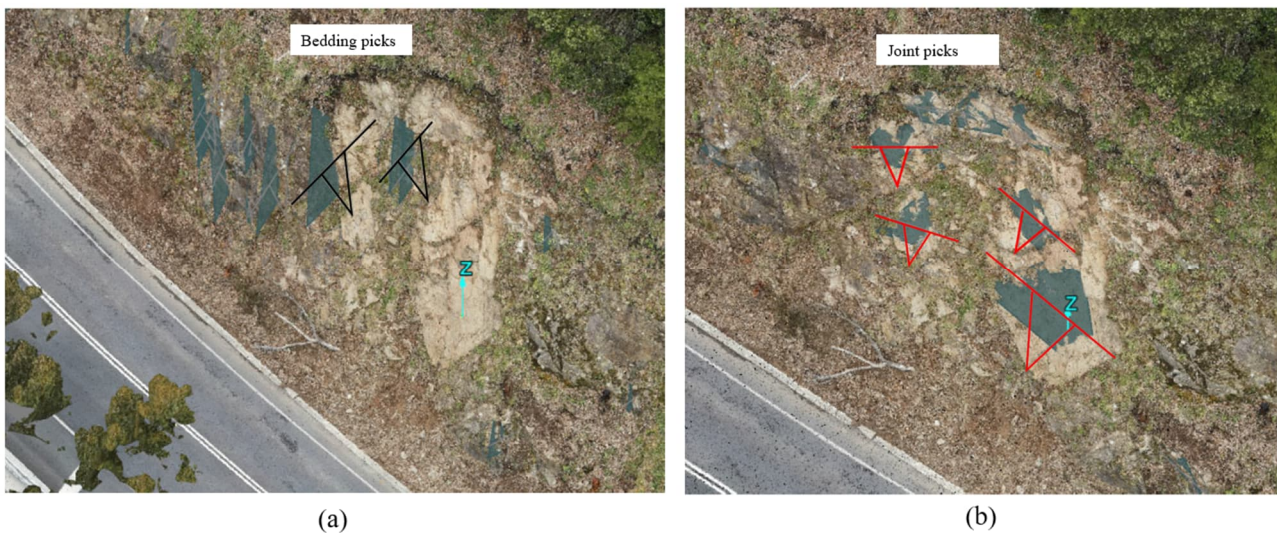
Typical excerpts from the photogrammetry-based mapping are highlighted in Figure 15. The mapping data from the site and photogrammetry mapping tasks was compared to Cooney (1982) to check for consistency with all data from line mapping and photogrammetry, Figure 16.

Figure 15: Photogrammetry picks at the Ch. 85 wedge failure (a) bedding planes (b) joint planes

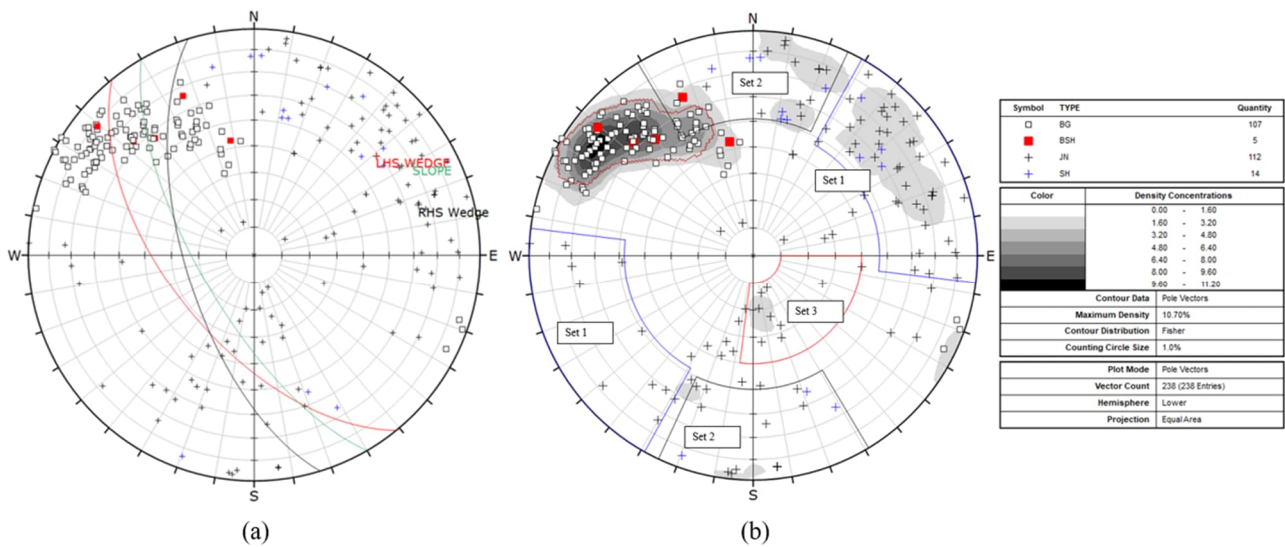
Figure 16 (a): Skenes Creek – all defects with 2018 wedge details (b): Skenes Creek – all joints and joint sets (note bedding and joints assessed independently)
